Great Falls Civic Center

Façade Assessment

April 1, 2016

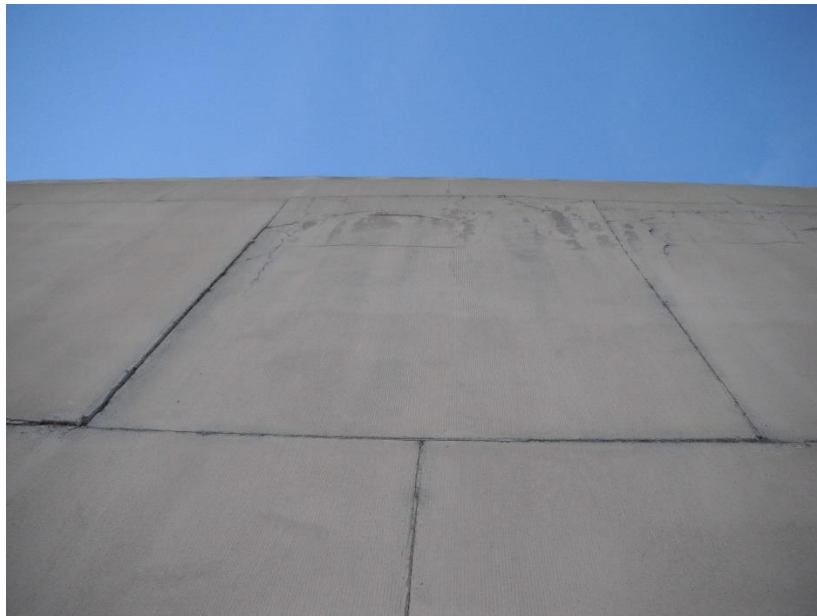
The panels themselves exhibit substantial cracking and heaving/buckling. Primarily in the larger panels at the sign above the entry, the veneer panels exhibit a mixture of surface cracking and large shear cracks in their faces. Also observable are panels that have heaved toward the exterior. This heaving is a likely cause of the bulk of the stress cracks and fractures, and is also a partial cause of mortar failures. As the panels swell independent of each other, the differential movement inherently exerts high stresses on the mortar joints, causing cracking and mortar failure.

Figure 2- Surface Cracking

It is recommended that all of the stone panels eventually be removed and replaced with panels that match the existing in order to maintain the historical integrity of the facade. These can be completed and contracted in phases, focusing on sections of the building at a time.

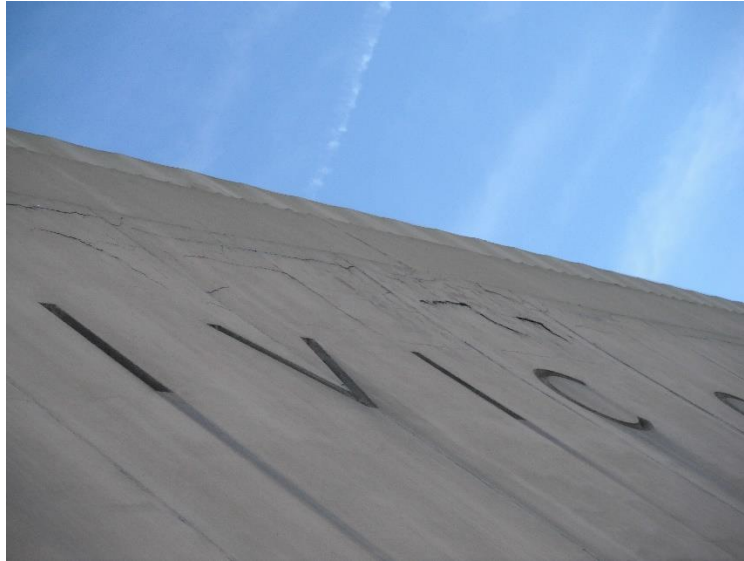
Figure 3 - Some Panels Exhibit Potential for Shearing due to Internal Forces

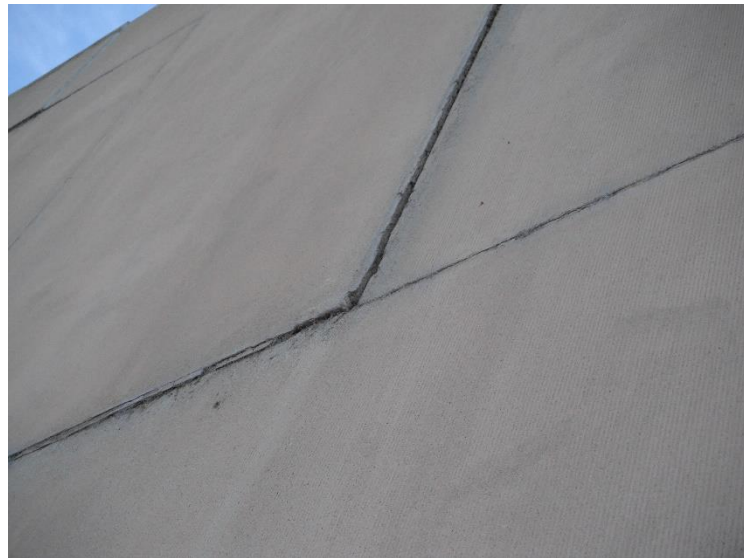
Figure 4 - Noticeable Buckling is Observed on Some Panels

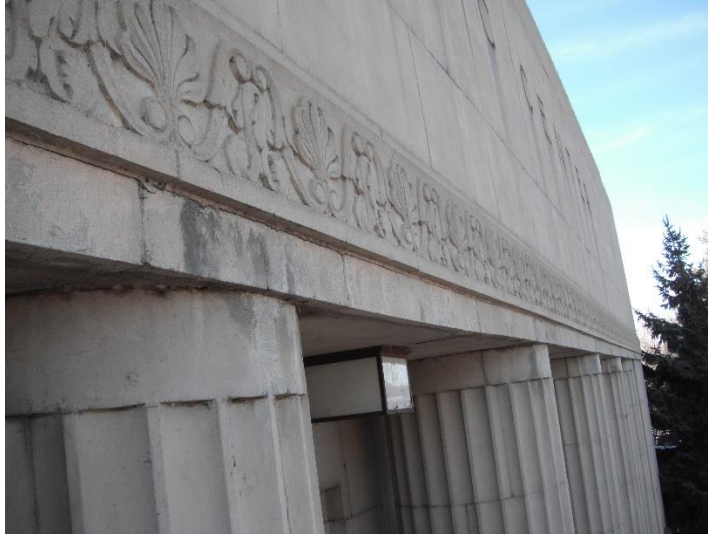
Some of the stone panels appear to still be in relatively good shape. Most of the decorative frieze above the entry is in good condition, as are the fluted stone columns at the entry. The stone panels at the entry itself are in relatively good condition as well, and are sheltered from direct exposure to rainfall and weather. Denticel detail bands at the top of the walls are both in rough condition, with exposed reinforcement and spalling/peeling panels. Visible cracks are in locations where water is provided easy entry and freeze-thaw cycles can further damage the façade.

Figure 5 - Some features, such as this frieze, are still in good condition.

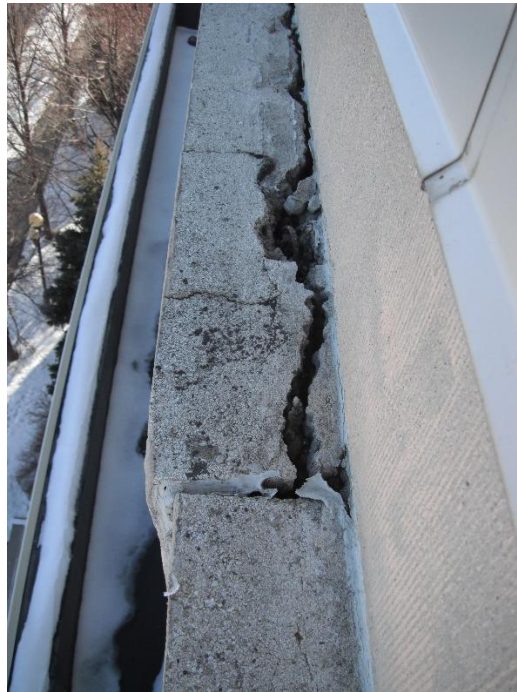
Figure 6 - Major Cracking at Top Edge of Veneer

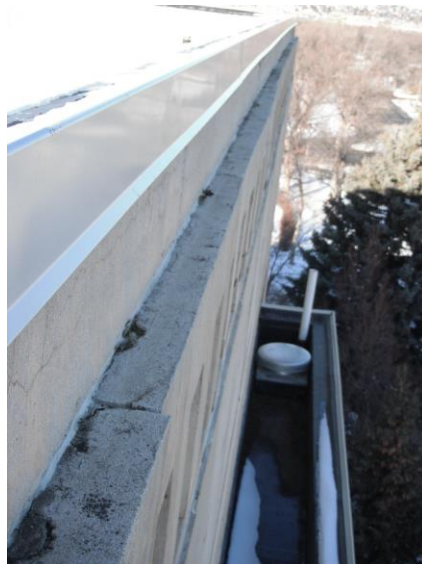
Both of these vents are either absent or covered up at the existing installation. No weep vents could be observed during our site inspections, and no head vents were exposed. There is evidence that the masonry has been re-pointed at some point in the past. Perhaps there were vents at one time, but have since been filled or covered.

At the small roof over the entry, a relatively new EPDM membrane was installed. It is terminated on the top of the stone with a standard manufacturer's termination bar, and is terminated on the face the brick similarly and sealed. It appears that this membrane covers up a flashing band and possible weep vents for the brick wall. It may also be preventing the veneer face from ventilating properly on the front as well, resulting in increased moisture in the cavity of the wall. Visual observation underneath the membrane was not available without compromising the weather-tightness of the membrane.

Figure 7 - Both Upper and Lower Roofs have covered any potential Air Space

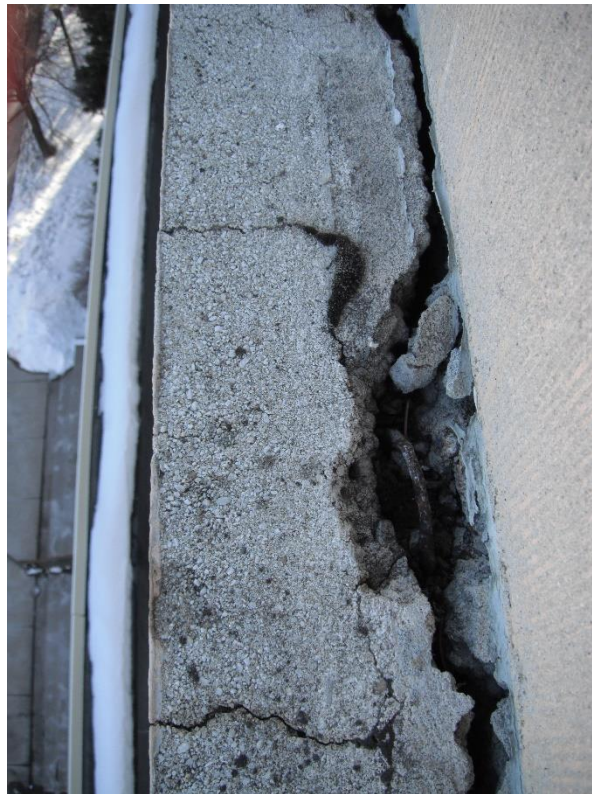
Further, as indicated in the Hessler report, the interior reinforcement steel within the panels is corroding and will continue to corrode due not only to presence of water, but to the chlorides and chemical composition that now exists within the stone panels and the wall system. Further corrosion of the steel will continue to compromise the structural integrity of the panels.

Figure 8 - Exposed Reinforcement
