ASSESSMENT of the CONDITION of and RECOMMENDATIONS for REHABILITATION and REPAIR to the BUILDING EXTERIOR

**Civic Center Restoration - GTF
STPE 7(47)
Control No. 6338, O.F. #1525
2 Park Drive South
Great Falls MT 59401**

April 18, 2011

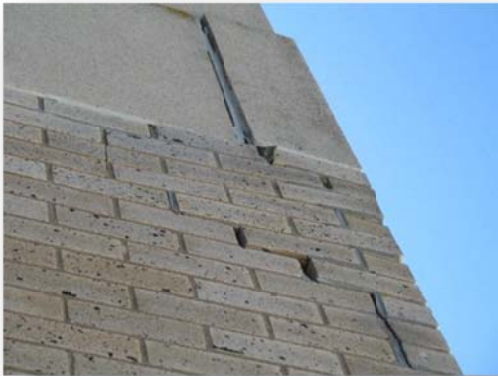
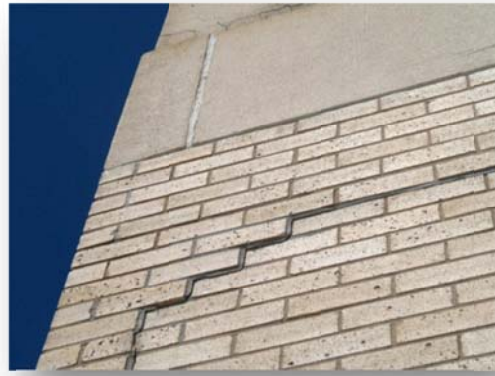
1. The brick veneer of the building was placed in very large expanses, particularly in the length of the walls. There were no expansion joints noted in any of the brick veneer wall expanses. It is very probable that with thermal and moisture expansion of the brick veneer that the only place for the brick to “give” is at the building corners where expansion caused displacement of the veneer and cracking occurred where the pressures were eventually relieved. Unrestrained sections of brickwork will expand vertically from their support and horizontally from the center of the wall towards the unrestrained corners.

There seems to be compounding errors in the lack of expansion joints and proper placement of expansion joints that has caused displacement and cracking of the brick veneer at virtually all unrestrained building corners.

Displaced Brick Corners

2. It is possible that these brick problem areas could have been caused by the migration of water behind the veneer, freezing, expanding and displacing the brick. When confined water freezes, it expands with pressures in the order of 15,000psi. It is not very probable that this is the cause since the problems occur only at building corners and there were no flashing problems noted that could account for the quantity of water it would take to cause this brick displacement and cracking.
3. The problem could also be the result of structural settlement of the building structure, but it is not possible to make this determination without extensive destructive examination.

3. Repoint wall areas with weathered mortar joints.
4. Carefully dismantle brickwork at wall corners where cracking and dislocation has occurred. Salvage and clean the brick. Reconstruct wall corners using salvaged brick. This will also give us an opportunity to inspect the area for cause of brick movement other than the suspected expansion.

5. Saw cut into the brickwork vertical expansion joints at a determined spacing and at other recommended locations in the brickwork. This will change the appearance of the building very slightly due to the addition of these vertical lines each 25 feet, but they will be caulked in a color to closely match the brick. Installing these joints will solve the problems created by not having the expansion joints.

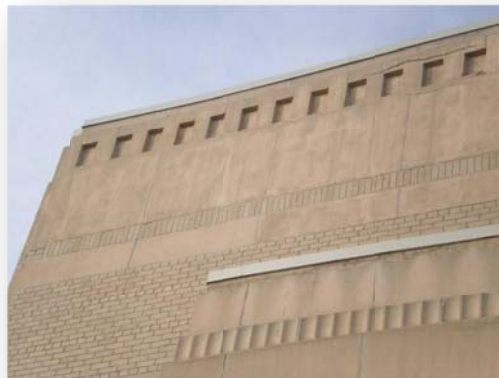
The brick veneer on the East Façade has “pinkish” staining on it caused by migration of whatever coating was applied to the “stone veneer”. This coating was applied only to the East Façade of the building and thus the staining of the brick veneer occurs only on the East Façade. Petrographic examination of the coating indicates it is pigment.

Pink Staining on East Façade

6. Clean all brickwork with mild cleaning process, in particular to remove pink staining on the East Façade and accumulated dirt and staining on all other brick areas.

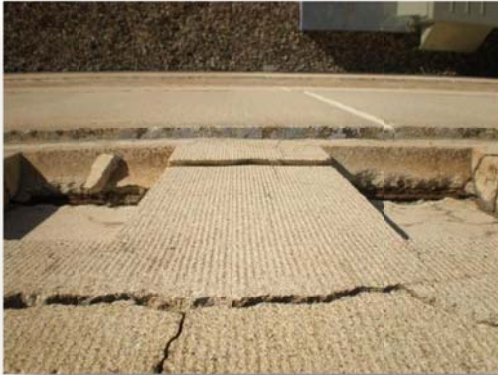
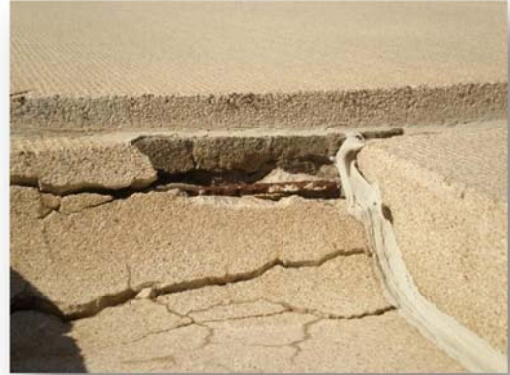
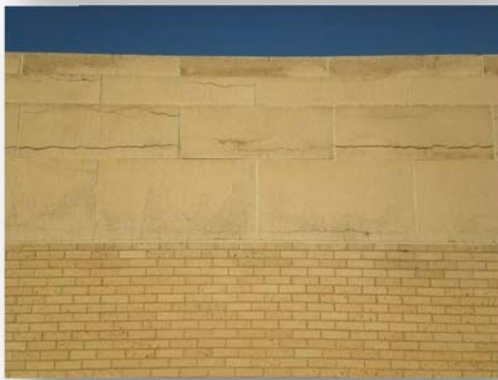
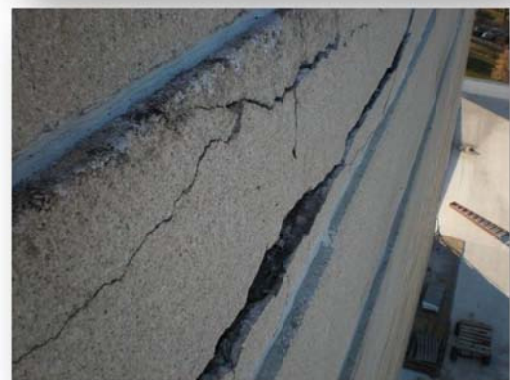
Investigation of the cast stone veneer revealed large expanses of panels with major cracking and major expanses of panels with "spider web", very fine cracking visible on the surface. A couple loose pieces that had broken off some panels indicate the reinforcing bars in those two cases to be 1.25 inches below the exterior surface of the panel. This distance from the surface is generally considered to be too close and rusting of the reinforcement will cause spalling or cracking of the panel. Note that the reinforcing bar in the sample submitted for petrographic examination was 2.125 inches from the surface, which is an acceptable distance. It is clear that those panels with open cracks are severely damaged with severe deterioration caused by the

rusting of the steel reinforcement. However, a petrographic examination was ordered to determine the serviceability of panels that do not have major open cracks. It was not apparent whether these panels were experiencing rebar corrosion or just a cosmetic damage.

Various Degrees of Cast Stone Deterioration

3. REMOVE ALL cast stone veneer, cast lintels, cast stone copings, etc. and replace with modern cast stone to exactly match the existing cast stone panels and shapes. It is recommended that all lintels have painted, galvanized steel lintels installed underneath them. Repair/replacement of roof flashings will be required on all parapet walls in order to accomplish this work. It is recommended that the following items not be replaced: ornamental course, large slabs above entry doors, large fluted columns on the East Façade, stone window sills, and "granite" panels.

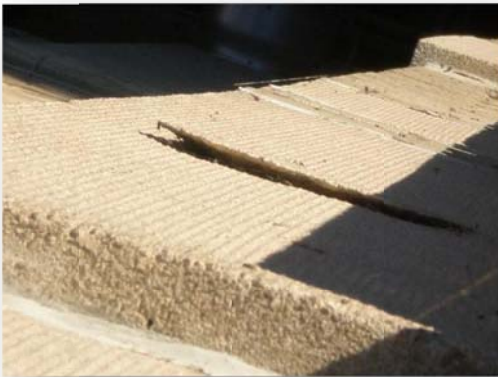
Spalling Panel Face

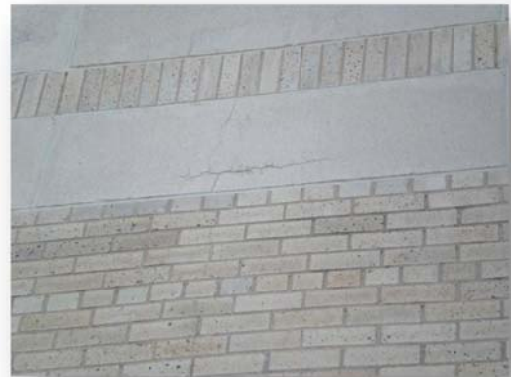
Fine Cracking

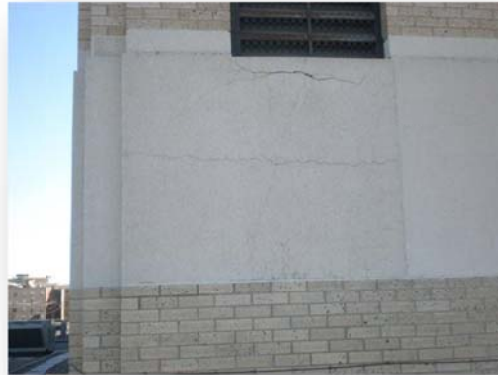
Petrographic Examination. A 4 inch diameter core was extracted from one of the cast stone panels above the Convention Center, on the West Wall of the stage fly loft wall. The core was just over 4 inches in length and the distance from the face of the panel to the concrete structure behind the core is 5.5 inches. A stereoscopic and petrographic examination using a polarized-light microscope was conducted by Material Scientists – Wiss, Janney, Elstner Associates, Inc., Northbrook, Illinois. Their report is attached as **Exhibit A**. The conclusion of their report is that several cracks radiate in different directions from the location of a corroded rebar. Two major causes for the corrosion are: 1) carbonation of the cement paste that extends virtually full depth

of the concrete and 2) high chloride levels that are two to more than four times the typical corrosion threshold of uncoated reinforcing in concrete. They suspect that chloride was likely added to the concrete mix when it was originally cast to accelerate the setting. They say that corrosion of the embedded rebar is expected to continue because of the carbonation and the chloride content and that panel deterioration appears to be past what is practical to affect a lasting repair of the panels.

Panel Where Petrographic Sample Was Taken

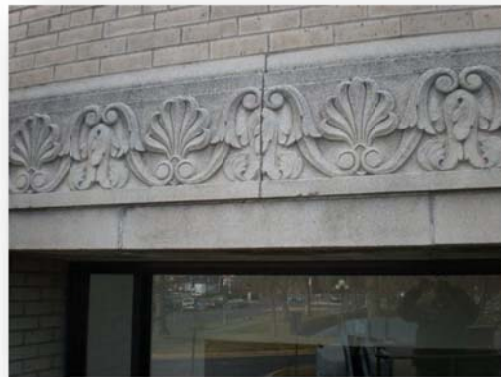
There are bands of ornately carved or cast “stones”. All of these ornate stones appear to be in very good condition, with the exception of one which has a crack through it. It is not known whether these are actually stone or if they also are cast stones.

Ornately Carved Stone

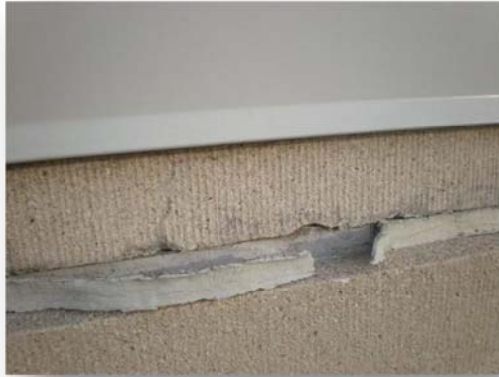
Joints between cast stone panels were noted to be caulked joints. Upon further examination it was determined that these joints are actually mortar joints and that at some point in time a caulking material was placed directly over the top of the mortar joints. This may have been in response to noticing panel cracking and suspecting water was entering the panels at the joints.

Caulking Over the Top of Mortar Joint

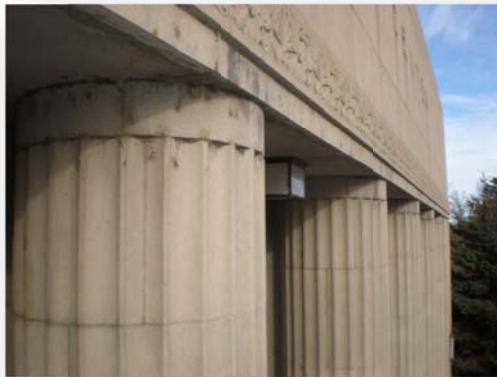
The large, round, fluted “stone” columns on the East Façade are in good condition with weathered mortar joints.

Fluted Columns on East Façade

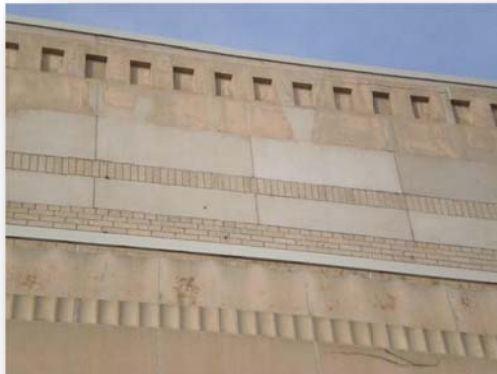
The East Façade of the building has a “pinkish” tint to it. Upon close examination it could be seen that perhaps a coating had been applied at some time in the past. This coating was scraped off and sent in for petrographic examination. The examination determined the material is pigment. So, at some time in the past a paint type product was applied only to the East Façade. The reason for the application of this coating is unknown.

Cast Panels with Pinkish Tint
Highlighted by the Area Where the Marquee Sign Was Removed

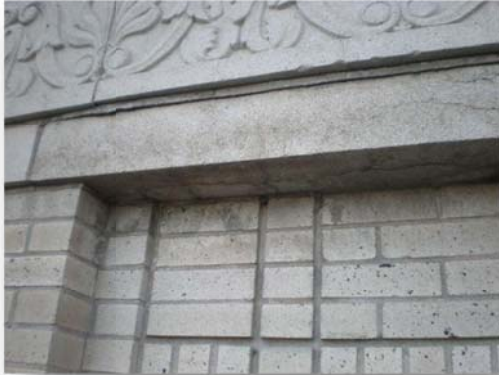
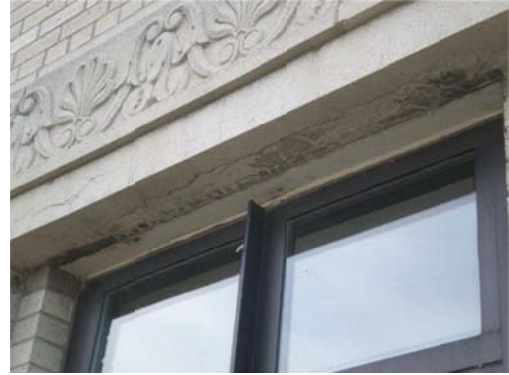
Window lintels. Many of the cast stone window lintels have a steel plate under them and many do not. Most of the lintels are cracking, some severely.

Examples of Cracked Lintels

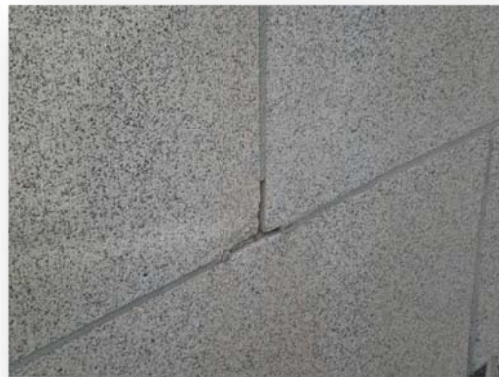
The base of the East Façade and South Façade has what looks like granite veneer. It is presumed this is also cast stone veneer. However, due to the surface pattern it is difficult to see if there is any surface cracking or crazing.

"Granite" Cast Stone Panels

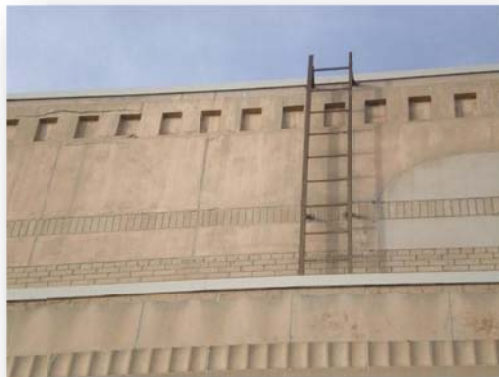
There are several ladders between various roof levels on the building exterior. These fixed ladders are regulated by OSHA 3124-12R 2003. The exterior ladders do not comply with these OSHA requirements. All roof levels have access to the roofs via interior ladders, so all of the exterior ladders could be removed and access to all roof levels would still be maintained. We did not investigate the interior ladders for OSHA compliance.

Roof Ladder

1. Remove all exterior roof ladders as they do not comply with current OSHA requirements.
2. Consider evaluating interior ladders for compliance with OSHA recommendations and upgrade these interior ladders if necessary to bring into compliance. Evaluation of interior ladders is beyond the scope of this contract.

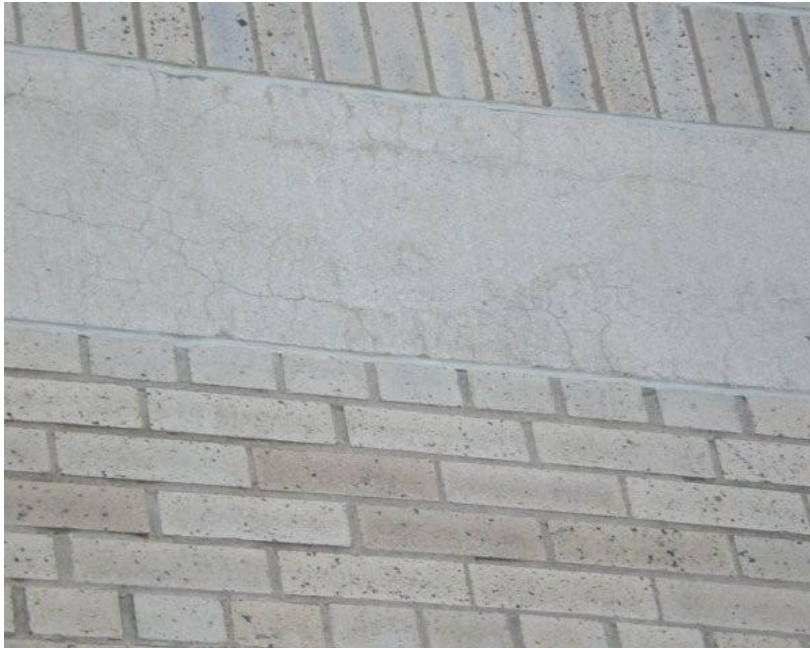
Figure 3. View of the fine cracks on panels that are currently in good condition (NTL).

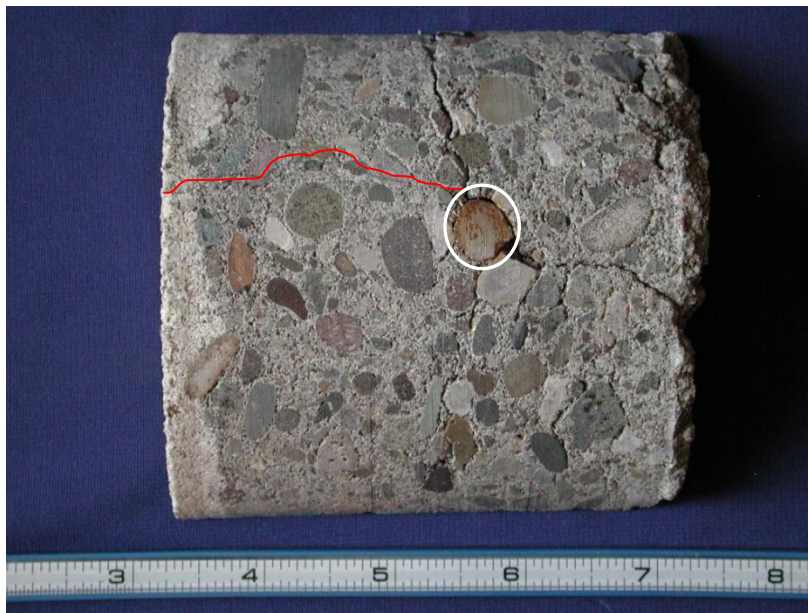
A 3/8-inch-diameter reinforcing bar is embedded 2-1/8 from the exposed surface of the core. The surfaces of the rebar exhibit significant corrosion. Cracks radiate in all directions from the location of the rebar. The cracks appear to be caused by corrosion of the embedded reinforcing bar. The concrete is not well densified within 1 inch of the inner surface of the core. A few cracks were detected within this 1 inch zone. The cracks in this zone usually follow the areas of abundant air voids related to incomplete consolidation. There is no evidence of cracking related to any deleterious chemical reactions within the concrete or paste. (Figures 4 through 8)

Figure 4. Side view of the core. Cracks radiate from the corroded reinforcing bar. One fine crack to the surface is outlined in red. The irregular cracks in the photo located to the right of the (encircled) rebar and oriented parallel to the inner surface coincide with abundant air voids that are typical of dry cast concrete.

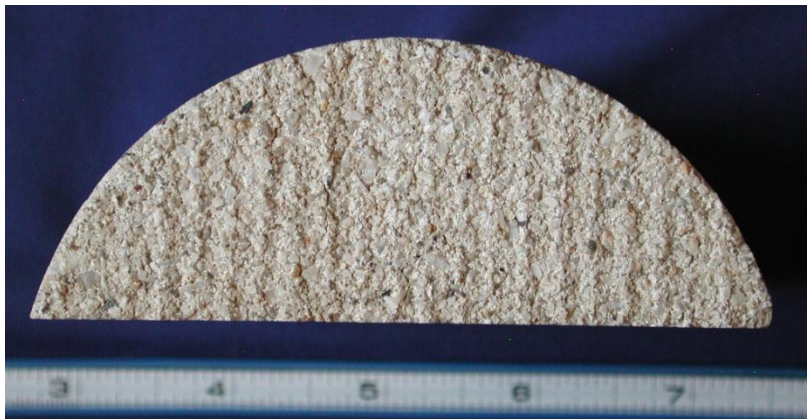
Figure 6. View of the finely ridged, exposed surface of the face mix.

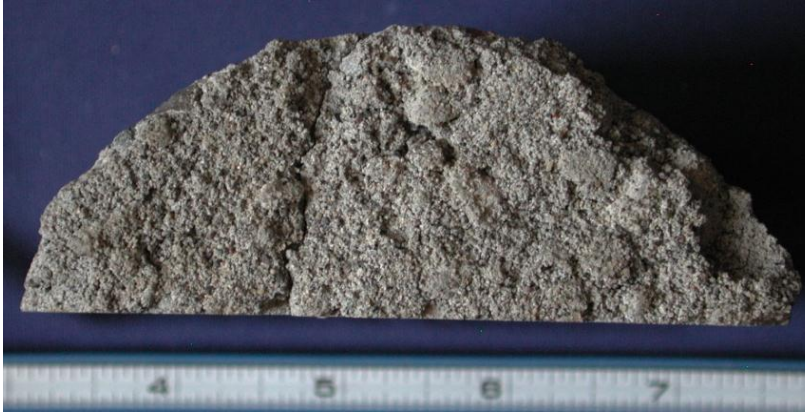
Figure 7. View of the inner, poorly densified surface of the backup concrete.

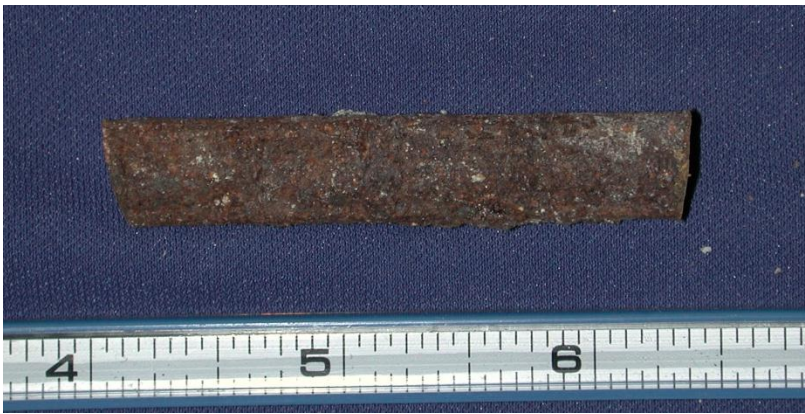
Figure 8. Section of the corroded reinforcing bar.

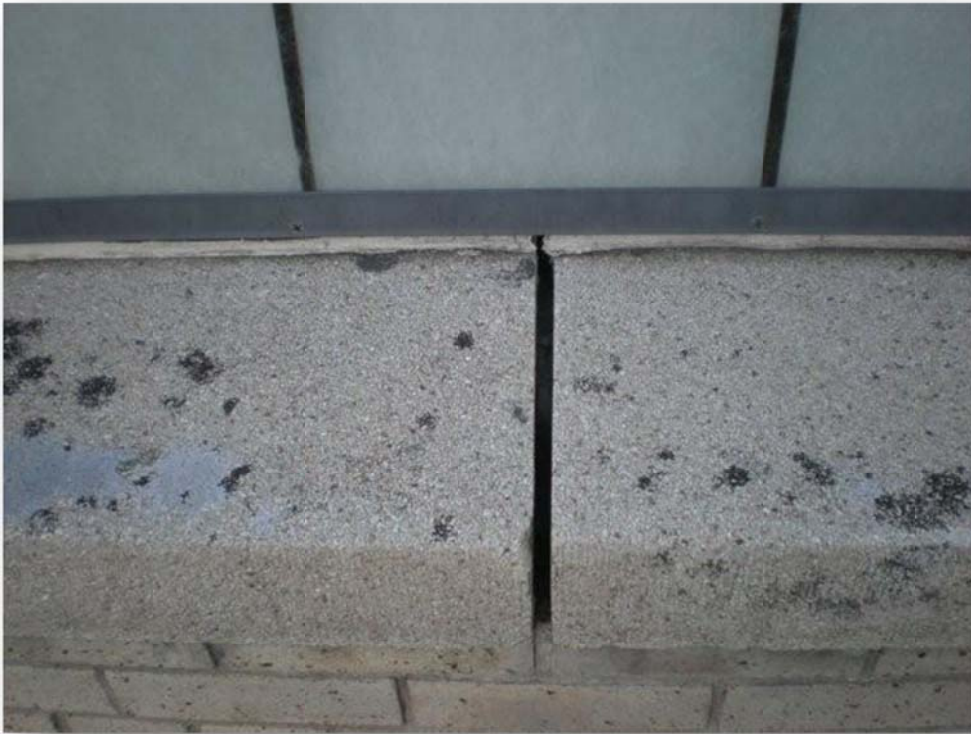
Photo W1 – Typical Window Sill Weathered Mortar Joint

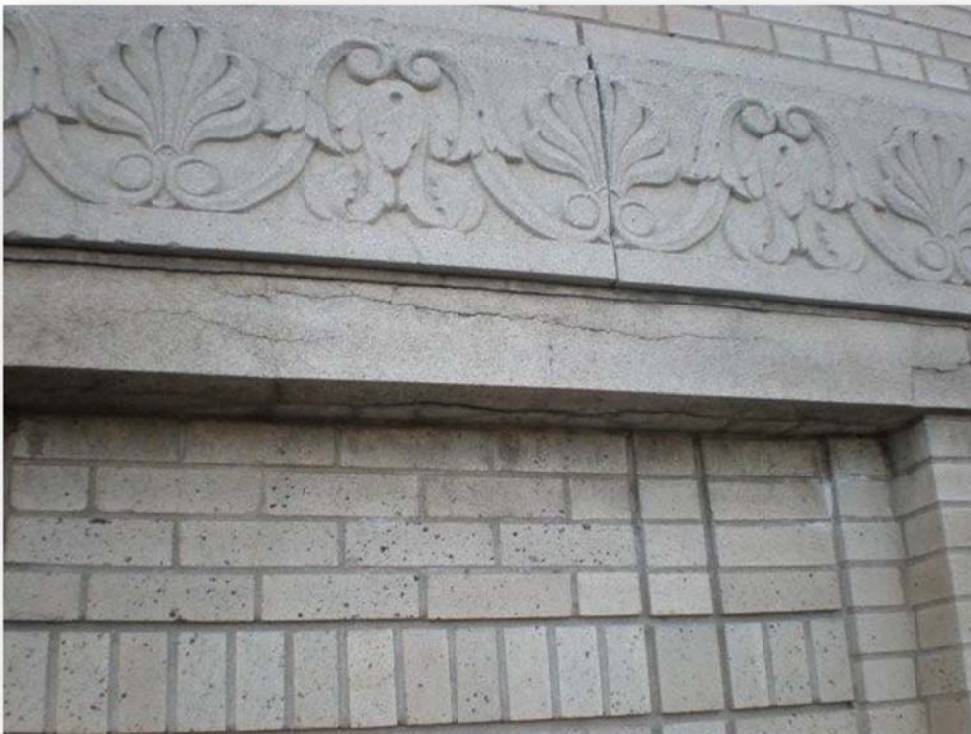
Photo W2 – Typical Cracked Lintel Block

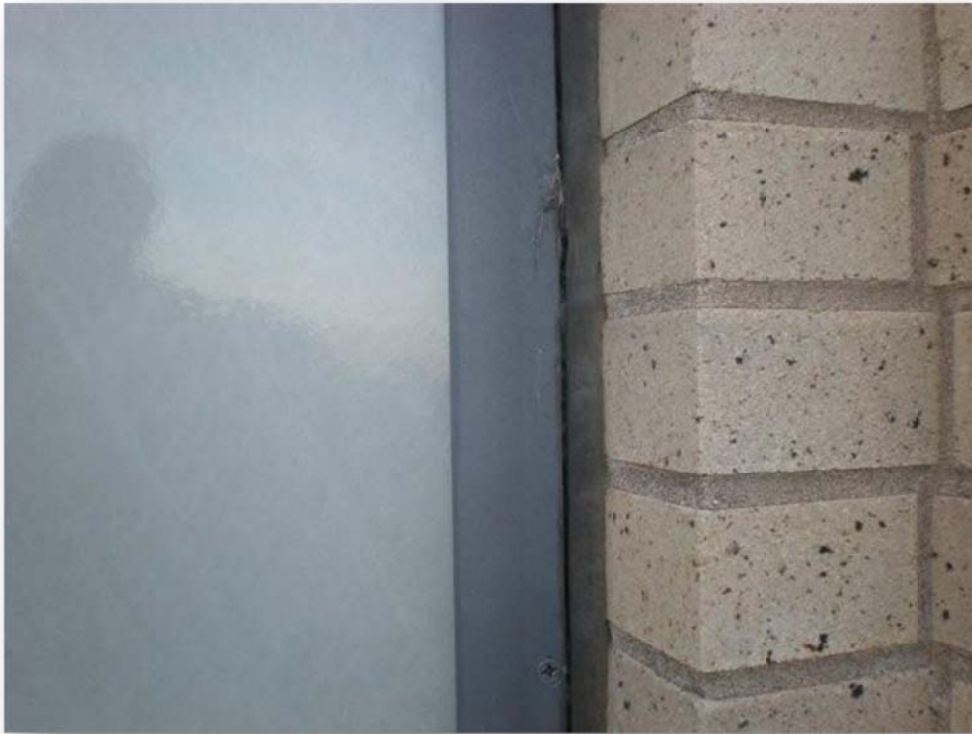
Photo W3 – Typical Window Weathered Caulking Joint

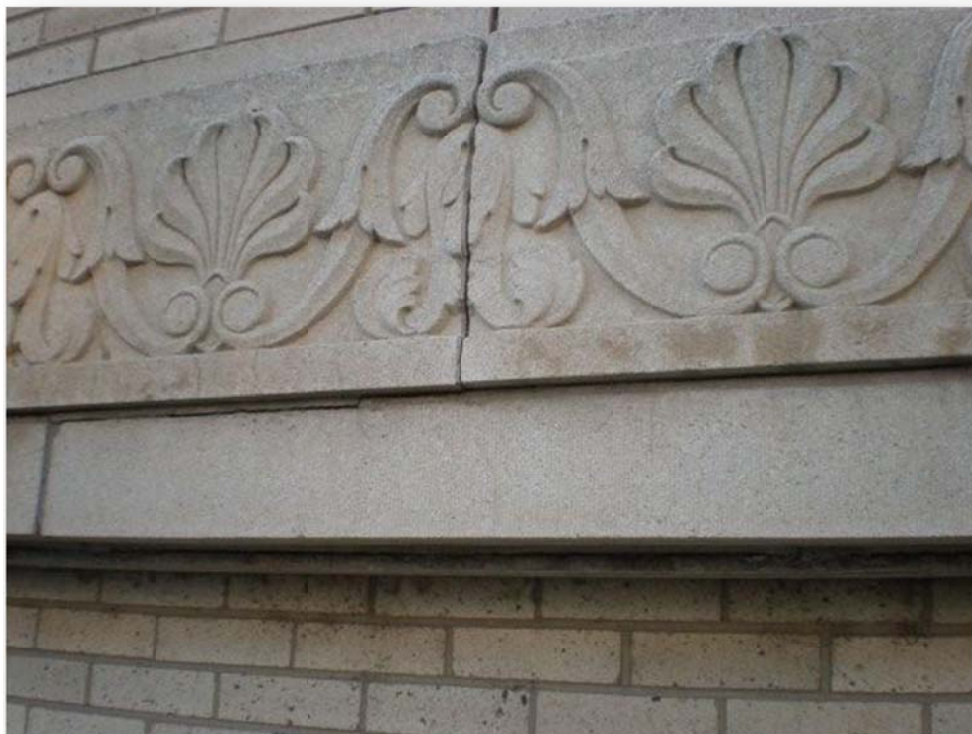
Photo W4 – Typical Weathered Mortar Joints

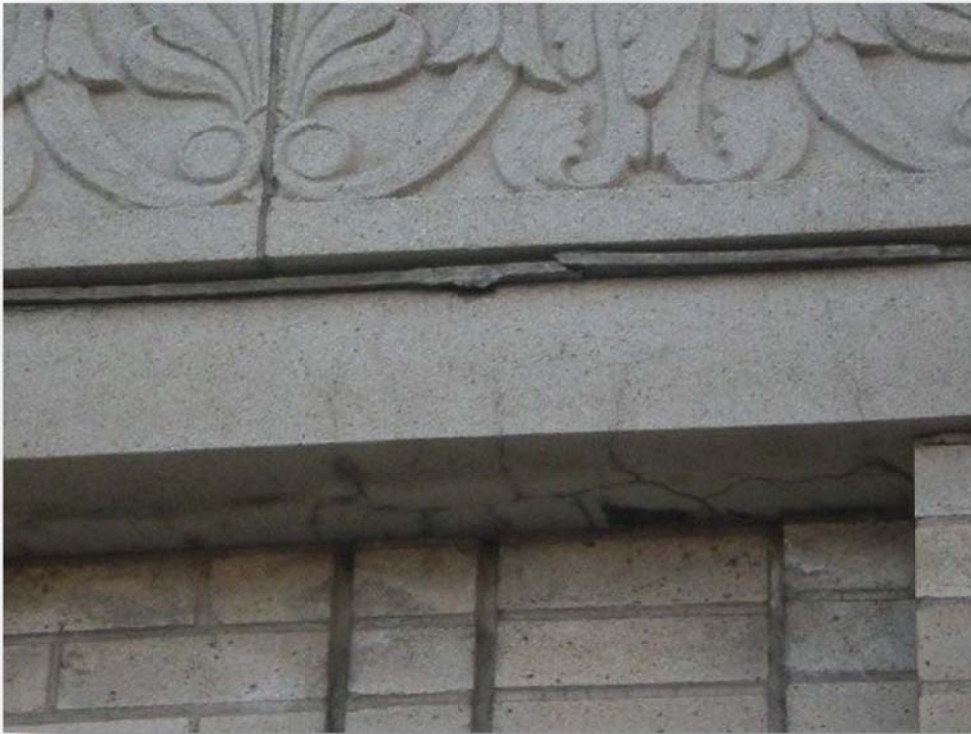
Photo W5 – Typical Cracked Lintel and Weathered Mortar Joints

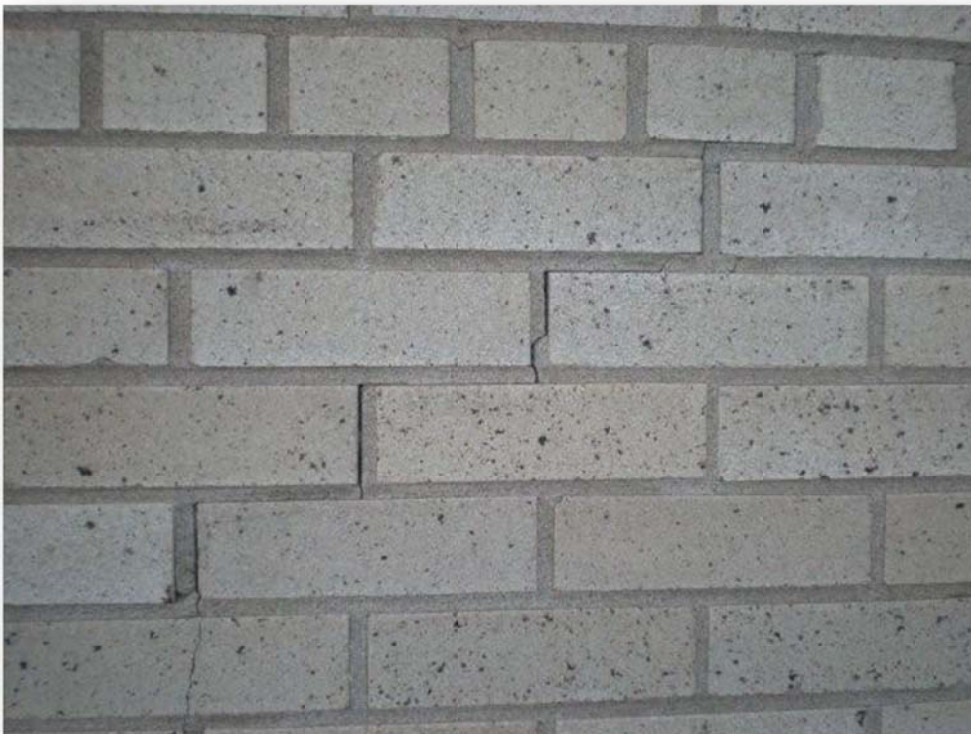
Photo W6 – Brick Cracking

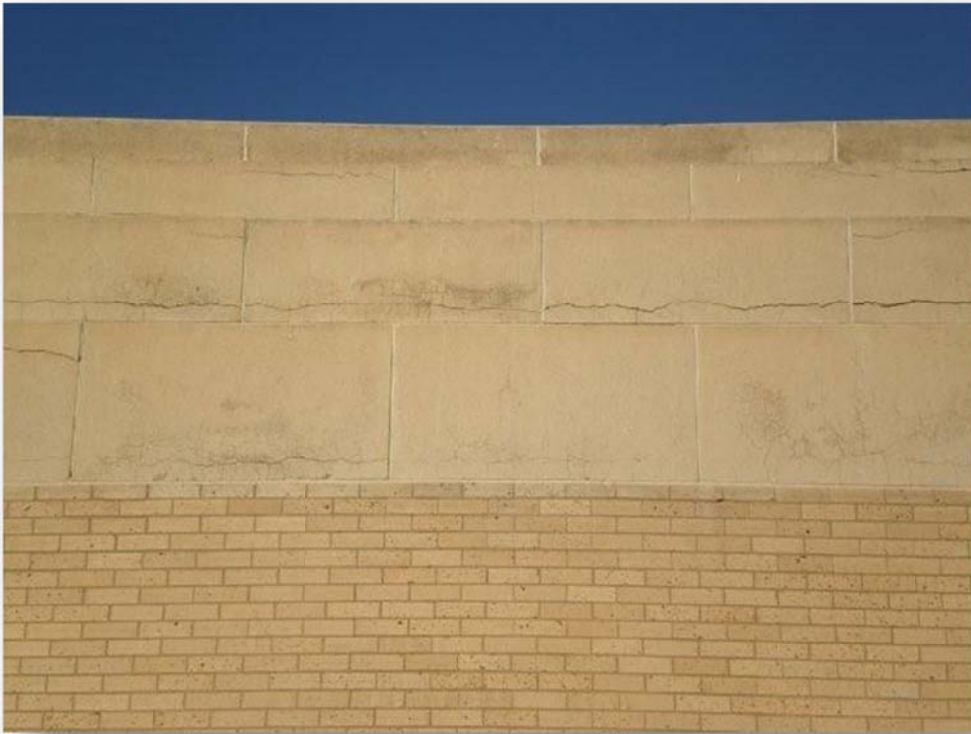
Photo W7 – Typical Cracking Cast Panels

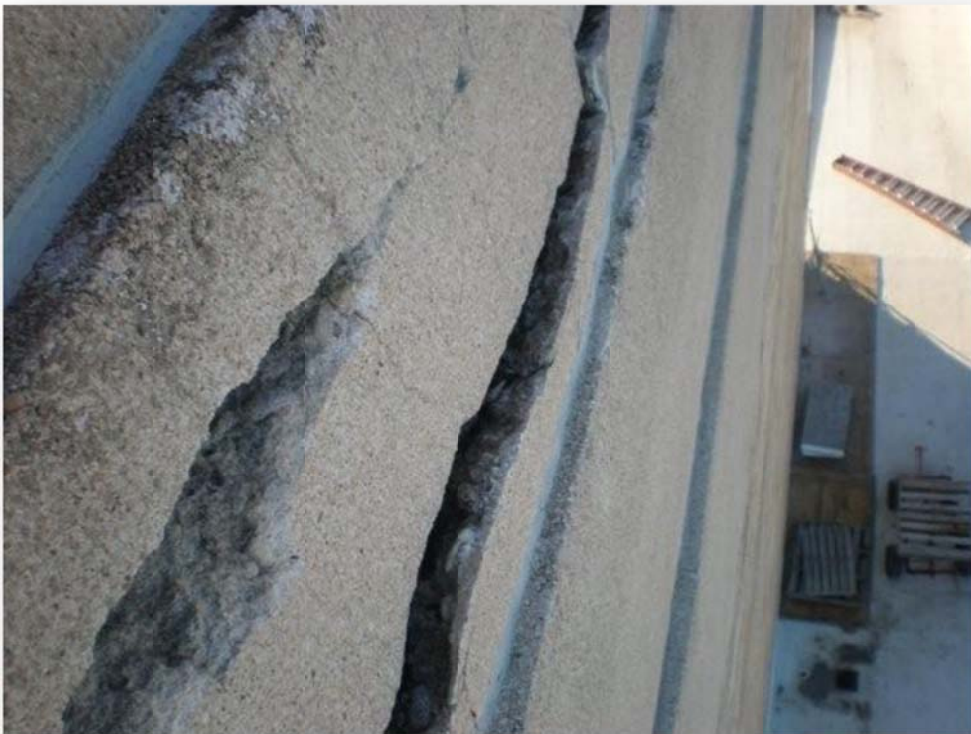
Photo W8 – Large Open Cast Panel Cracks

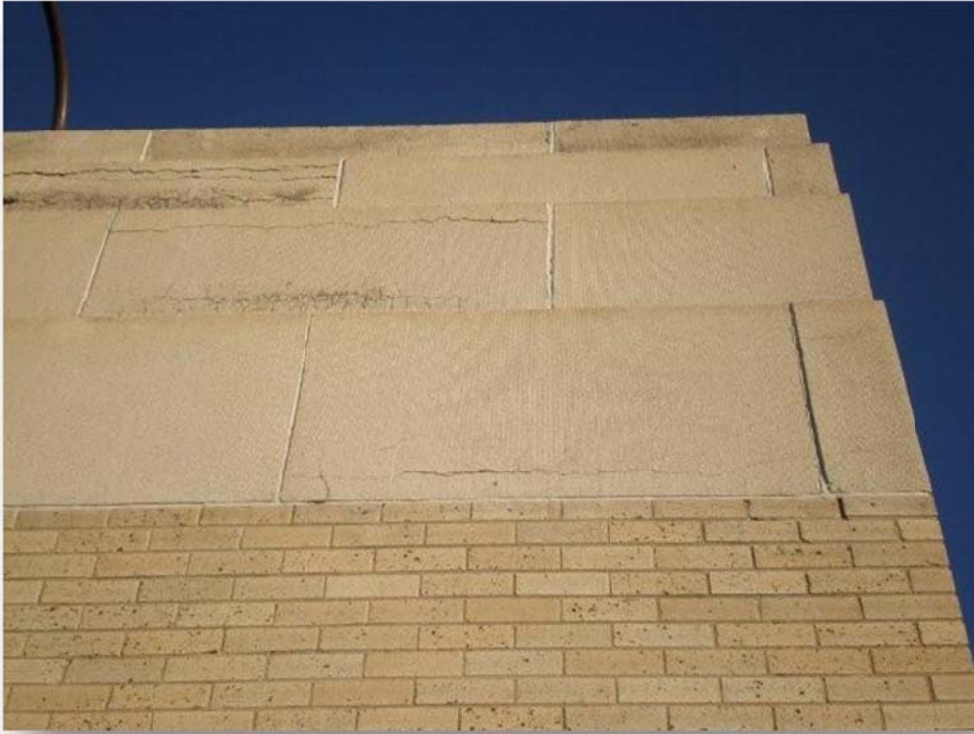
Photo S1 – Typical Cracking Cast Panels

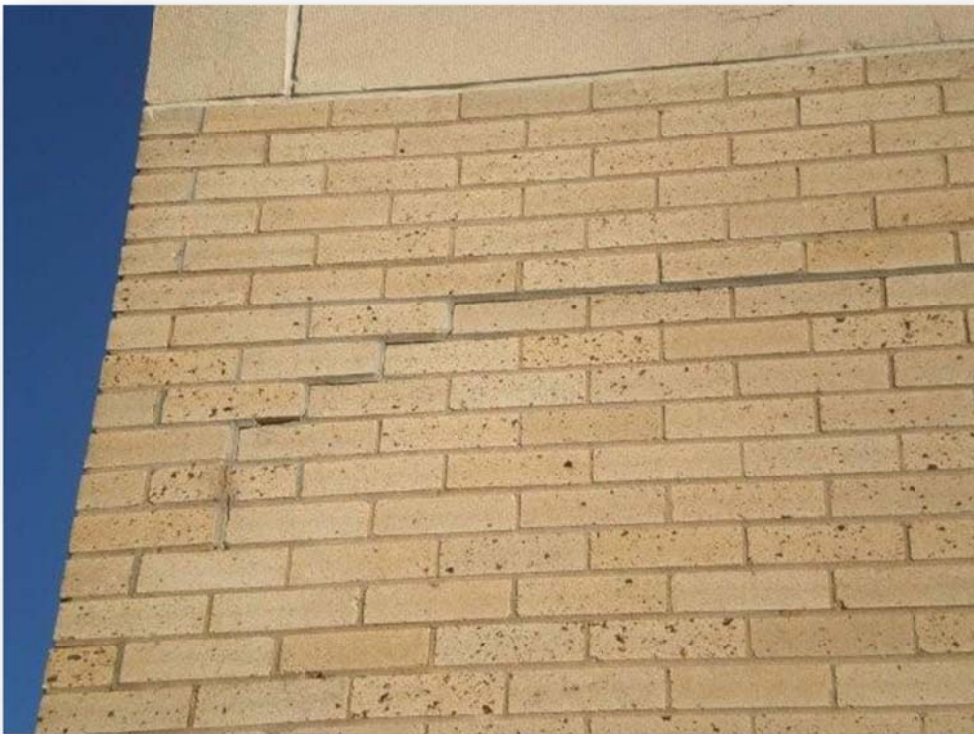
Photo S2 – Cracking & Displaced Brick

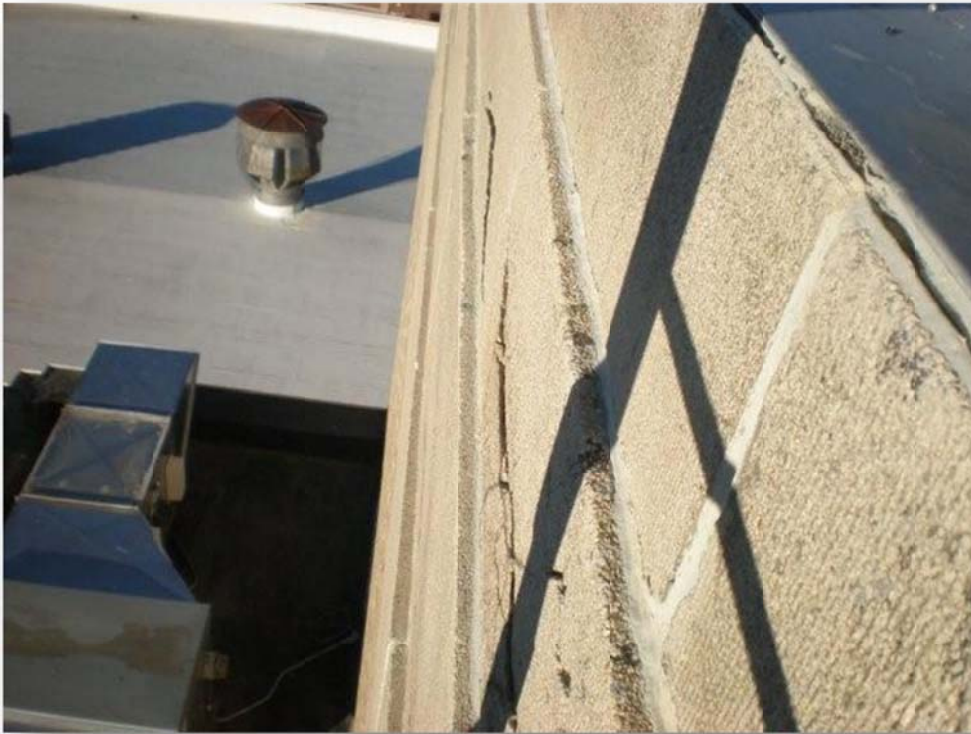
Photo S3 – Typical Cracking Cast Panels

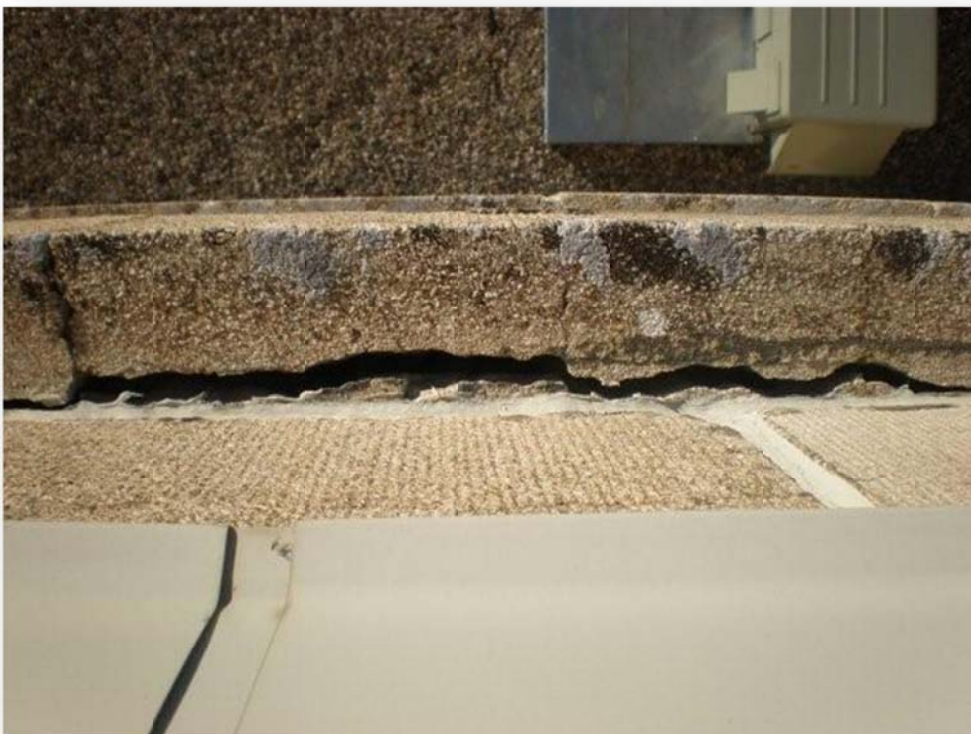
Photo S4 – Large Open Cast Panel Cracks

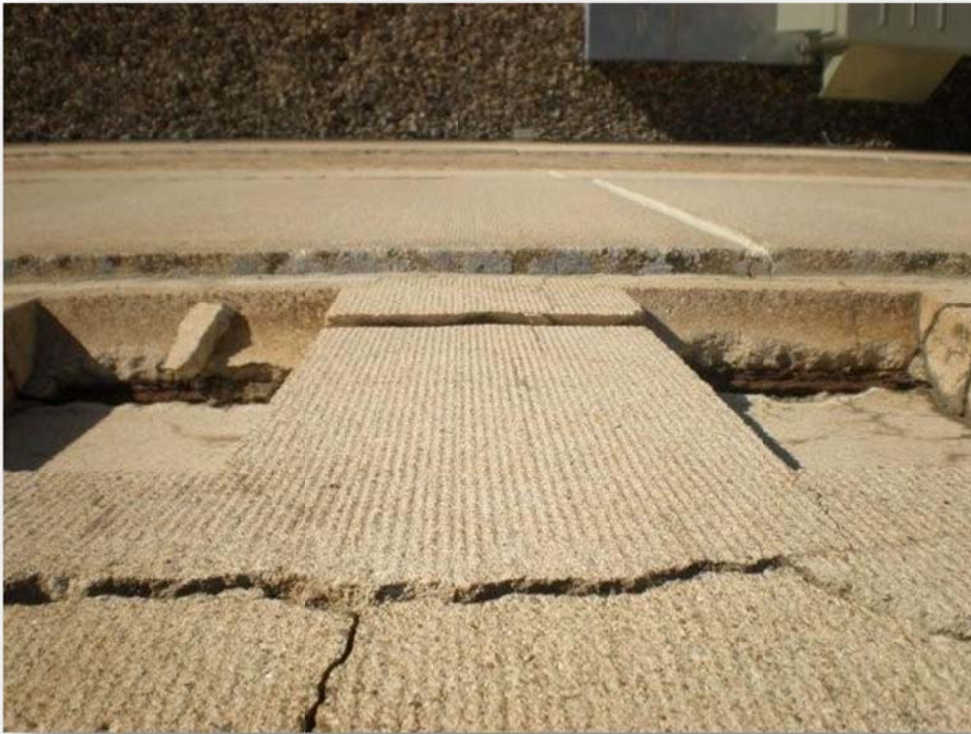
Photo S5 – Typical Cracking Cast Panels

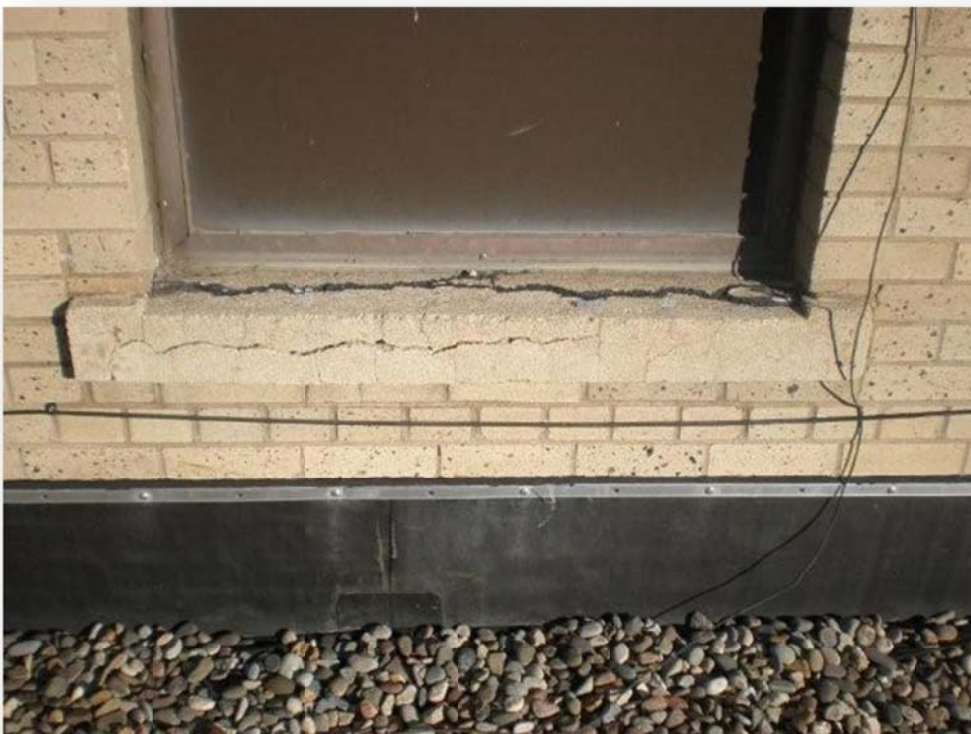
Photo S6 – Cracked Cast Window Sill

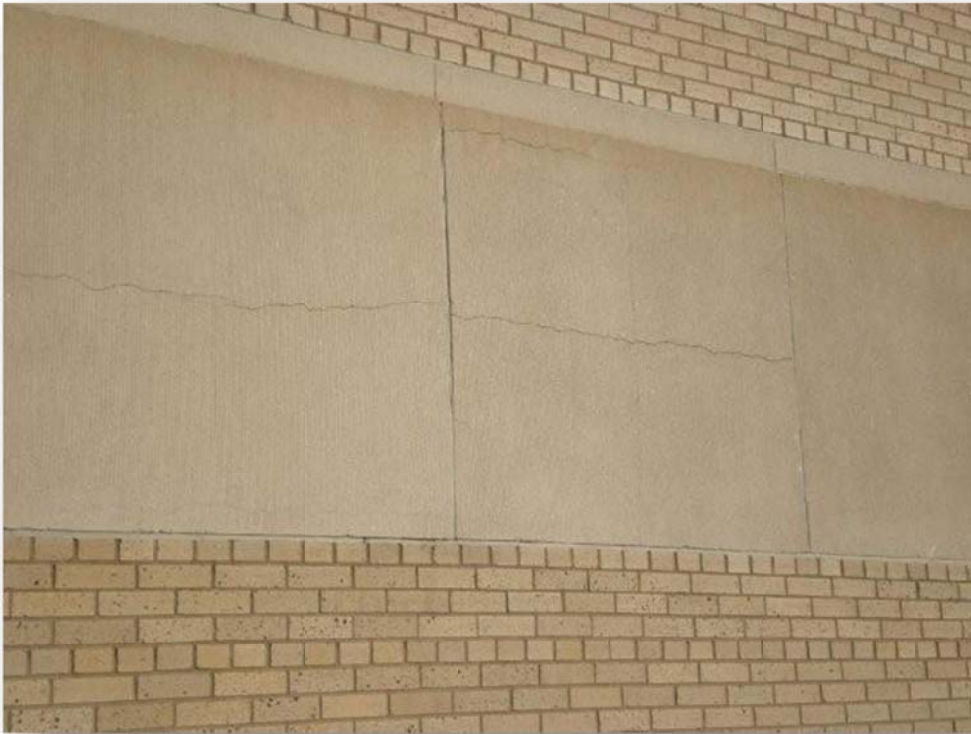
Photo S7 – Typical Cracking Cast Panels

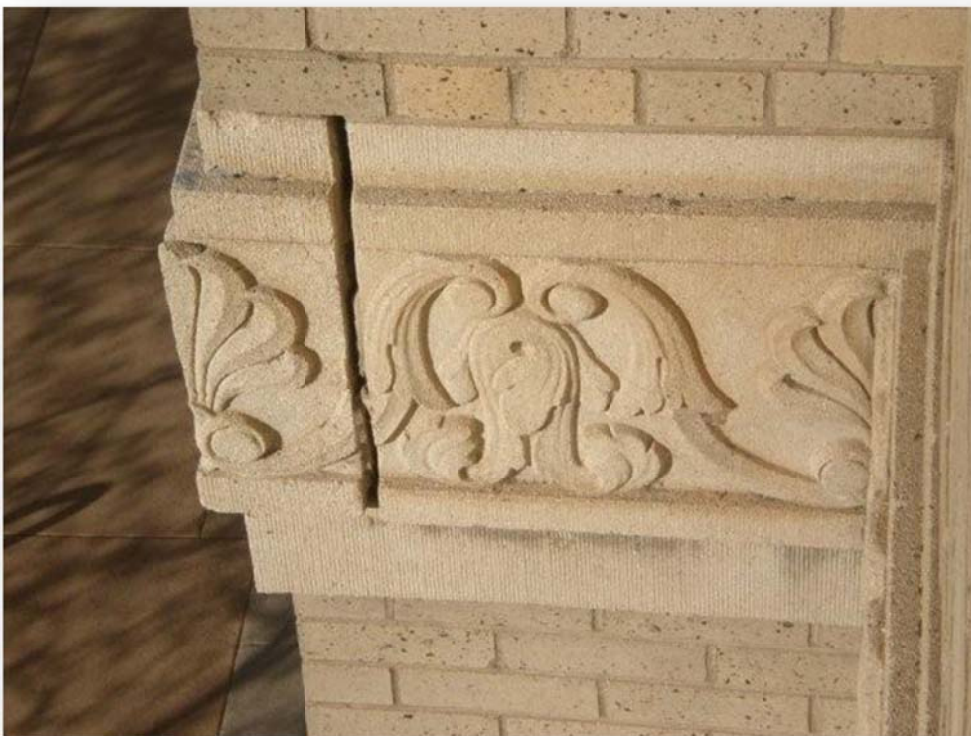
Photo S8 – Typical Weathered Mortar Joint

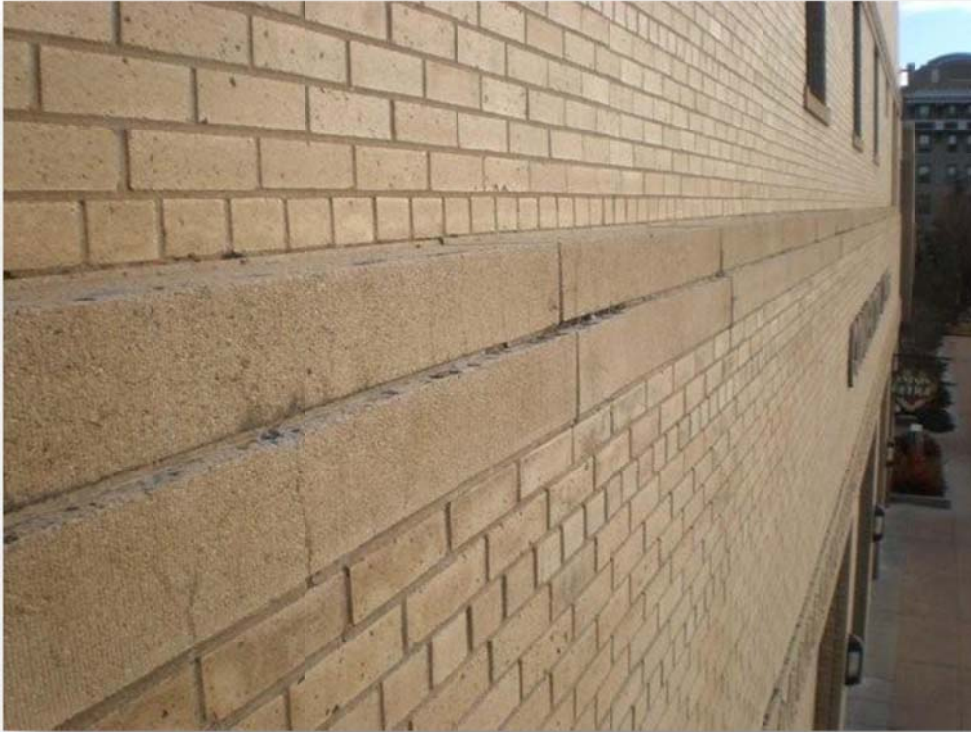
Photo S9 – Typical Cracking Cast Panels

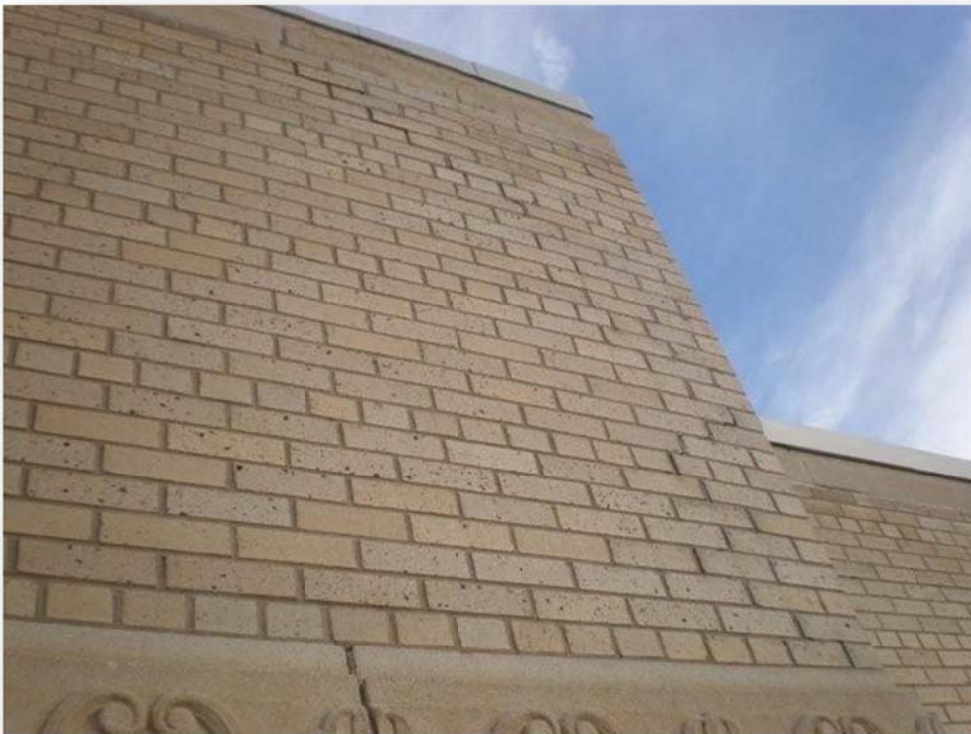
Photo S10 – Cracked & Displaced Brick

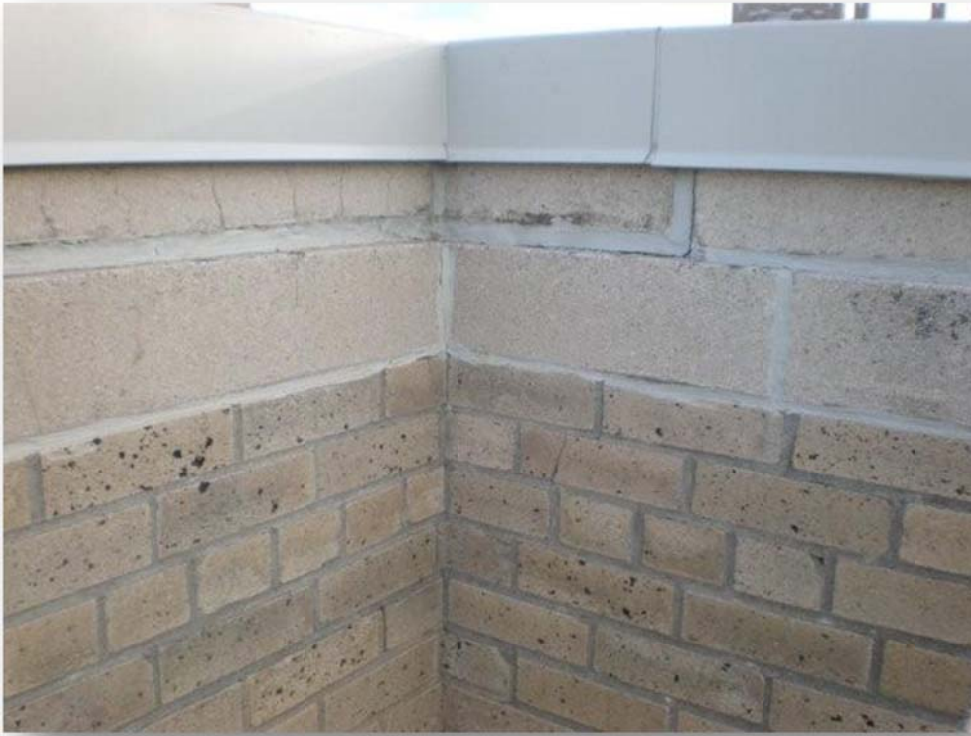
Photo S11 – Typical Cracking Cast Panels at Parapet Level

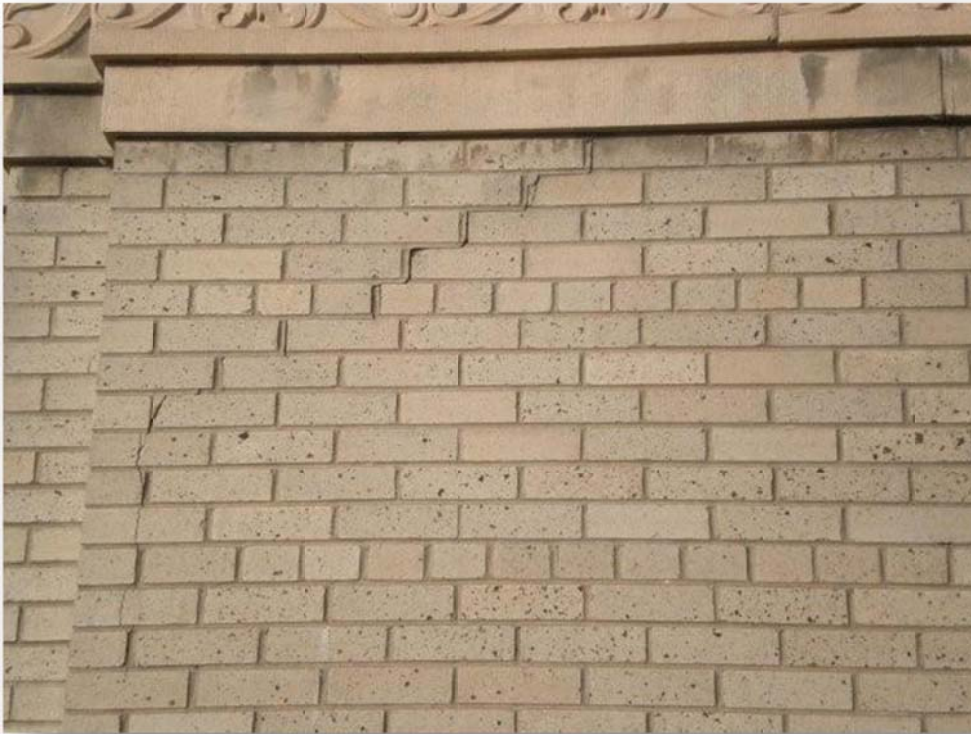
Photo E1 – Cracked and Displaced Brick
