ASSESSMENT of the CONDITION of and RECOMMENDATIONS for REHABILITATION and REPAIR to the BUILDING EXTERIOR

**Civic Center Restoration - GTF
STPE 7(47)
Control No. 6338, O.F. #1525
2 Park Drive South
Great Falls MT 59401**

April 18, 2011

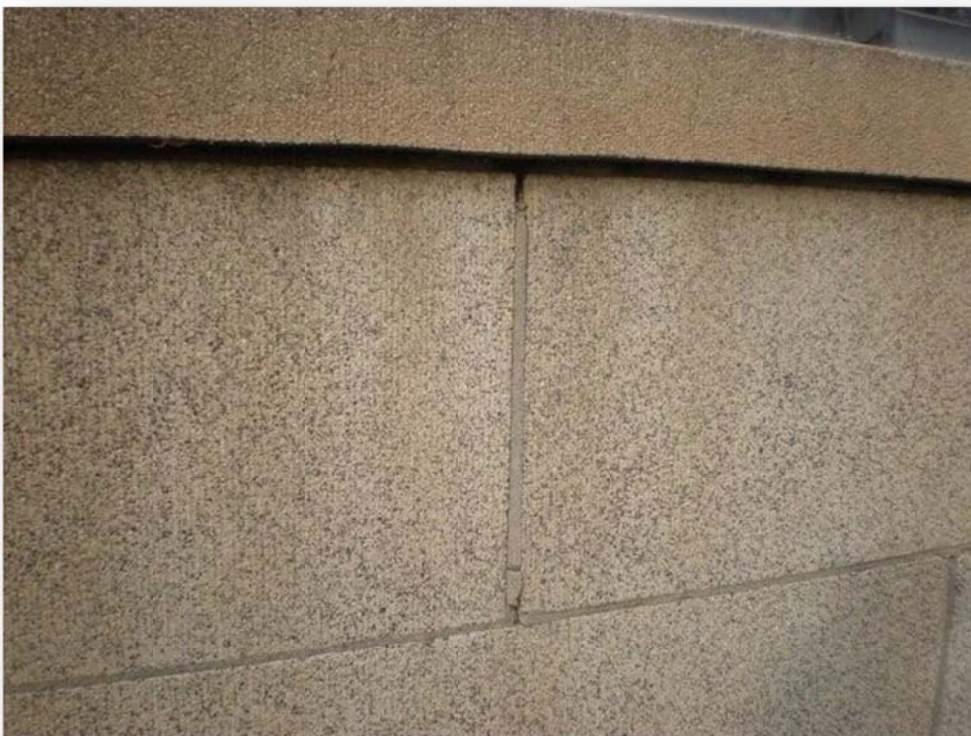
Photo E2 – Typical Weathered Mortar Joint

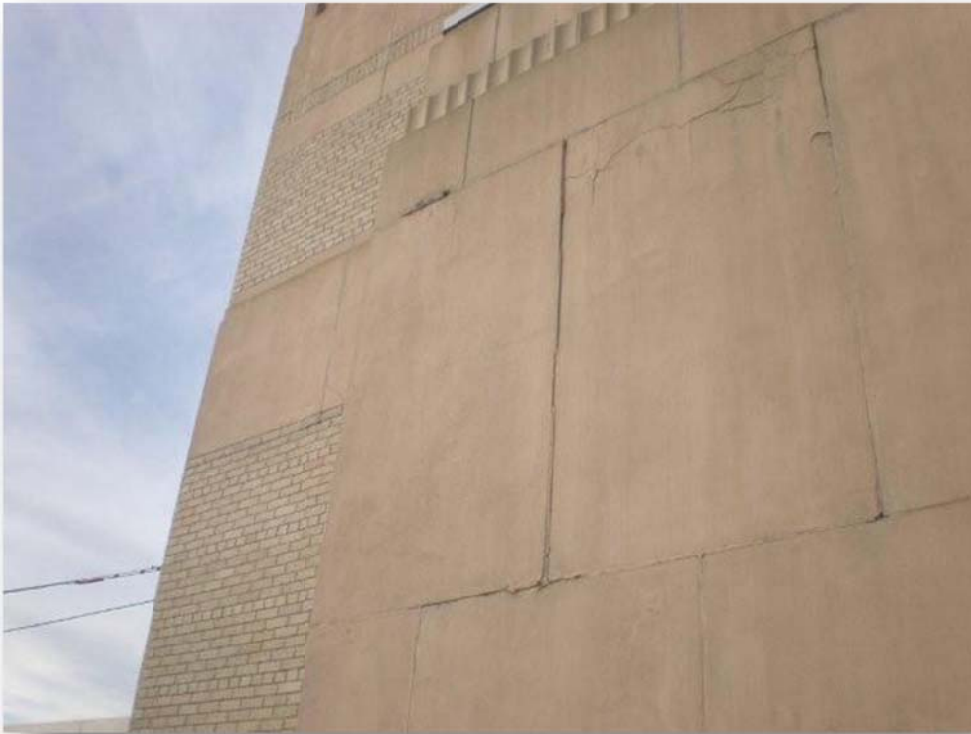
Photo E3 – Typical Cracking Cast Panels

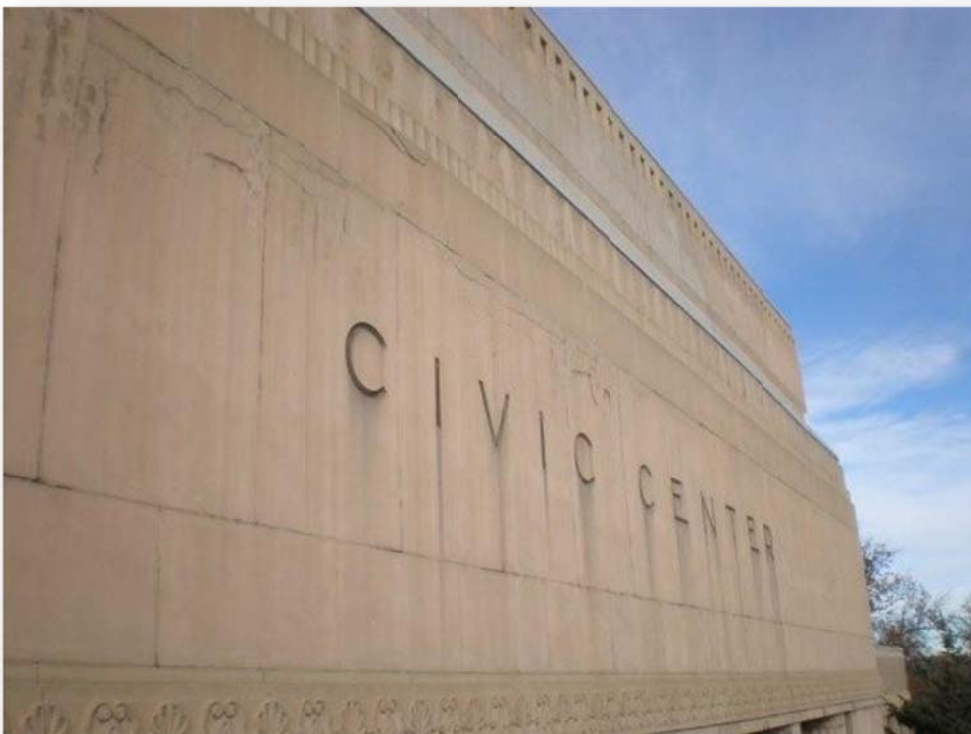
Photo E4 – Typical Cracking Cast Panels

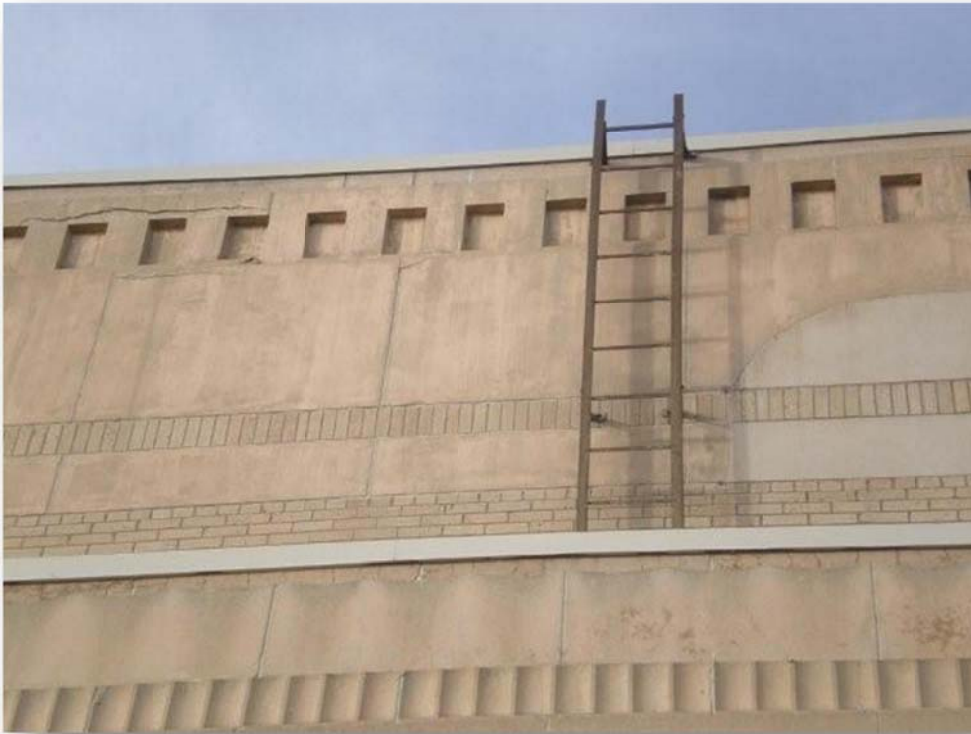
Photo E5 – Typical Cracking Cast Panels

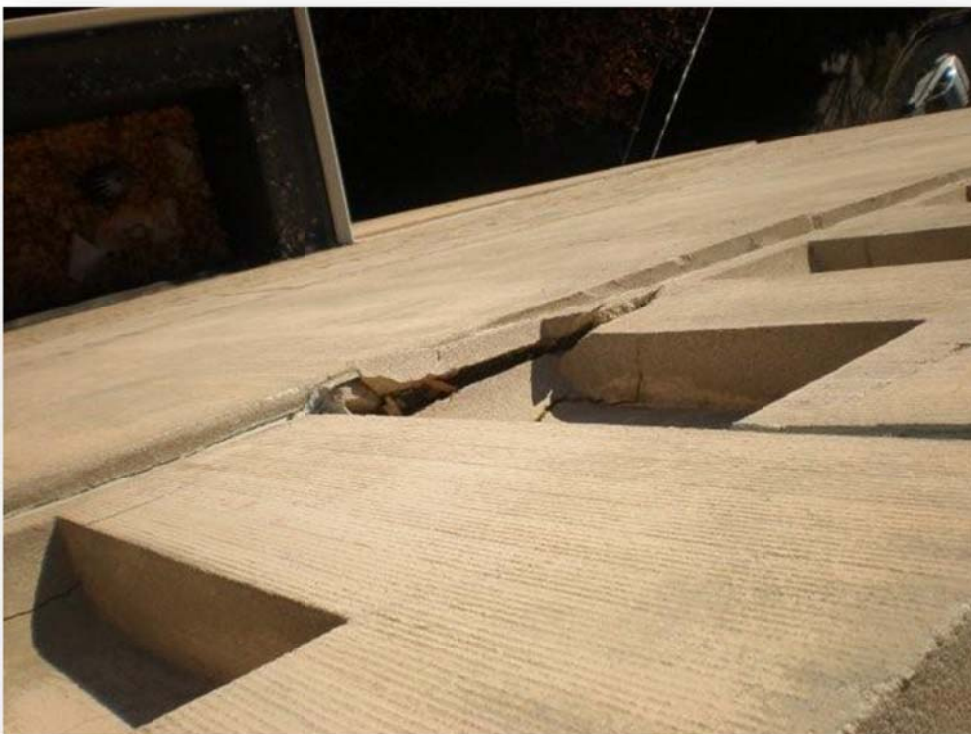
Photo E6 – Typical Cracking Cast Panels

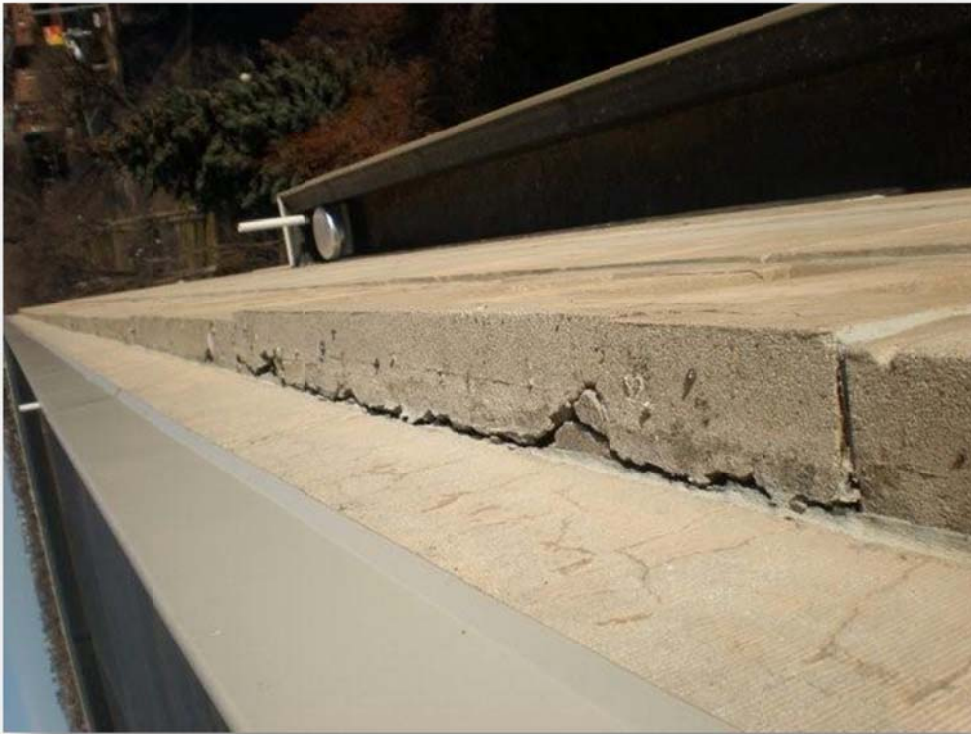
Photo E7 – Typical Cracking Cast Panels

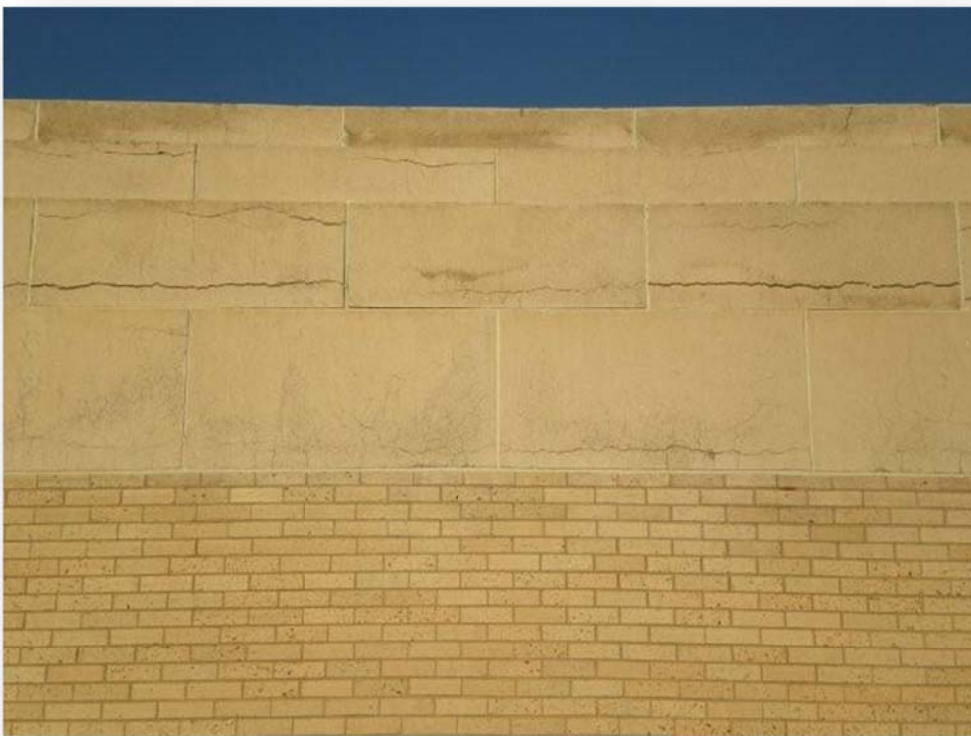
Photo E8 – Typical Cracking Cast Panels

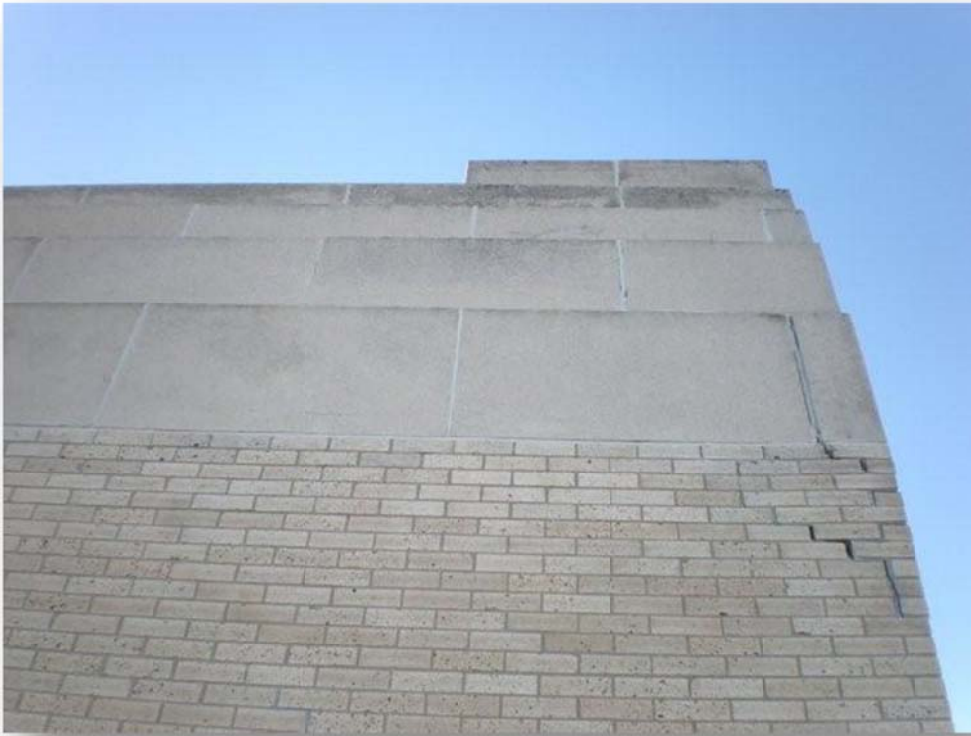
Photo N1 – Typical Cracking Cast Panels & Displaced Brick

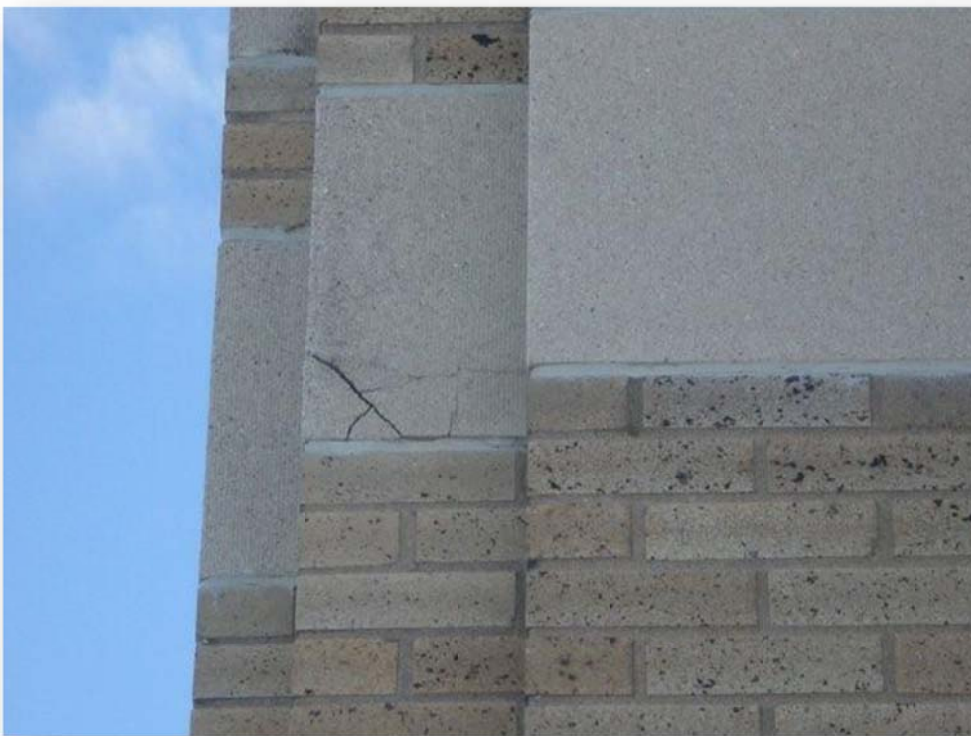
Photo N2 – Typical Cracking Cast Panels

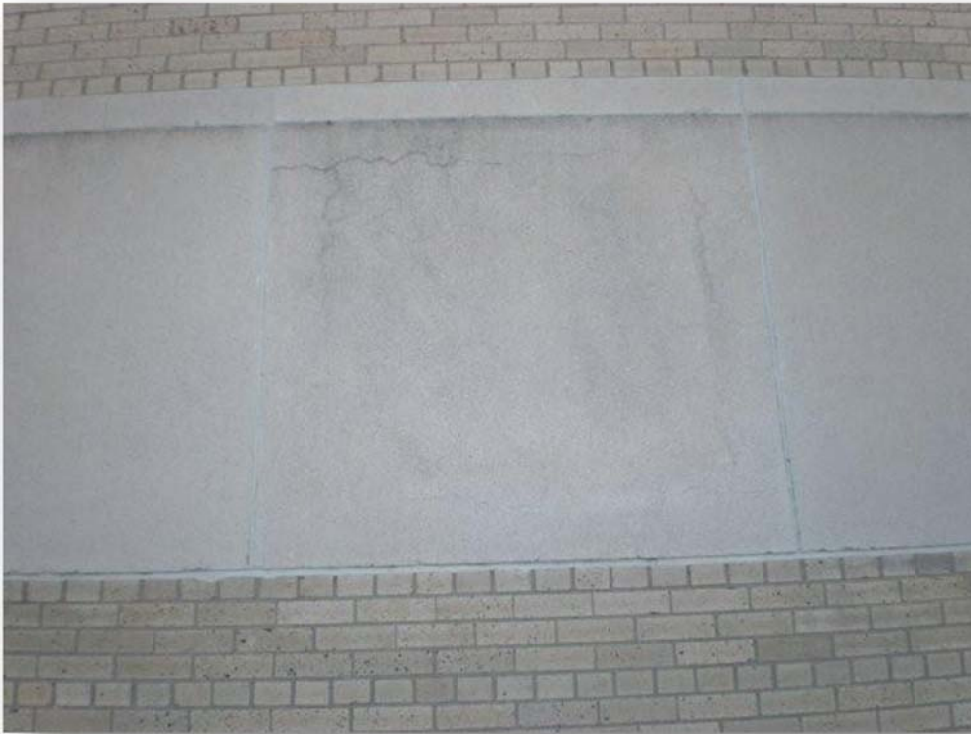
Photo N3 – Typical Cracking Cast Panels

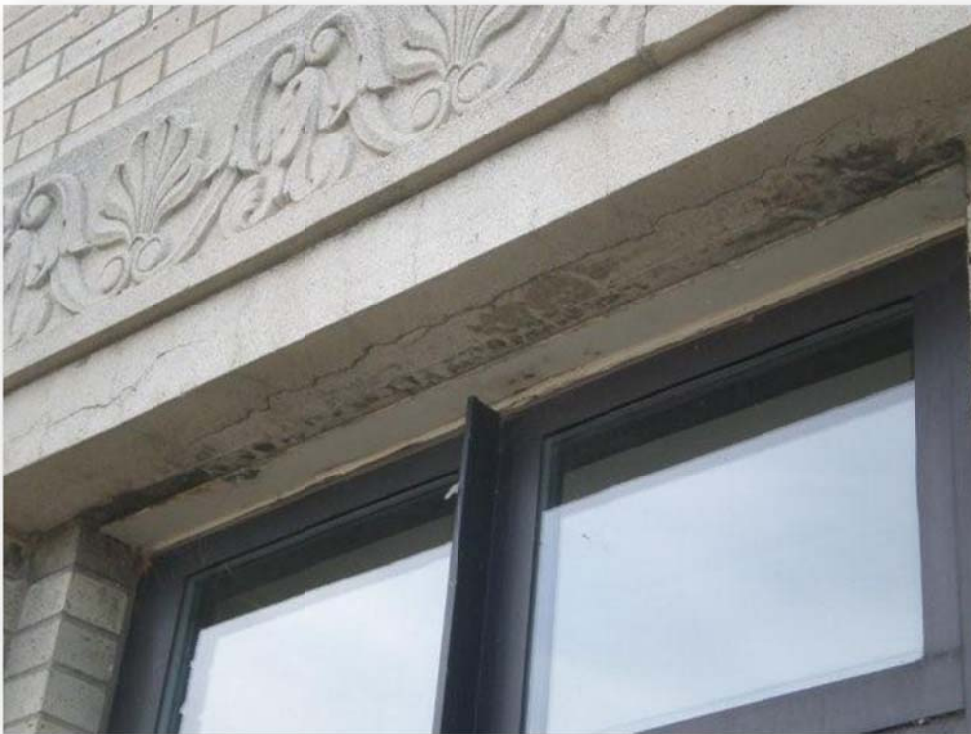
Photo N4 – Typical Cracked Window Lintel

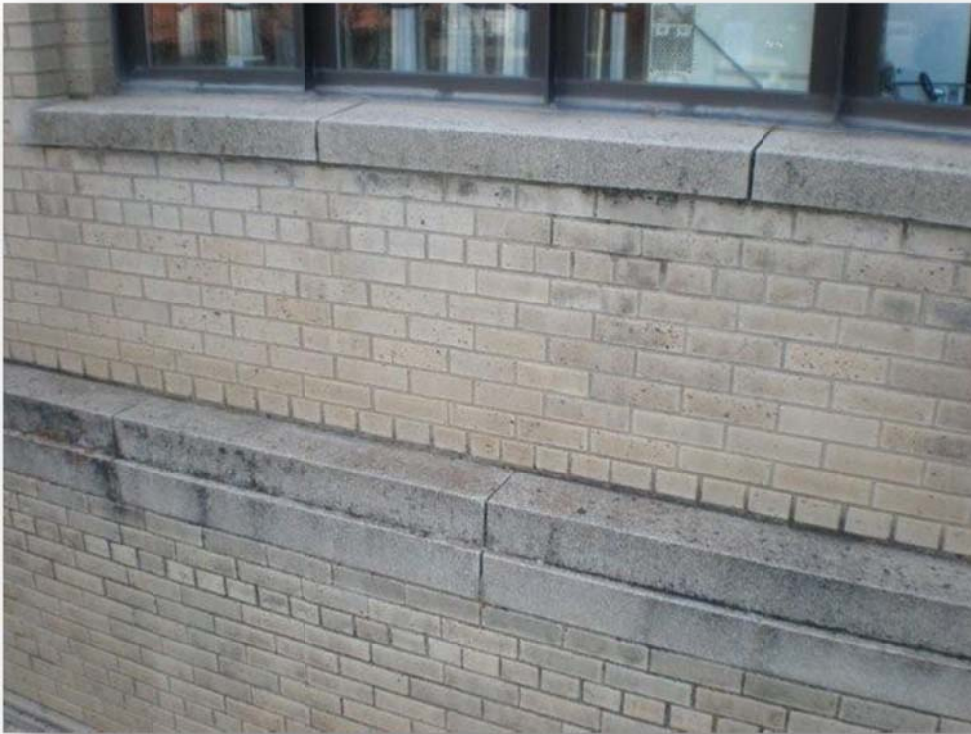
Photo N5 – Typical Weathered Mortar Joints

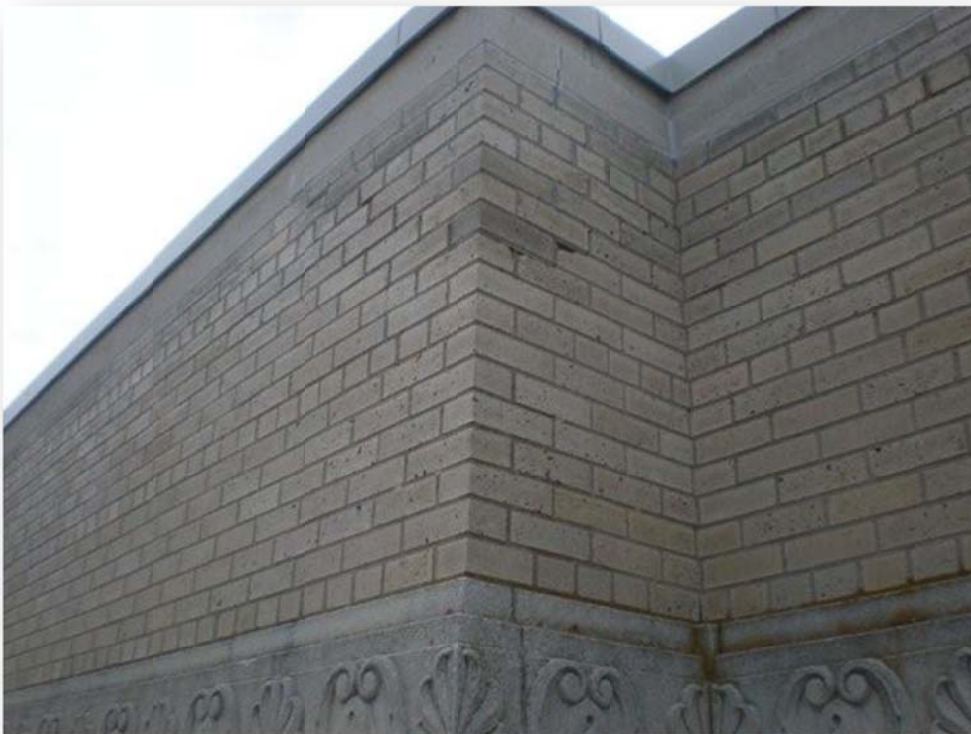
Photo N6 – Typical Weathered Mortar Joints & Displaced Brick

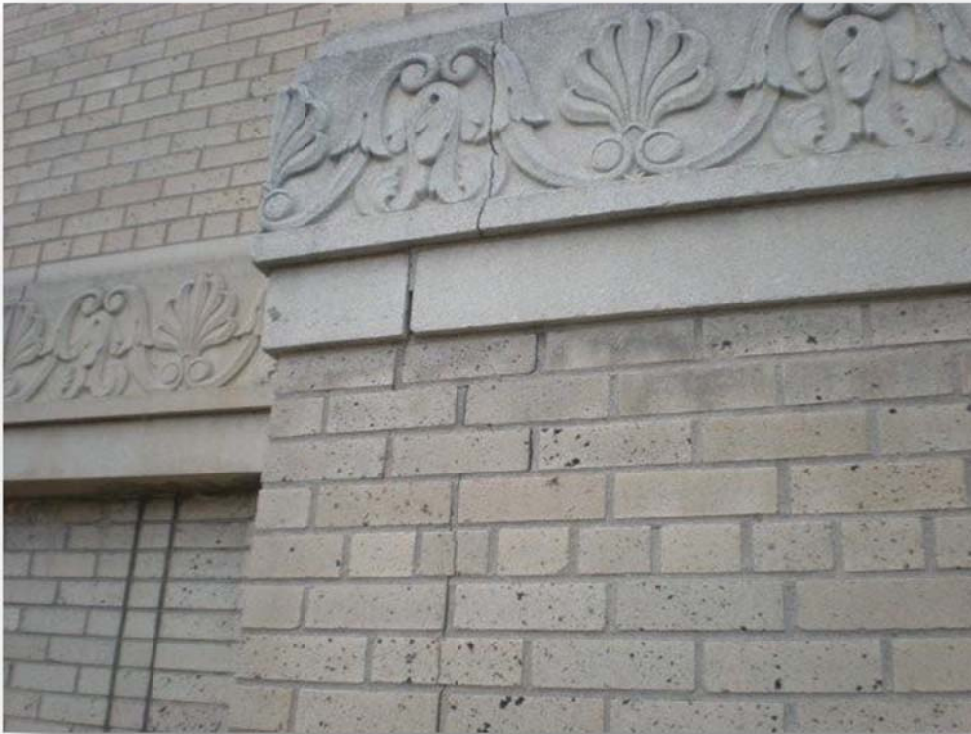
Photo N7 – Typical Cracking Brick & Weathered Mortar Joints

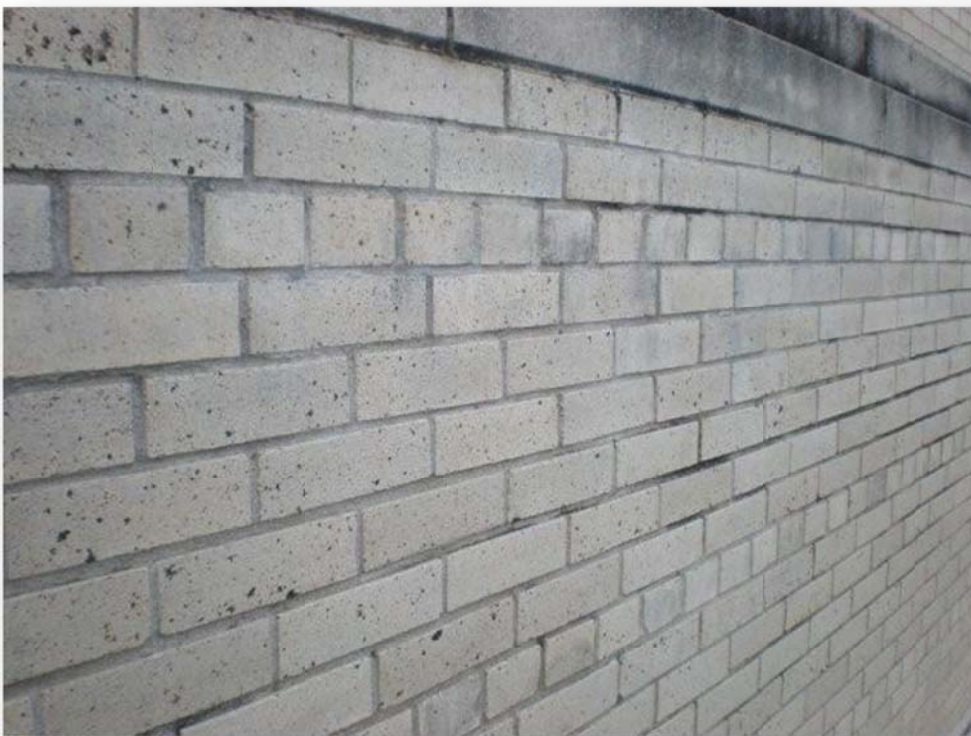
Photo N8 – Typical Weathered Mortar Joints
