# Boston and Montana Barn

Black Eagle, Montana

Existing Conditions Assessment

Recommendations for Stabilization and Protection

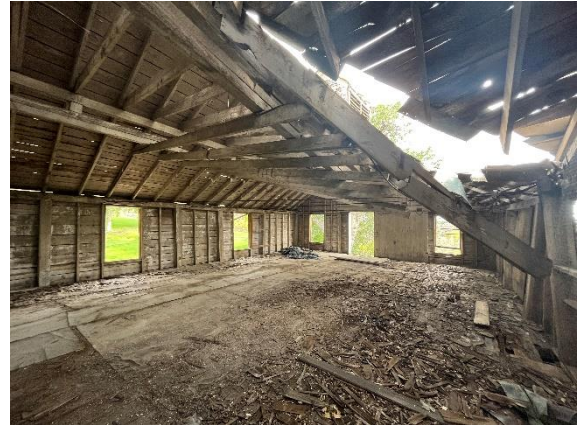
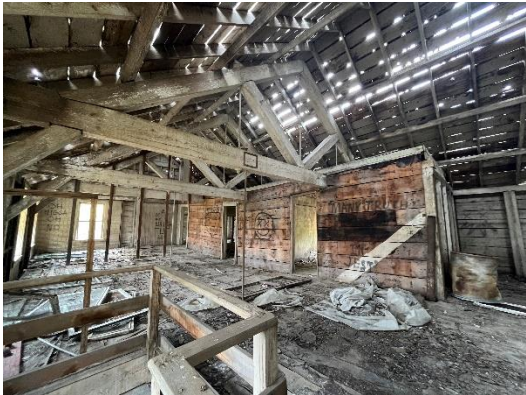
The existing shake roofing is well past its useful life and is neither complete nor capable of weather-protecting the interior of the building. Roof sheathing is heavily weathered and weakened throughout. Stick-built trusses on the north section are broken and the bottom chords are completely sheared from the primary structure, allowing the walls to shift laterally. Hip-jacks are broken, allowing the roof to sag, especially under the weight of snow. These failures have resulted in substantial sag in the ridge of the north section.

Roof structure on the south section is relatively intact and in more serviceable condition. Lateral purlins are undersized, but in generally good working condition. No ridge exists currently. Rods that extend from the girder trusses to the floor system below are intact.

Once the exterior walls are plumb and the top plates are repaired as necessary, the roof can be stabilized by rebuilding the trusses and restoring a continuous, level ridge line at the roof. This will allow for resurfacing and weatherization of the roof assembly. It is our position that trying to weather-protect the structure without first setting the ridge level will compromise the weather-resistant properties and long term durability of any roofing system, and also make any future work such as permanent roofing much more difficult and costly.

Strip the existing roofing, resheathe, and provide a weather resistant roofing material capable of enduring Montana weather conditions for the length of time needed until a more permanent roof solution can be installed. Options for a protective membrane include :

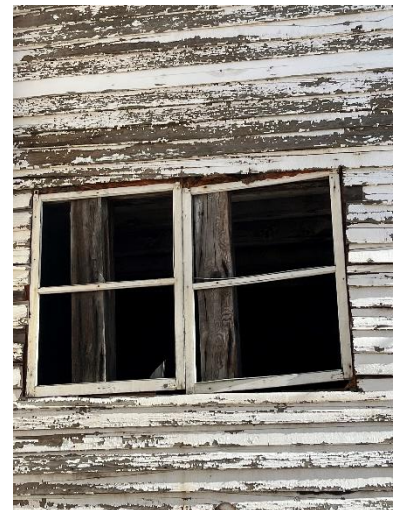
Exterior windows consist only of heavily weathered frames. Many of the headers have been dislodged or are broken, and their nailed connection points severed. As a result, the windows are collapsing. They don't currently keep the weather out of the building, and are open for potential rodent or avian access to the building.

Doors are wood and mounted on hinges. Most are no longer plumb and don't easily close. Wood is heavily weathered, dry, cracking, and no level of weatherstripping exists.

Windows can then be framed over, **protecting** the existing original window frames, trim, and other defining elements, while still allowing for protection from the elements, rodent and avian penetration. Doors shall all be closed and screwed shut to prevent leaking and/or intrusion. One door to remain operational for maintenance purposes only. We recommend this approach over trying to board up the window openings from the interior due to the lack of plumb/level conditions in the building and also because keeping water and snow out of the building will be difficult to accomplish unless handled from the exterior.

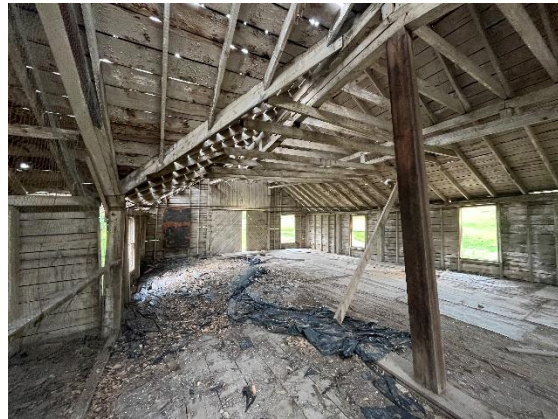
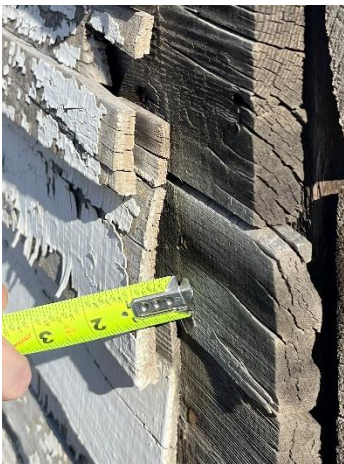
Exterior walls are failing. At the roof level, both the failure of the trusses on the north section as well as attempts to stabilize the structure have caused the walls to shift out of plumb heavily to the north. Much of the siding is intact, but checked in multiple areas and separating from the building.

Virtually all the corner trimboards as well as fascia boards are missing. As anticipated with a structure of this vintage, no weather barrier currently exists. Consequently, any weather events are absorbed by the sheathing boards at minimum and likely the framing as well.

Lap siding boards to be removed from the building, stored and marked in a safe place for future re-use/re-installation and the structure wrapped with weather barrier, secured per manufacturer's instructions for long term exposure, with all seams lapped for positive drainage and seam tape applied.

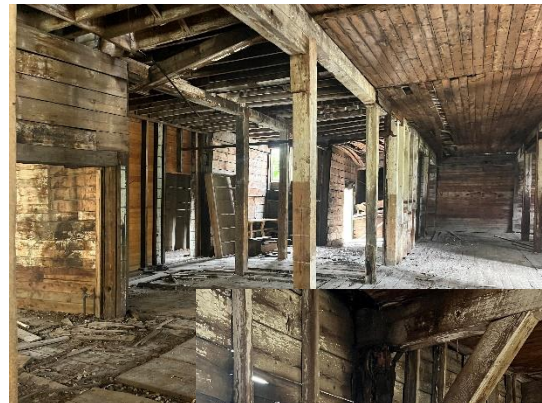
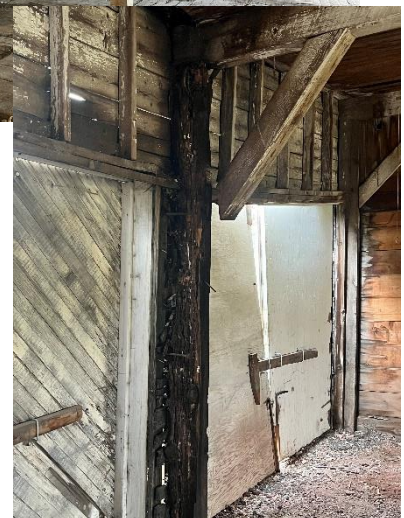
Primary structure is a series of heavy timber columns and beams serving as intermediate bearing for the building. Sizing of these beams and columns are in general accordance with the loading anticipated; however, many of the columns are suffering from dry-rot, and some of them have separations at their connecting points. The original design for the second floor required two parallel rows of columns to support the roof structure. These are all currently absent, resulting in a dangerous structural situation on the northern section. The structure is in danger of collapse.

Building lateral systems at both the roof and the walls are impaired, rendering the building unable to resist wind or seismic forces acting on the building.

First, the interior column grid in the north section must be rebuilt, infill framed with stud wall construction, and sheathed in order to create a central stabilizing core. This core is proposed to extend up to the truss bearing point so that it can successfully tie to the exterior walls and also anchor the roof itself. Secondly, this structural core will serve as a safe area from which to stage construction operations. Attached drawings indicate extent and preliminary design of this central stabilizing building core.

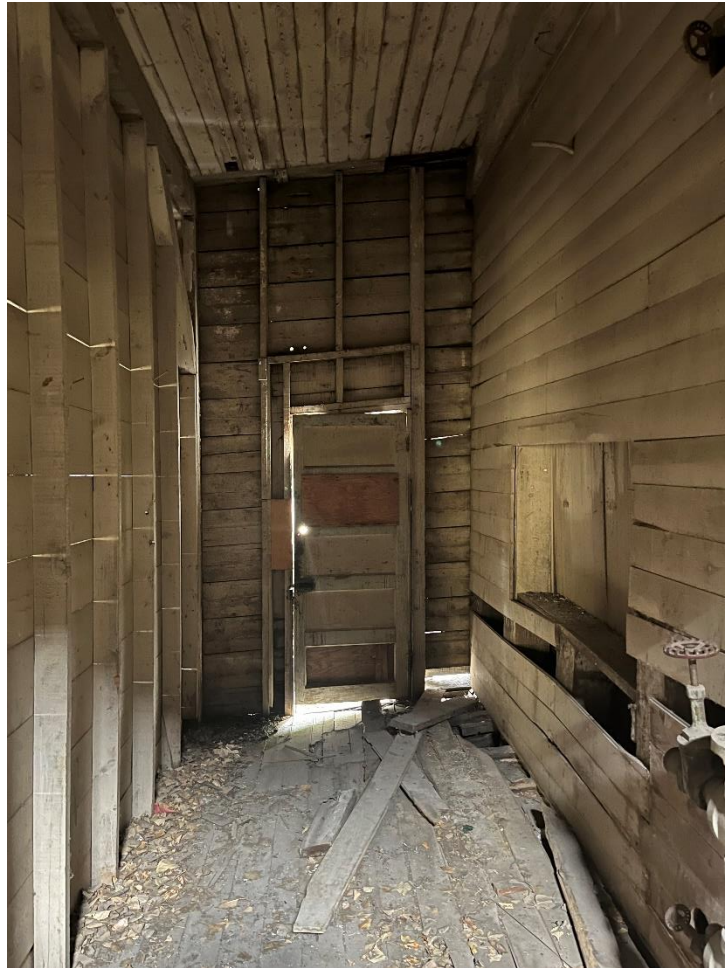
Internal stairwell is stable. Main floor level is not level, but apart from some holes and gaps in the flooring, is in relatively serviceable condition. The second level south section is covered with debris but is primarily stable. Floor in the north section is noticeably out of level, primarily at the north end of the building where the exterior walls have shifted out of plumb.

Foundations in the north section are mostly unobserved due to lack of access to below-floor areas. Foundations in the south section are accessible from openings in the wall along the southeastern corner of the building. Sandstone is weathered and the joints require maintenance, but the stone is in adequate condition.

The building now stabilized, openings in the foundation wall should be enclosed with materials capable of handling contact with the ground, but fully sealed to limit rodent intrusion into the building. An access door shall be installed for maintenance purposes only.

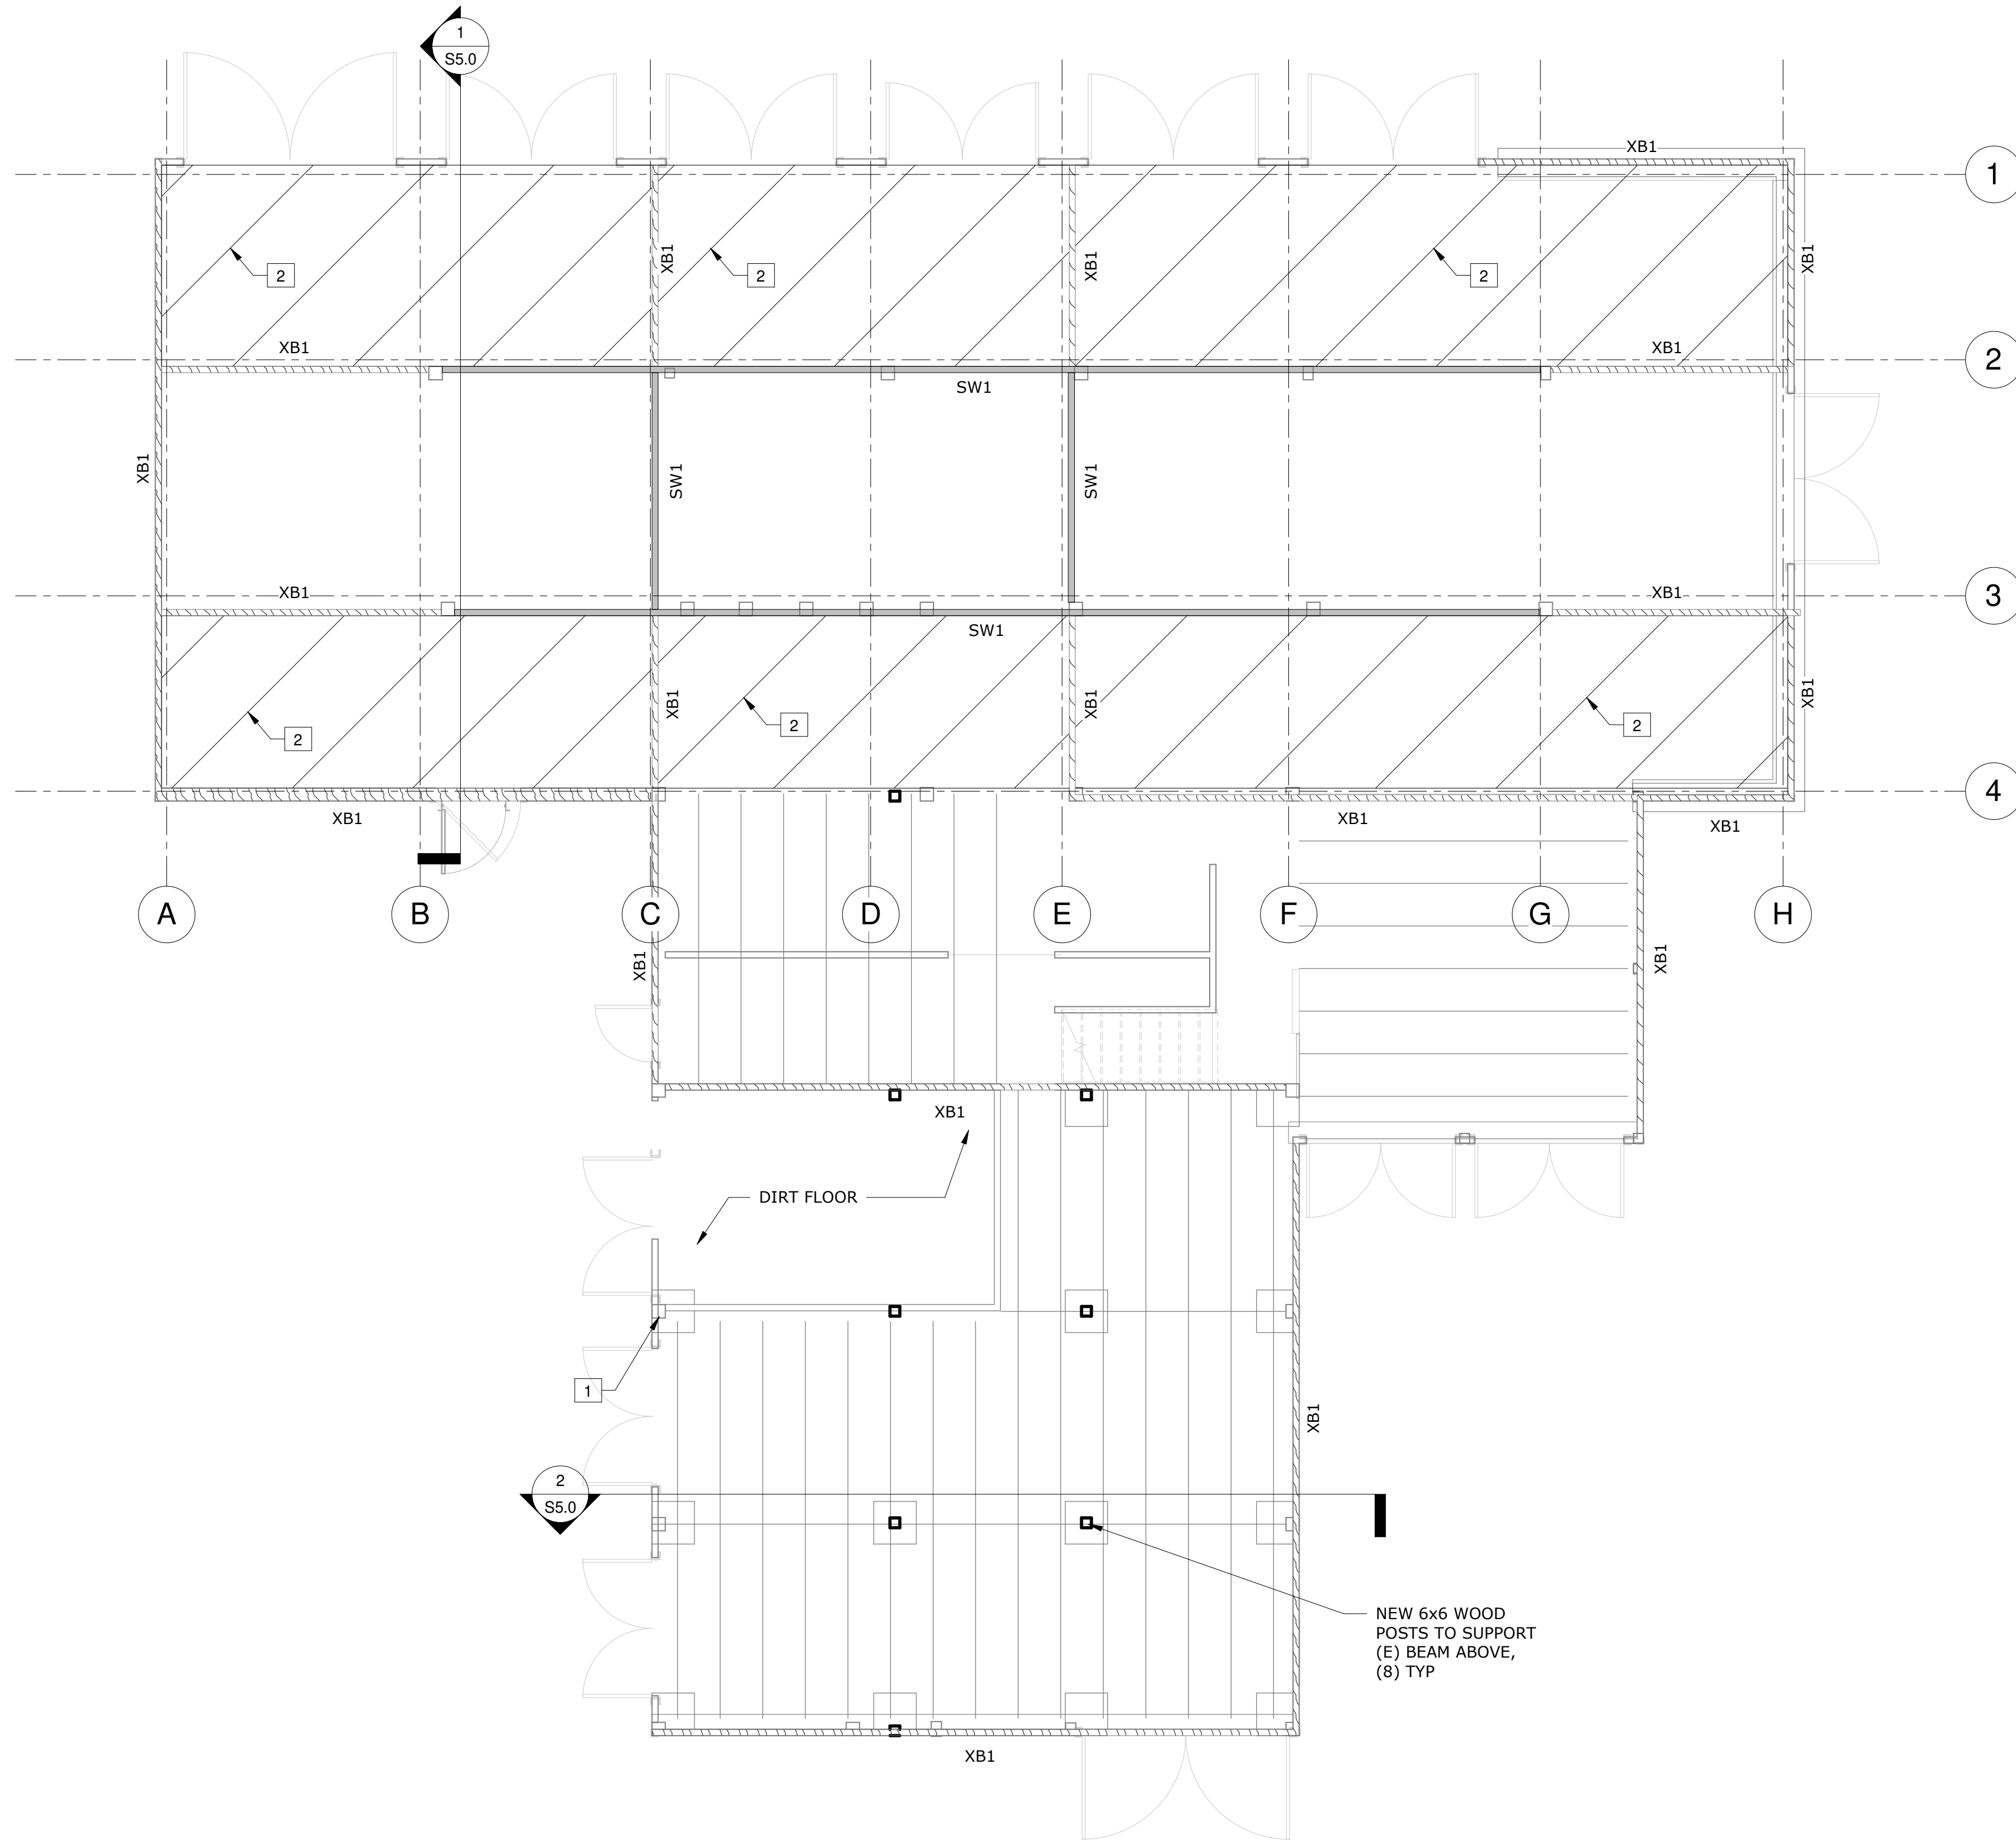
- 1 DAMAGED FLOOR FRAMING MEMBER, REPAIR OR REPLACE.
- 2 2x4 LAID FLAT @ 4'-0" OC W/ (2) 16d NAILS INTO EA JOIST, MIN (3) JOIST LAP.
- 3 FLOOR COLLAPSE AREA. NEW FRAMING & FLOORING REQUIRED.

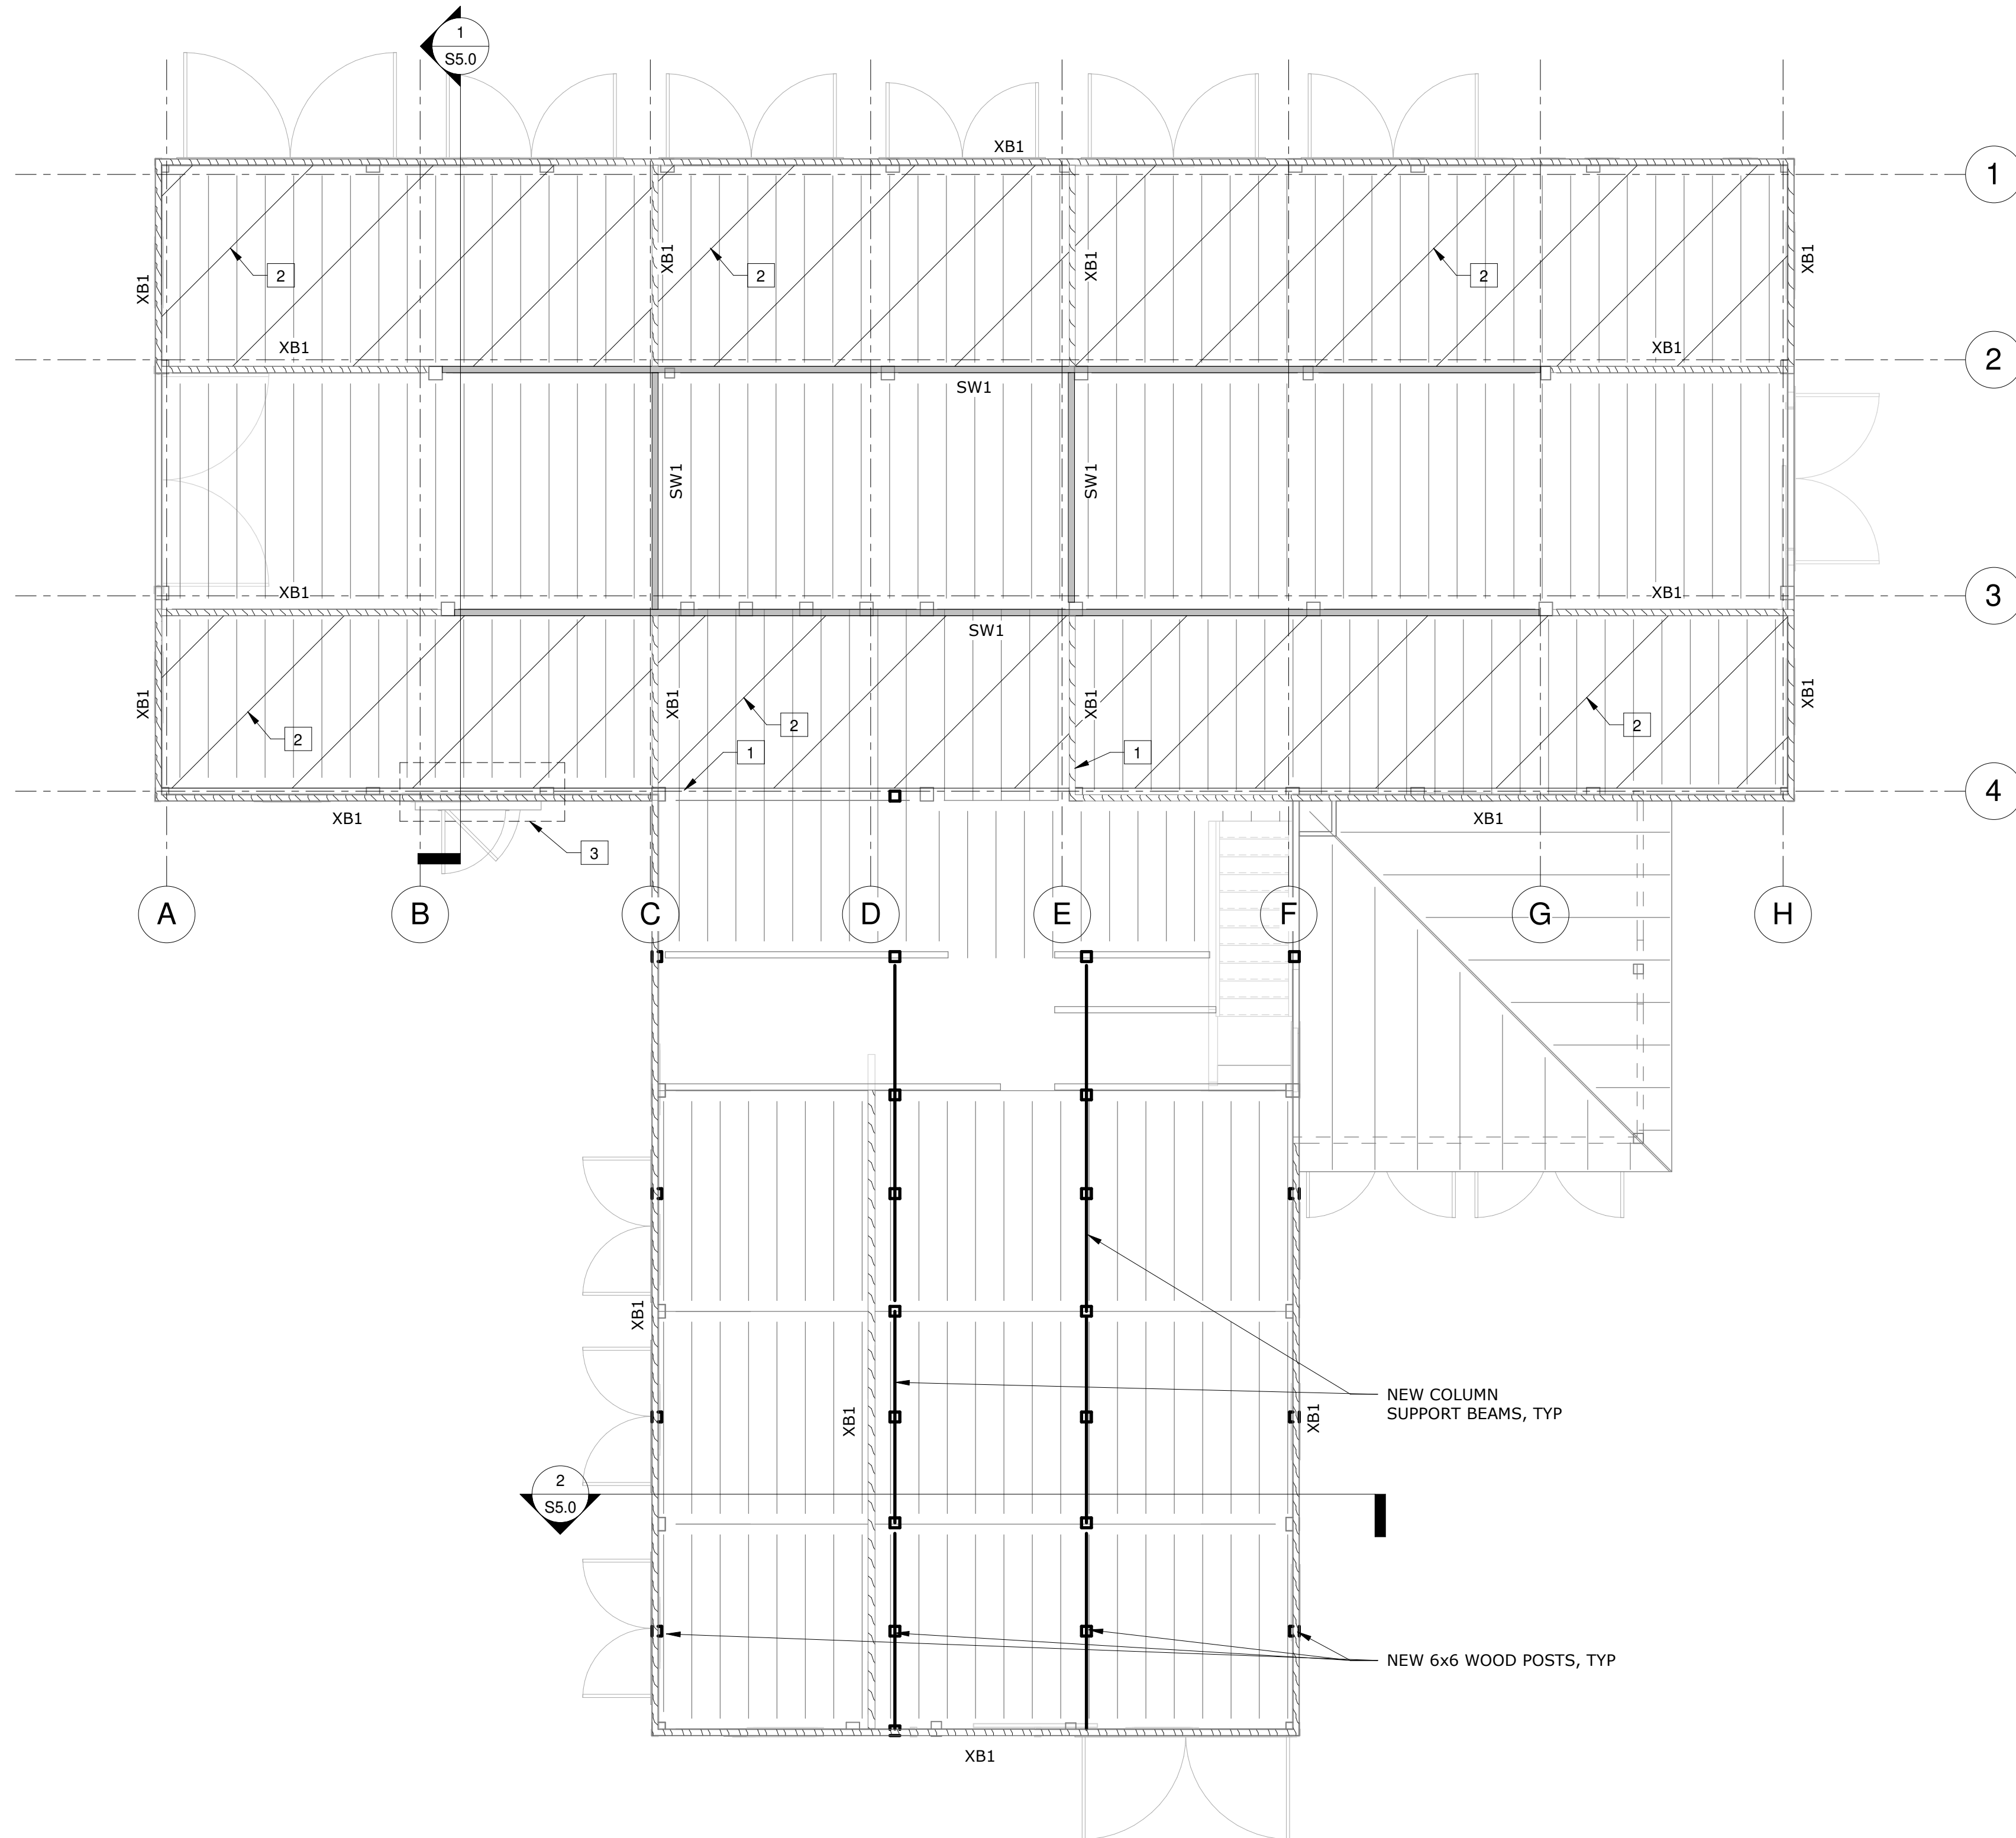
1 SECOND FLOOR FRAMING PLAN  
3/16" = 1'-0"

- 1 ROOF COLLAPSE AREA, REMOVE AND REPLACE FRAMING.
- 2 RAFTERS FAILING, REMOVE AND REPLACE.
- 3 FAILED WINDOW HEADER, REMOVE AND REPLACE.

- ROOF SHEATHING TO BE 19/32" 40/20 RATING OSB W/ 8d NAILS @ 6" OC PANEL EDGES, 12" OC FIELD.
- WORKING PLATFORM TO BE ADDED BETWEEN WALLS ALONG GRID LINES 2 AND 3.
