**Great Falls – Cascade County Historic Preservation Advisory Commission
Minutes from the August 14, 2024 meeting, held at the Great Falls Portage Overlook and the PCD
Conference Room at the Civic Center**

Boston and Montana Barn

Existing Conditions Assessment

Recommendations for Stabilization and Protection

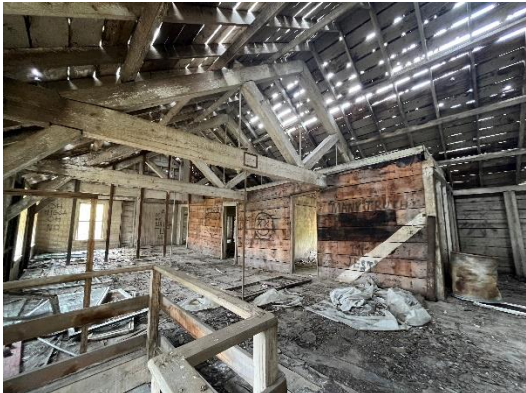
The existing shake roofing is well past its useful life and is neither complete nor capable of weather-protecting the interior of the building. Roof sheathing is heavily weathered and weakened throughout. Stick-built trusses on the north section are broken and the bottom chords are completely sheared from the primary structure, allowing the walls to shift laterally. Hip-jacks are broken, allowing the roof to sag, especially under the weight of snow. These failures have resulted in substantial sag in the ridge of the north section.

Roof structure on the south section is relatively intact and in more serviceable condition. Lateral purlins are undersized, but in generally good working condition. No ridge exists currently. Rods that extend from the girder trusses to the floor system below are intact.

Once the exterior walls are plumb and the top plates are repaired as necessary, the roof can be stabilized by rebuilding the trusses and restoring a continuous, level ridge line at the roof. This will allow for resurfacing and weatherization of the roof assembly. It is our position that trying to weather-protect the structure without first setting the ridge level will compromise the weather-resistant properties and long term durability of any roofing system, and also make any future work such as permanent roofing much more difficult and costly.

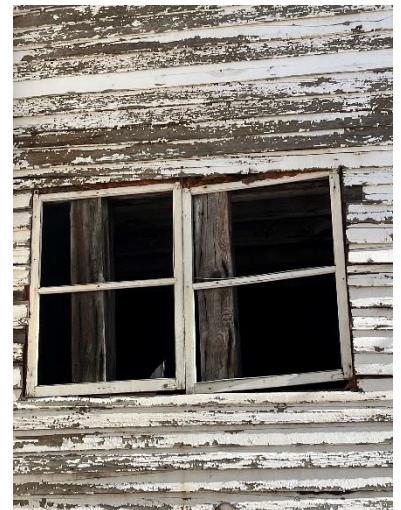
Exterior windows consist only of heavily weathered frames. Many of the headers have been dislodged or are broken, and their nailed connection points severed. As a result, the windows are collapsing. They don't currently keep the weather out of the building, and are open for potential rodent or avian access to the building.

Doors are wood and mounted on hinges. Most are no longer plumb and don't easily close. Wood is heavily weathered, dry, cracking, and no level of weatherstripping exists.

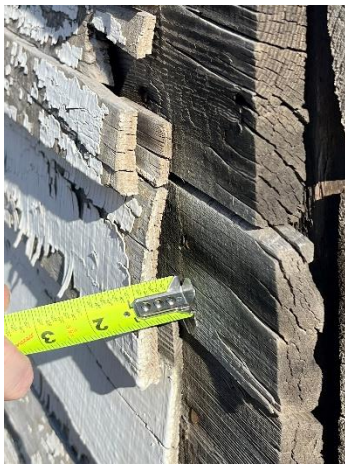
Exterior walls are failing. At the roof level, both the failure of the trusses on the north section as well as attempts to stabilize the structure have caused the walls to shift out of plumb heavily to the north. Much of the siding is intact, but checked in multiple areas and separating from the building.

Virtually all the corner trimboards as well as fascia boards are missing. As anticipated with a structure of this vintage, no weather barrier currently exists. Consequently, any weather events are absorbed by the sheathing boards at minimum and likely the framing as well.

Following construction of the central stabilizing core, the exterior walls can be positioned more closely to plumb by anchoring them to the central core. This will ensure that subsequent envelope stabilizing strategies will succeed.

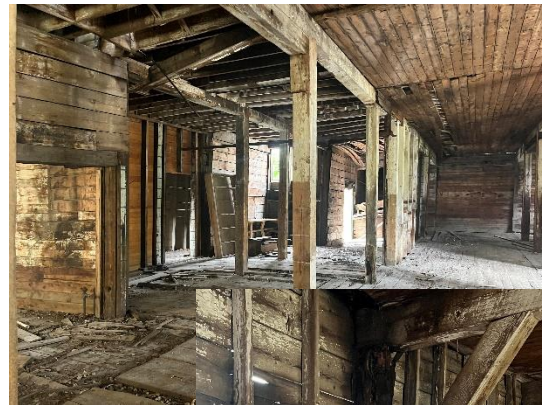
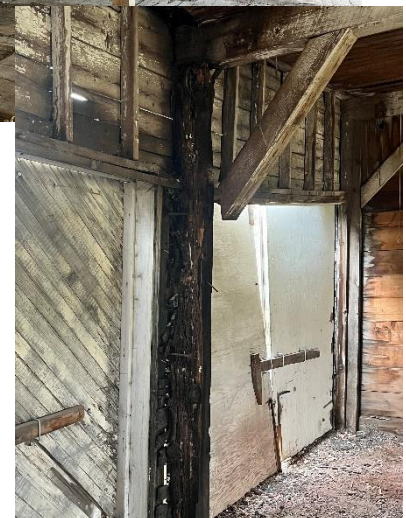
Primary structure is a series of heavy timber columns and beams serving as intermediate bearing for the building. Sizing of these beams and columns are in general accordance with the loading anticipated; however, many of the columns are suffering from dry-rot, and some of them have separations at their connecting points. The original design for the second floor required two parallel rows of columns to support the roof structure. These are all currently absent, resulting in a dangerous structural situation on the northern section. The structure is in danger of collapse.

Building lateral systems at both the roof and the walls are impaired, rendering the building unable to resist wind or seismic forces acting on the building.

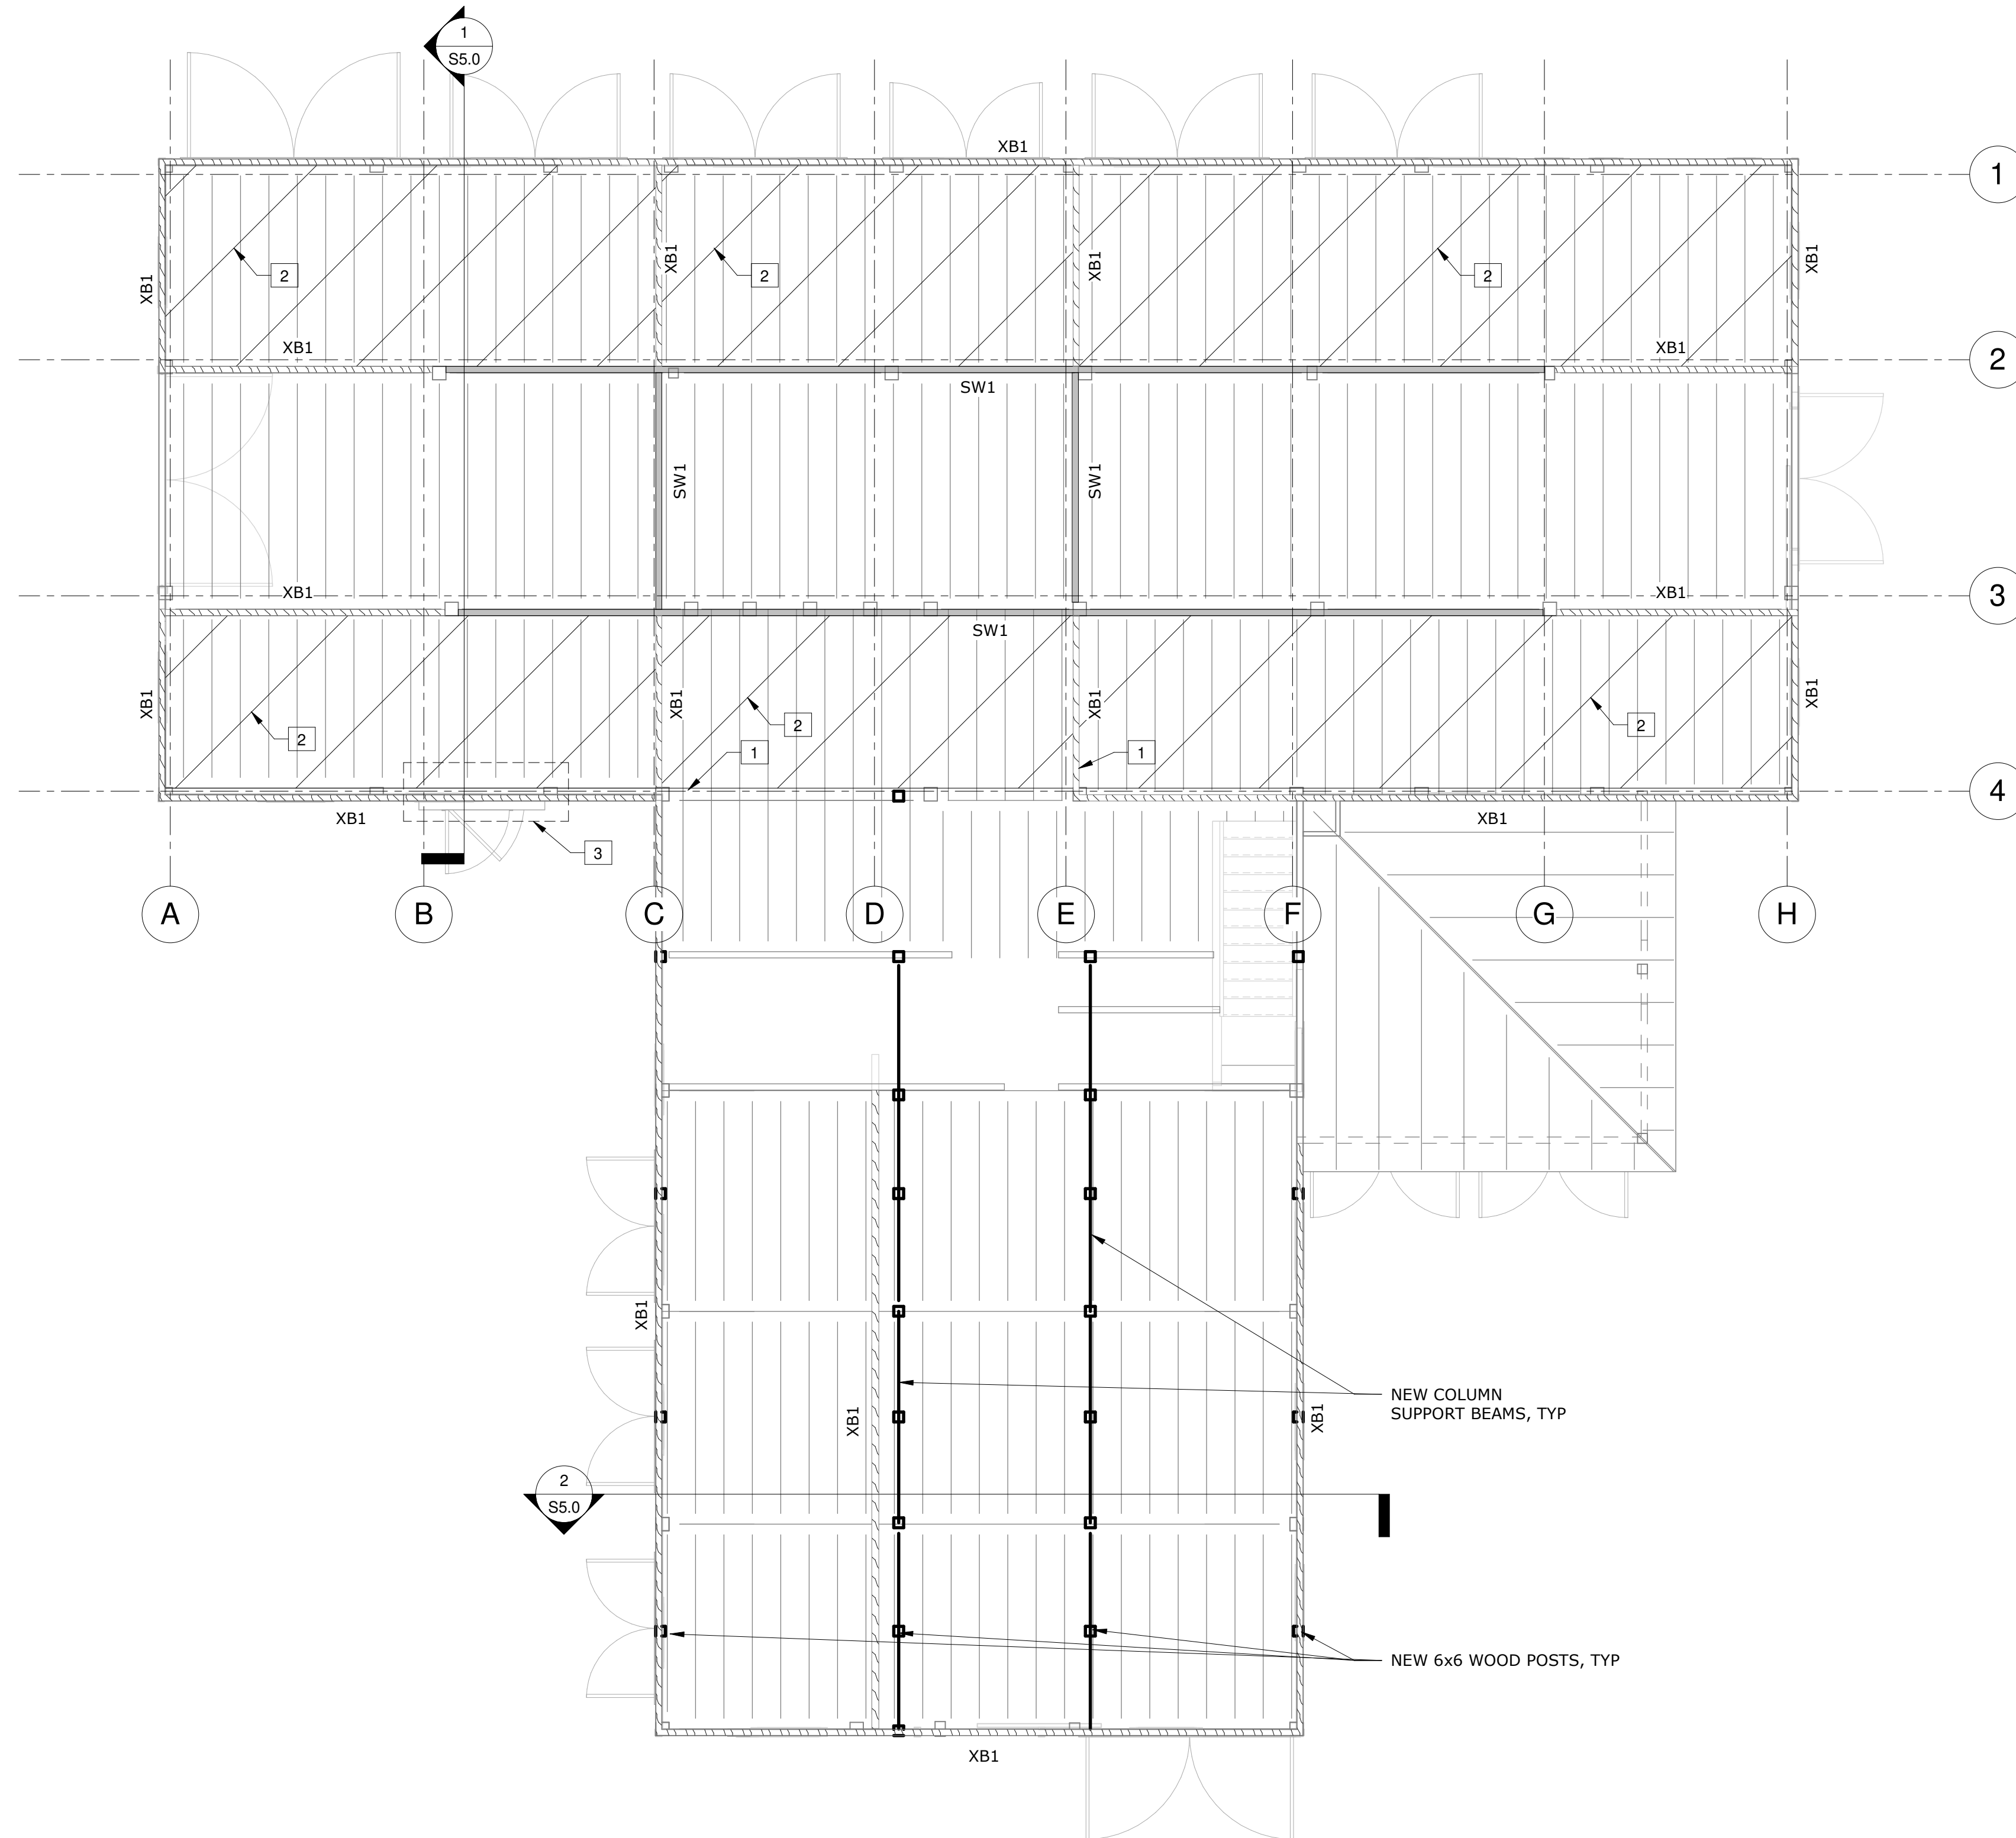
SECOND FLOOR FRAMING PLAN

- 1 DAMAGED FLOOR FRAMING MEMBER, REPAIR OR REPLACE.
- 2 2x4 LAID FLAT @ 4'-0" OC W/ (2) 16d NAILS INTO EA JOIST, MIN (3) JOIST LAP.
- 3 FLOOR COLLAPSE AREA. NEW FRAMING & FLOORING REQUIRED.

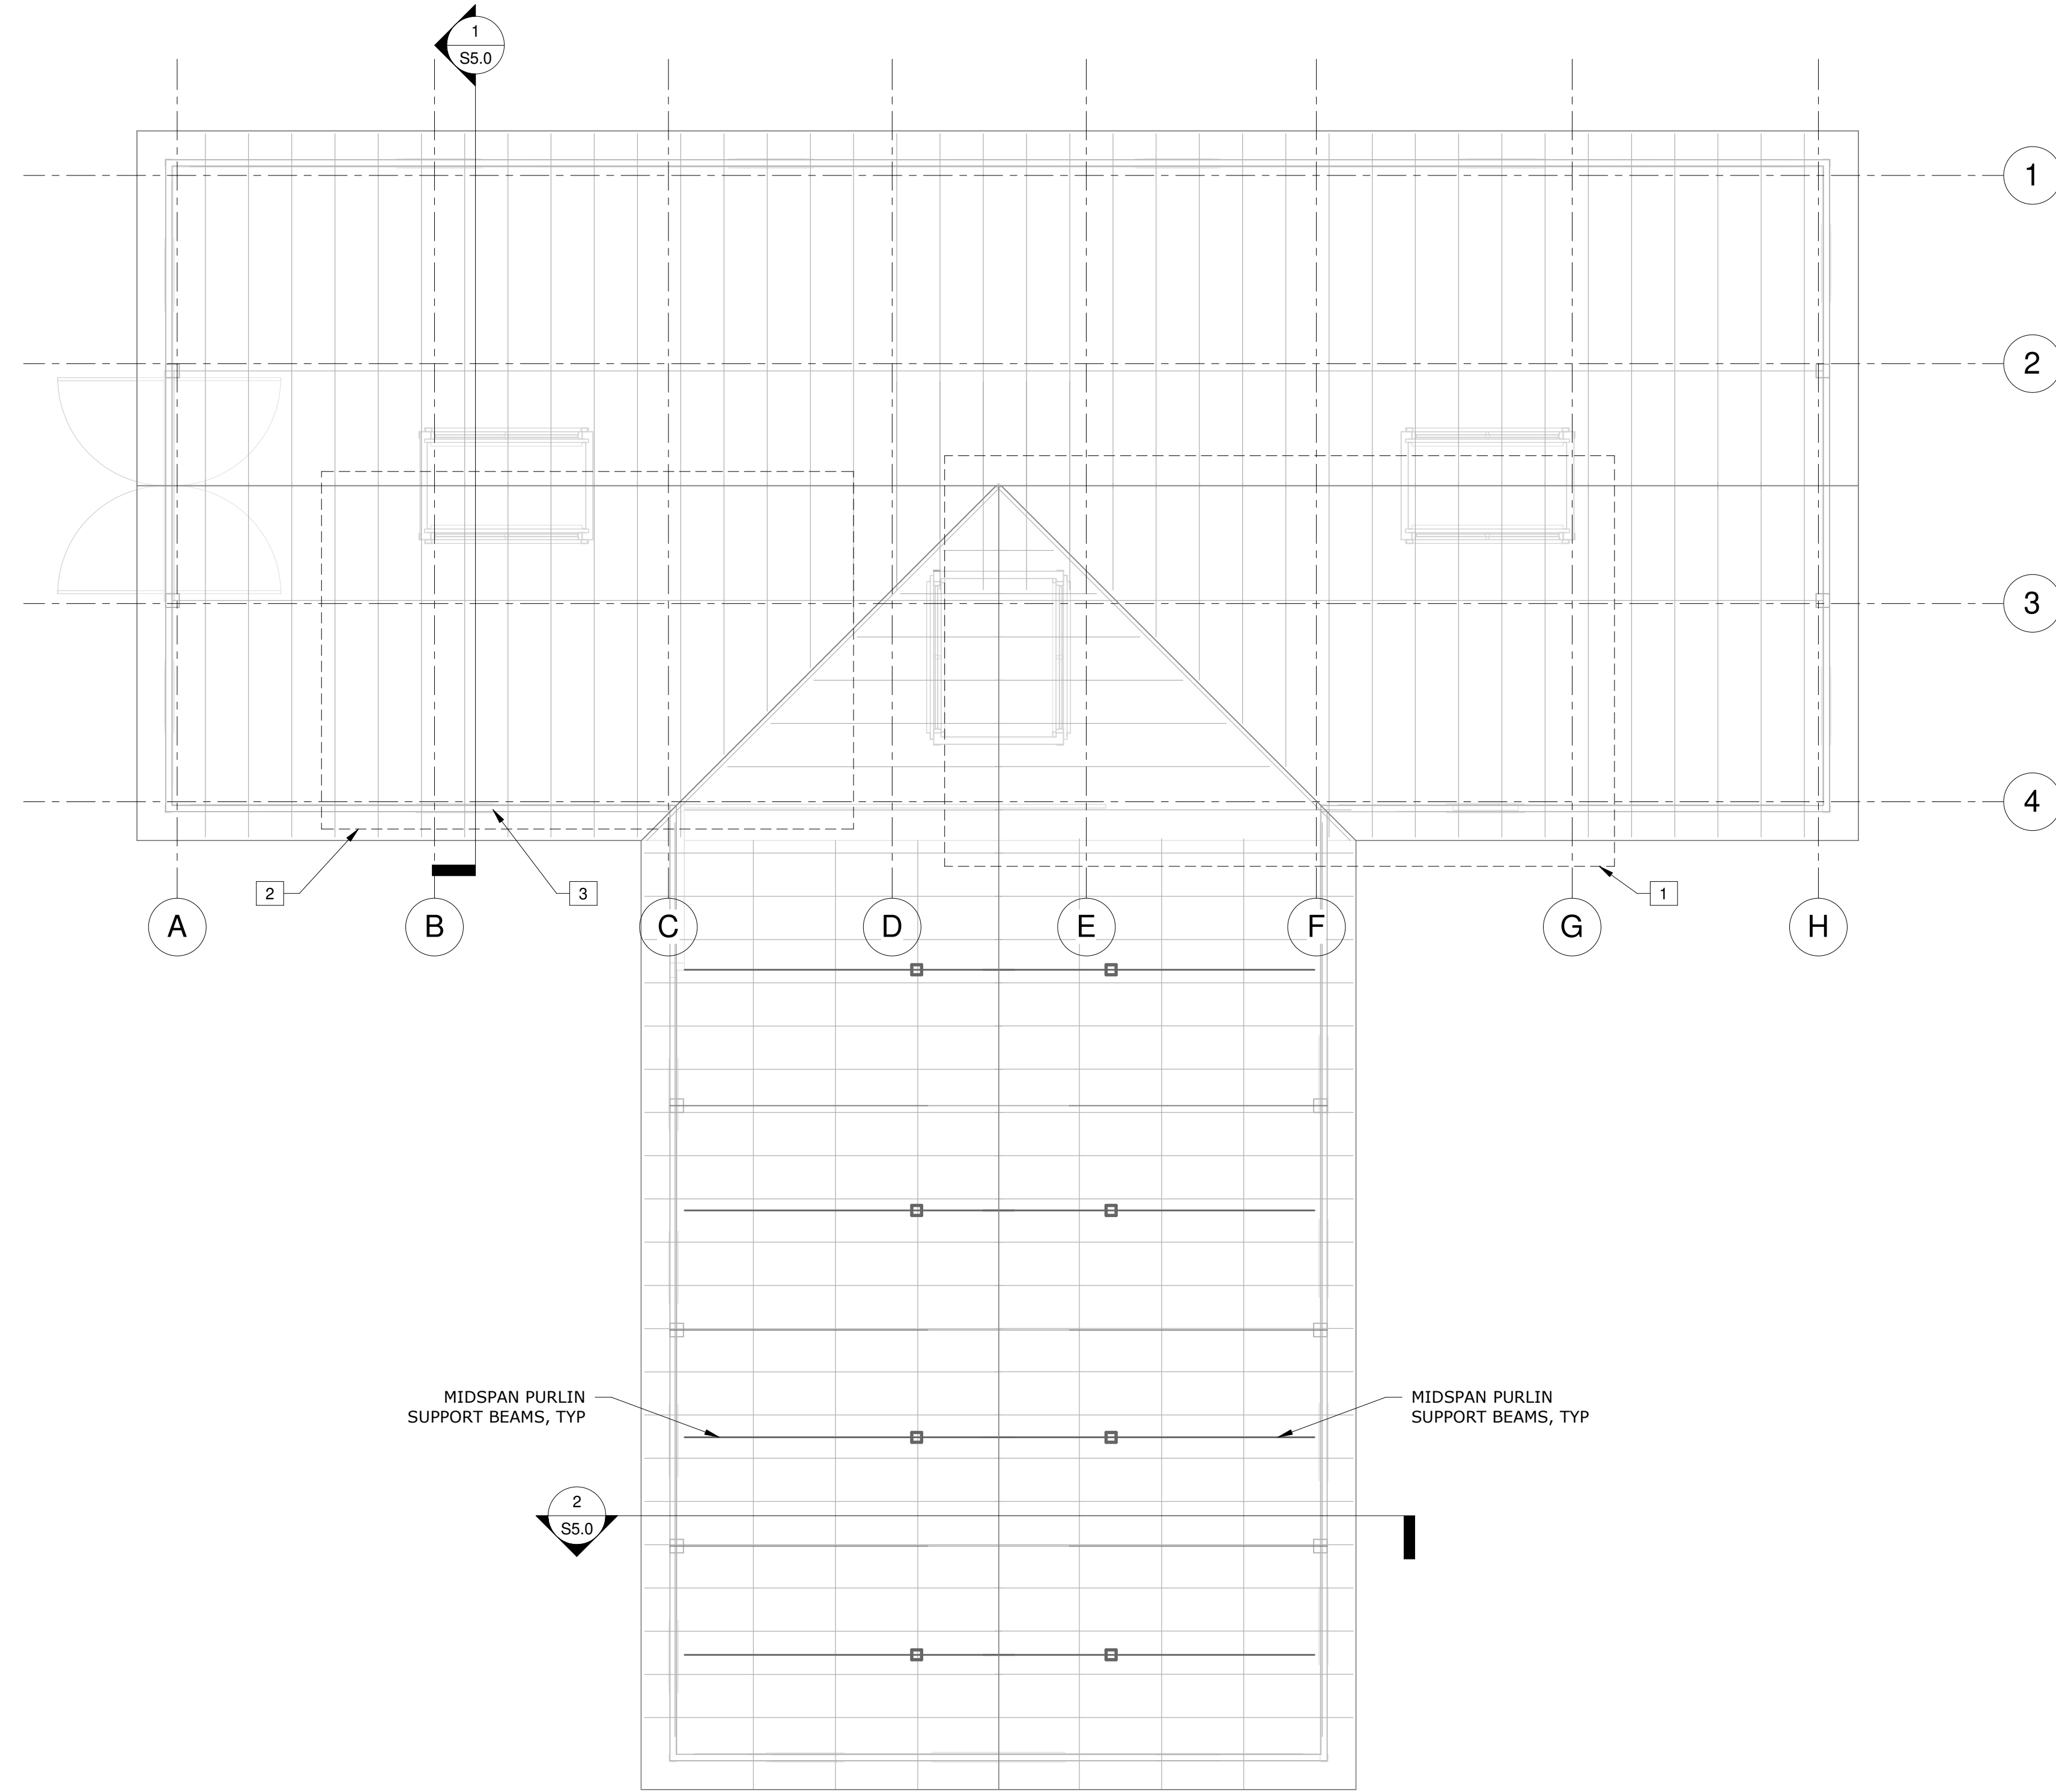
ROOF FRAMING PLAN

- 1 ROOF COLLAPSE AREA, REMOVE AND REPLACE FRAMING.
- 2 RAFTERS FAILING, REMOVE AND REPLACE.
- 3 FAILED WINDOW HEADER, REMOVE AND REPLACE.
