North Parking Structure

Engineering
Condition
Appraisal

Great Falls, MT

April 26, 2012

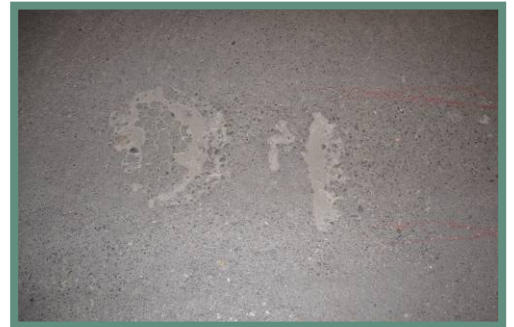
The floor slabs appear to be in good condition with a total of 150 square feet of floor delaminations. Most of the delaminations are relatively small in size ranging from 1 to 6 square feet. This deterioration is located mostly over the beams, where bar reinforcement and tendons are located near the top of the slab. Major contributors towards the deterioration of the concrete slabs are typically high chloride concentrations, shallow concrete cover for the reinforcing steel, and cracks in the slab.

C1 – Top of Slab Repair: Remove delaminated concrete, clean and coat of the embedded reinforcement, and install a new high quality concrete repair mortar.

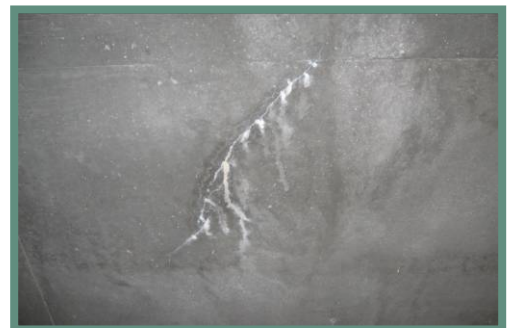
To assess the condition of the ceiling (or underside of floor slabs) we performed a visual survey of all areas. The ceilings appear to be in excellent condition with no ceiling delaminations observed. Cracks were observed in the slab typically at the end bays (between column lines 1 & 2) and at the pour strips (between column lines 7 & 8). Staining was observed at some of the cracks which indicates that the cracks may be actively leaking. Some of the cracks have been routed and sealed at the top side of the slab. The condition of the sealant varies from poor to good.

W1 – Rout & Seal Cracks: Routing and seal the cracks in the concrete slab to help prevent the infiltration of moisture and chlorides. This includes resealing cracks where the existing sealant has failed.

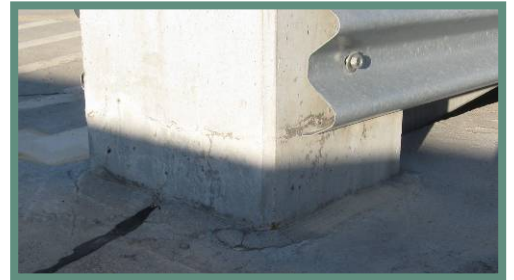
The concrete columns appear to be in excellent condition. No column delaminations were observed. Deterioration of the grout at the base of the columns was observed at the exposed roof level.

W4 – Remove Grout at Base of Column & Replace with Cove Sealant: Remove the deteriorated grout at the bases of the columns at the exposed roof level and installing cove sealant.

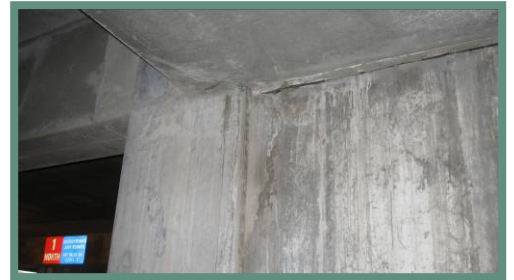
The concrete walls are in good condition with approximately 10 square feet of small isolated wall delaminations observed. The wall delaminations were observed at the retaining walls.

C3 – Wall Repair: Remove the delaminated concrete, clean and coat the embedded reinforcement, and install a new high quality concrete repair mortar.

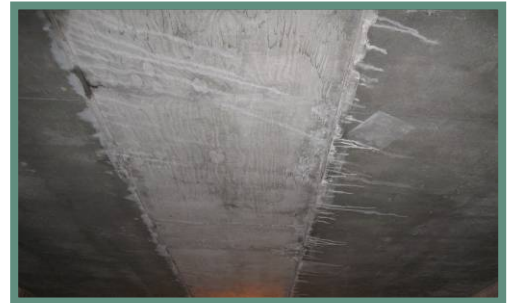
The construction joint sealants appear to be in fair condition at the lower levels and in poor condition at the exposed roof level. Staining was observed at the underside of the slab directly below the construction joints at some locations. Maintenance of the construction joint sealants is critical to prevent water from penetrating the slab down to the post-tensioning anchorages.

W2 – Remove & Replace Sealant at Construction Joints: Remove and replace the sealants at all construction joints to help prevent the infiltration of moisture and chlorides.

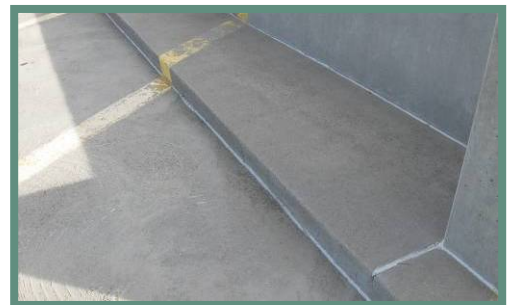
Cove sealants are installed at the perimeter of the structure at the curb/precast spandrel interface and at the curb/structural slab interface. The cove sealants appear to be in fair to good condition at the lower levels and in poor condition at the exposed roof level. The sealants at the roof level are in worse condition due to UV exposure.

W3 – Remove & Replace Cove Sealant: Remove and replace the sealants at all cove joints to help prevent the infiltration of moisture and chlorides. The cove sealants at the exposed roof level should be replaced in the Near-Term (within 5 years), while the cove sealants at the lower levels can be deferred until the Mid-Term (6 to 10 years).

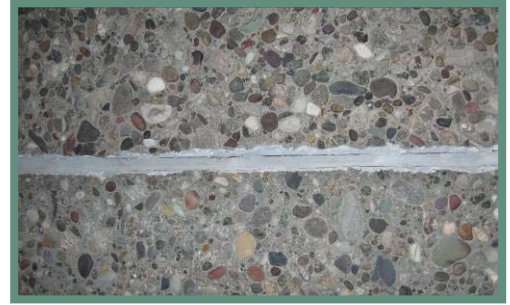
The exterior façade consists of precast panels with an exposed aggregate finish. The joint sealants between the precast panels at the exterior of the structure are showing signs of wear and are near the end of their useful service life.

W5 – Remove & Replace P/C Panel Sealants: Remove the existing sealants between the precast panels and replacing them with silicone sealant.

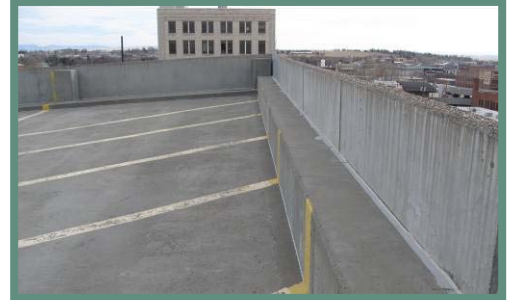
Failed sealant was observed at the horizontal isolation joint between the upturned beam and the precast panels at column lines 6 and 9.

W6 – Remove & Replace Isolation Joint Sealant at Level 7: Remove the existing sealant at the horizontal isolation joint between the upturned beam and the precast panels at column lines 6 and 9 at Level 7 and replace them with silicone sealant.

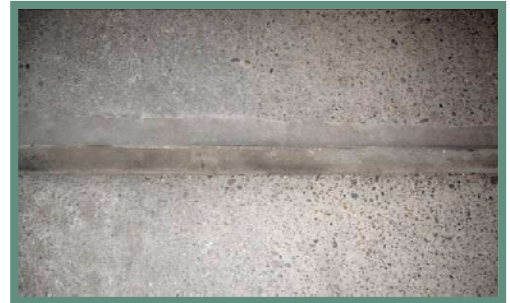
Deterioration was observed at the expansion joints between the slab-on-grade and the supported slab at Level 1. The expansion joint appears to be silicone sealant which has experienced adhesive failures. The failed expansion joint at the north bay (between column lines A and B) is allowing water to leak into the electrical/maintenance room below.

W7 – Remove & Replace Expansion Joints at Level 1: Remove the existing expansion joints at Level 1 and replace them with new multi-cell winged expansion joints.

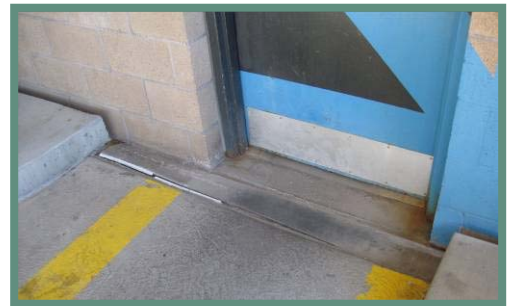
The expansion joints between the stair towers and the parking structure consist of pre-molded seals and almost all of them have failed. The expansion joints appear to have failed due to their age and the settlement that is occurring at the stair towers.

W8 – Remove & Replace Pre-Mold Expansion Joints at Stair Tower: Remove and replace the existing pre-Mold expansion joints at the stair towers. We recommend that further investigation, including soil borings and consultation with a geotechnical engineer, be performed to determine the cause of the settlement prior to replacing the expansion joints.

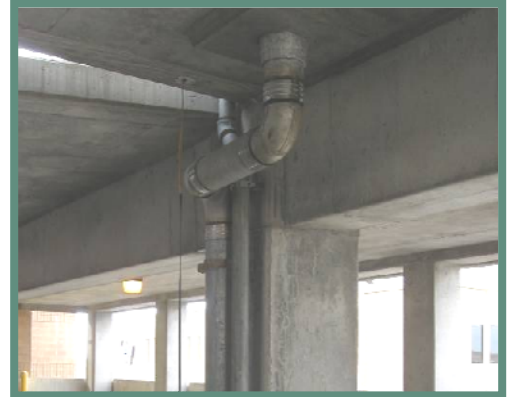
Based on conversations with the facility manager, there is a ponding issue at the center crossover at level 6. The ponding water creates a slipping hazard during the winter months.

ME1 – Install Supplemental Floor Drain: Install a supplemental floor drain at the center crossover at Level 6 to eliminate the ponding water and potential slip hazard. The supplemental floor drain should be connected to the existing storm drainage system.

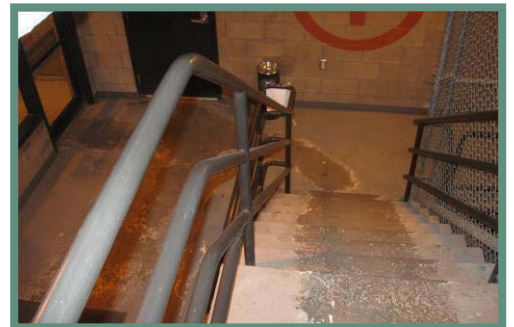
The concrete stairs and landings are painted at both stair towers. The paint is worn down to the concrete at some locations. The locations of the heaviest wear were observed at the lower levels which experience higher volumes of pedestrian traffic.

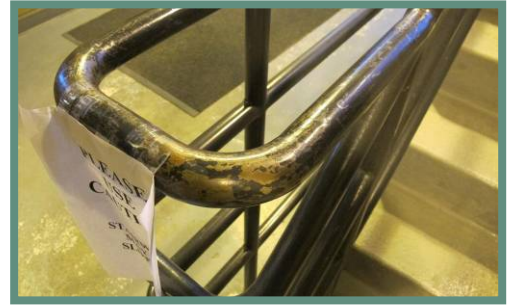
The metal railings in the stairwells do not meet the height and opening requirements of the current code. The height of the railing is approximately 34 inches and the openings between the horizontal rails are approximately 7 inches. The current code requires that the height shall not be less than 42 inches and the opening shall be less than 4 inches. The railings most likely met the requirements of the code when it was built and likely remain grandfathered in. Deterioration of the paint on the railings was observed at isolated locations throughout the stairwells.

S1 – Repaint Stair Tower Railings: Repaint the stair tower railings. This work is scheduled for the Mid-Term (6-10 years) since the paint is currently in good to fair condition overall.

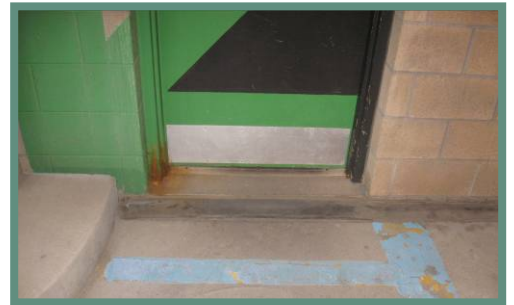
Corrosion was observed at the bottom of the metal door frames at level 4 of the northeast stair tower and at level 5 of the southwest stair tower. The corrosion is limited to the bottom 6 inches of the frame.

S2 – Clean & Paint Door Frames: Clean and paint all corroded door frames.

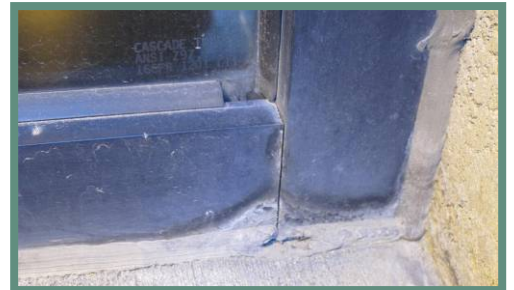
Shrinkage of the exterior window gaskets was observed at both of the stair towers. The gaskets are pulling away at the corners of the window frames creating an opening which allows water to easily penetrate the window system.

S4 – Remove & Replace Window Perimeter Sealants: Remove and replace all window perimeter (masonry to metal frame joint) sealants at all stair tower windows to provide a watertight enclosure.

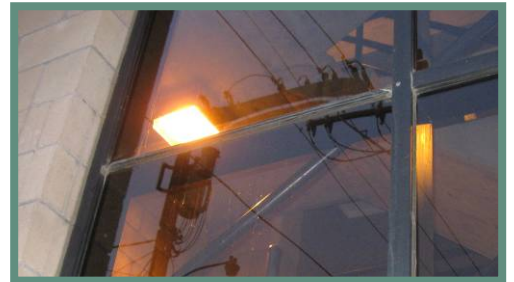
One of the mullion covers is missing at the east side of the southwest stair tower.

S5 – Replace Mullion Cover: Replace the mullion cover that is missing at the southwest stair.

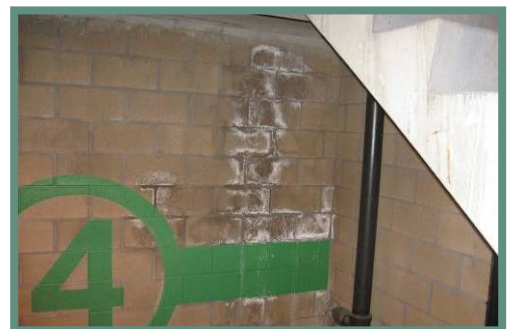
Efflorescence was observed at the masonry walls at both stair towers. The efflorescence was primarily observed at the east end of the north wall in the southwest stair tower, and at the south and west walls of the northeast stair tower. Potential sources of water infiltration could be leaking at the stair tower roof, failed expansion joints, failed mortar joints, failed window gaskets, and failed window perimeter sealants. We did not have access to the stair tower roofs so we were not able to review the roofing system.

S6 – Re-point Deteriorated Mortar Joints: Re-point all deteriorated mortar joints at the exterior of the stair towers to minimize water infiltration.

S7 – Install Masonry Sealer: Apply a clear water repellent sealer to all exterior wall surfaces of the stair towers to help reduce water infiltration.

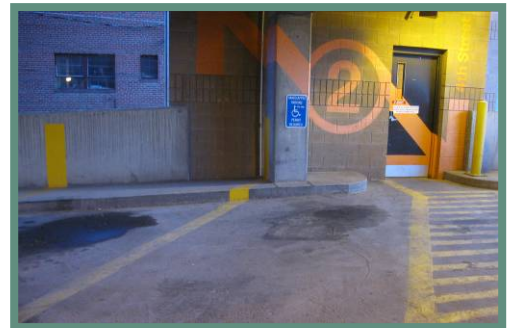
There are approximately 18-20 spaces indicated as accessible throughout the structure. Accessible spaces are provided at the southwest quadrant of Level 1 and near the stair towers at the upper levels. Only 2 of the 11 spaces with accessible signage and pavement markings on Level 1 have the required access aisle adjacent to the stall, rendering the remaining 9 spaces non-compliant. One of the accessible spaces at Level 2 near the southwest stair tower has a sign indicating that it is an accessible space, but the pavement markings are yellow in lieu of blue.

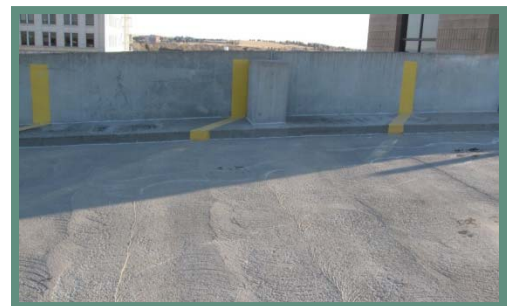
Pavement Markings: The pavement markings are showing signs of wear and are completely worn down to the concrete at some locations at the exposed roof level. Reapplication of the pavement markings is generally required every 3 to 5 years.

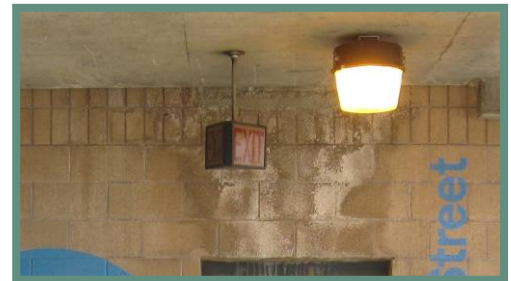
The signs are in generally good condition with the following exceptions. One of the signs is missing at Level 6, graffiti was observed on a few of the signs, and the exit signs near the stair towers are not illuminated.

M2 – Replace Missing or Damaged Signs: Replace all signs that are damaged or missing.

M3 – Replace Exit Signs: Replace all of the exit sign with new illuminated exit signs.

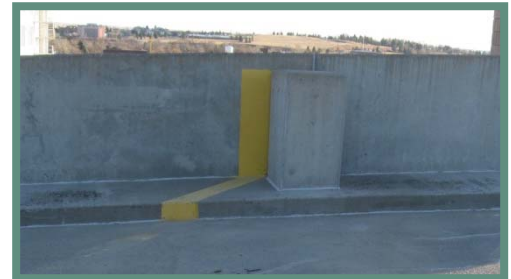
Vehicle/Pedestrian Barriers: The vehicle and pedestrian barrier consists of precast spandrels at the perimeter of the structure. The height of the precast spandrel from the top of the curb to the top of the spandrel is approximately 41 3/4 inches which does not meet the current code requirement of 42 inches.

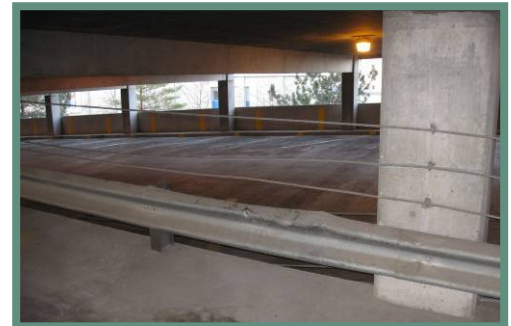
The vehicle and pedestrian barrier consists of a steel guardrail with barrier strands at the interior column line. The height from the top of the slab to the top barrier strand is approximately 42 inches. There is approximately 10 inches between the top of the slab and the bottom of the steel guardrail and there is an opening of approximately 7 inches between the barrier strands. The current code requires an opening of less than 4 inches.

The barrier near column B-12 at Level 3 was damaged by vehicular impact. The steel guardrail is damaged and one of the barrier strands is sagging.

M4 – Guardrail Repair: Replace the barrier strand and section of steel guardrail that has been damaged due to vehicular impact at Level 3.

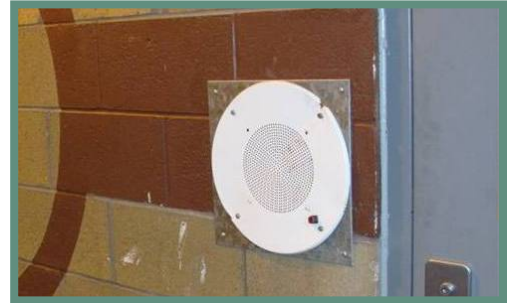
Intercoms are provided at each level within the stair towers, but there is no signage to identify them.
