Addendum No. 01
Date: February 8, 2021
Project: City of Great Falls Envelope Renovation

GREAT FALLS
CIVIC CENTER
FRIEZE
VENEER
REPORT

Concrete Core Evaluation

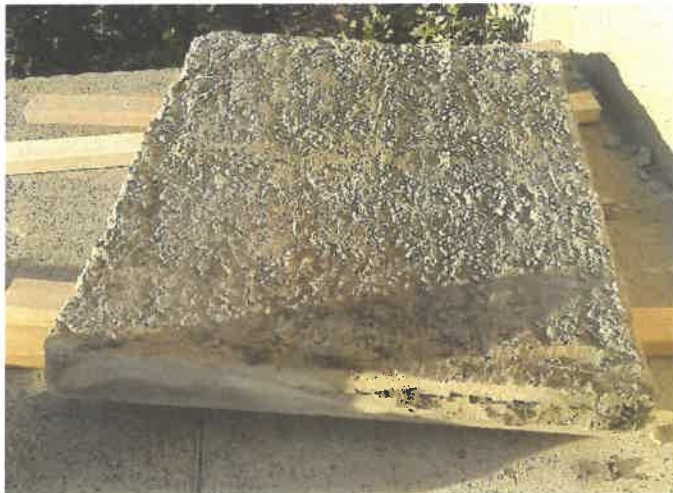
Photo 2

As specified we removed one piece of the exterior veneer from the entrance frieze of the Great Falls Civic Center. The installation of this piece had no masonry anchorage or vertical restraints. Please see photos 1, 3 and 4. The cladding was set in a concrete mortar with no attempt to adhere the piece to the substrate. Please see photo 2.

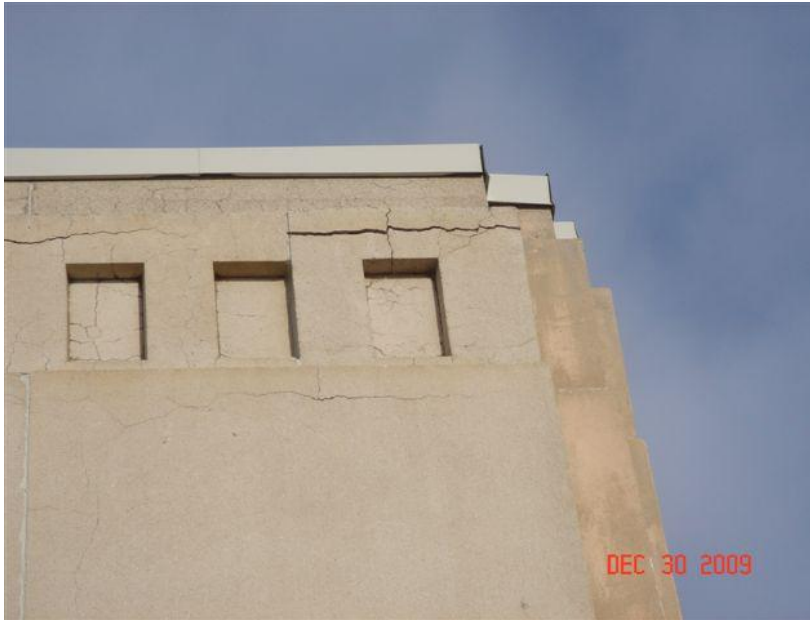
Sections of the building show large cracks in the precast concrete panels caused by corrosion of the embedded reinforcing steel. Photographs you provided to us are shown in Figures 1 and 2 show some of this distress. Other areas of the building only show fine surface cracking, as shown in Figure 3, and appear in better condition. The core provided reportedly represents this better condition and the intent of this analysis is to help assess the need to replace all panels or if some panels can be repaired.

Figure 1. View of cracking on upper part of Civic Center (NTL).

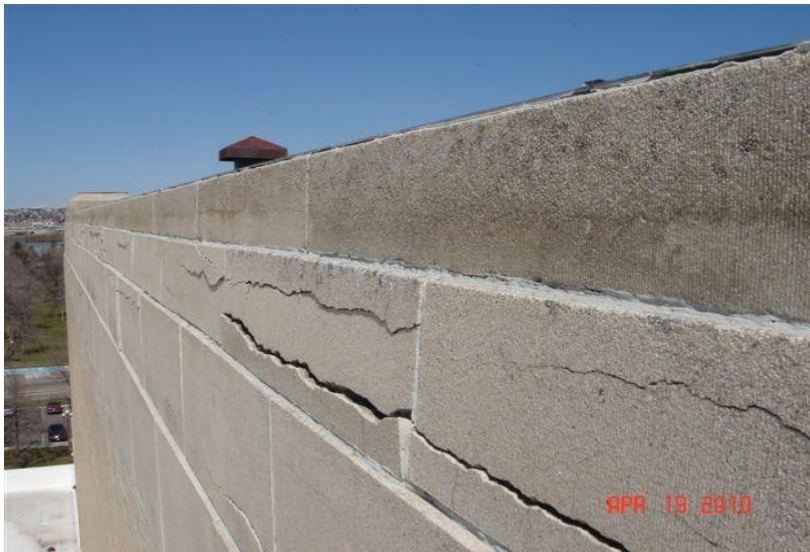
The cracking in the panels is a result of corrosion of the embedded reinforcing steel. Regular carbon steel reinforcing bars (black bars) are passive in normal portland cement concrete because the concrete provides a desirable high pH (~13) medium and also acts as a physical barrier isolating the steel from the environment. However, black reinforcing bars are vulnerable to corrosion when the high pH of the concrete at the steel depth is lost or when chloride ions are present. Chloride from sea water or road deicers is known to penetrate the concrete cover and cause aggressive corrosion of the embedded reinforcing. Calcium chloride based chemical admixtures were added to reinforced concrete prior to the 1950’s as a setting time accelerator. This practice was mostly stopped when it was found that this admixture would cause corrosion of the embedded reinforcing. Chloride contamination causes corrosion because steel is active after a threshold concentration of chloride (often called chloride threshold, C_T) is reached. Though varied from case to case, the C_T of black bars is low and typically about 0.03% by weight (1.2 lb/yd³). The concrete sample examined contained chloride above this threshold value so the corrosion is likely chloride induced. While the near surface had slightly higher chloride than the center of the sample, it is likely that the chloride was admixed into the concrete as a set accelerator when the panels were built, possibly with more chloride added to the face mix than to the backup mix.

steel. A combination of chloride contamination and concrete carbonation has resulted in corrosion of the embedded reinforcing steel.

Figure 2. View of cracking caused by corrosion of embedded reinforcing steel (NTL).

Our laboratory studies of a single concrete core indicate that the cracking present within the core is due to corrosion of the embedded reinforcing bar. Several cracks radiate in different directions from the location of the corroded rebar. There are two major causes for the corrosion; (1) carbonation of the cement paste that extends virtually full depth of the concrete, and (2) high chloride levels that are two to more than four times the typical corrosion threshold for uncoated reinforcing in concrete. A source of chloride is likely the addition of chemical admixtures to the concrete to accelerate the setting of the concrete and face mix. Drift of chlorides from deicing salts spread on the streets and sidewalks in winter could also contribute to the chloride. Additional sampling and testing could determine the source of the chloride contamination. Corrosion of the embedded steel is expected to continue because the concrete paste is carbonated and the chloride contents are well above the corrosion threshold level. Surface sealing the panels is not likely to extend their service life significantly since the carbonation and chloride is within the concrete and in contact with the reinforcing. Assuming that this core sample is representative of the moderately deteriorated panels, this panel deterioration appears to be past what is practical to affect a lasting repair of the panels.

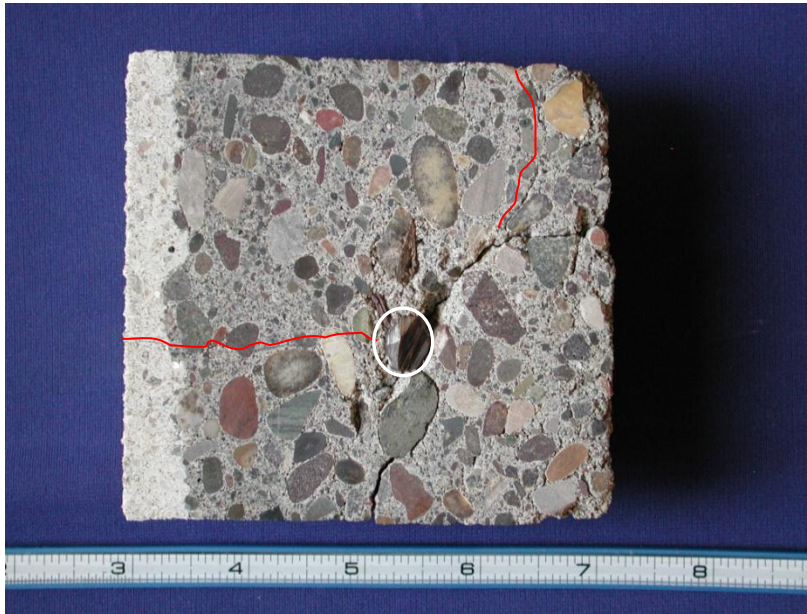
A 3/8-inch-diameter reinforcing bar is embedded 2-1/8 from the exposed surface of the core. The surfaces of the rebar exhibit significant corrosion. Cracks radiate in all directions from the location of the rebar. The cracks appear to be caused by corrosion of the embedded reinforcing bar. The concrete is not well densified within 1 inch of the inner surface of the core. A few cracks were detected within this 1 inch zone. The cracks in this zone usually follow the areas of abundant air voids related to incomplete consolidation. There is no evidence of cracking related to any deleterious chemical reactions within the concrete or paste. (Figures 4 through 8)

Figure 5. Lapped section of the core. Cracks radiate in all directions from the corroded reinforcing bar (encircled). The finer cracks are outlined in red.

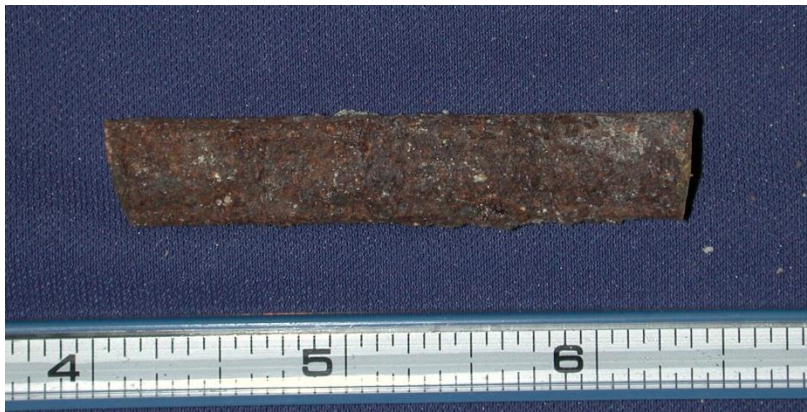
Figure 8. Section of the corroded reinforcing bar.

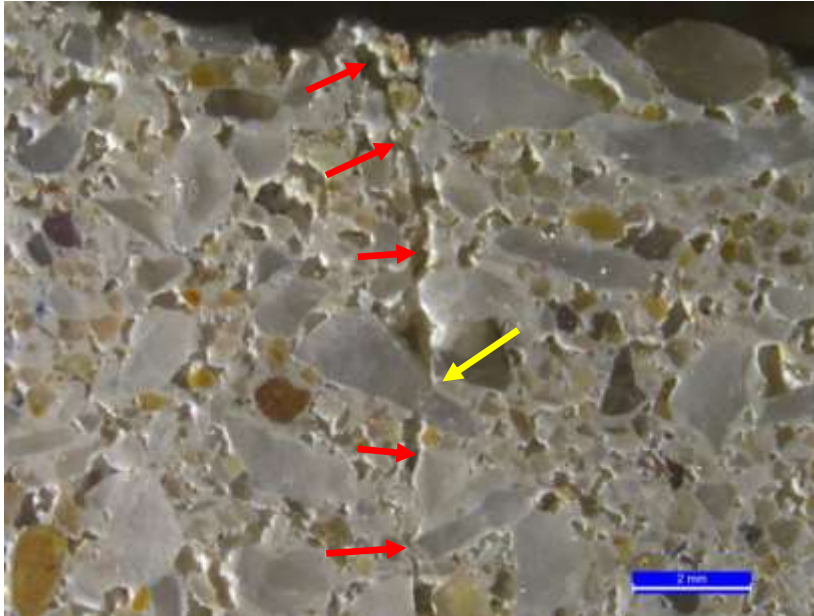
Cracking is limited within the samples, and cracking is not apparent on the exterior surfaces of the cores. Core 3A North contains a longitudinal crack that begins along the exterior face of the sample (Figure 26); however, the crack was not visible before the core was cut in half because the large volume of entrapped air voids within the mix camouflages the crack along the exposed surface. The crack in Core 3A North is widest at the exterior surface and tapers with depth. The crack breaks aggregates beginning approximately 6 mm from the exterior surface, indicating that the crack propagated through the cast stone after it had gained appreciable strength. The crack is likely early-age shrinkage induced, however the small aggregate size, low matrix volume, and high volume of irregularly shaped voids contribute to poorly-defined crack surfaces (there are no sharp, well-defined crack boundaries observed), which limits the interpretation of cause and relative age of the cracks. However, the petrographic studies have definitively established that cracking was not caused by alkali-aggregate reactions or cyclic freeze/thaw distress.

Figure 26. A crack (red arrows) that begins along the exterior surface of Core 3A North and breaks its first aggregate particle (yellow arrow) approximately 6 mm from the surface.

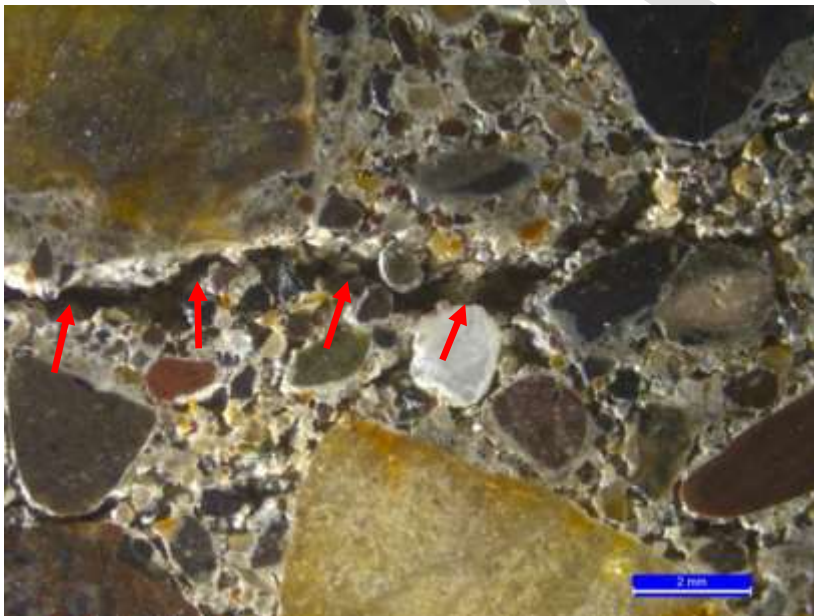
Within Core 3A North, transverse elongate voids appear similar to cracks, but are caused by the compaction of the dry tamp product. The elongate voids occur primarily in the transverse direction, but also occur longitudinally to a lesser degree, around aggregate particles (Figure 27 and Figure 28). In Core 3A North, these elongated void spaces are visible within the backup mix, and are not observed in the face mix.

Figure 27. Elongated voids are observed within the backup mix in Core 3A North. The void in this image (red arrows) runs transverse through the core.

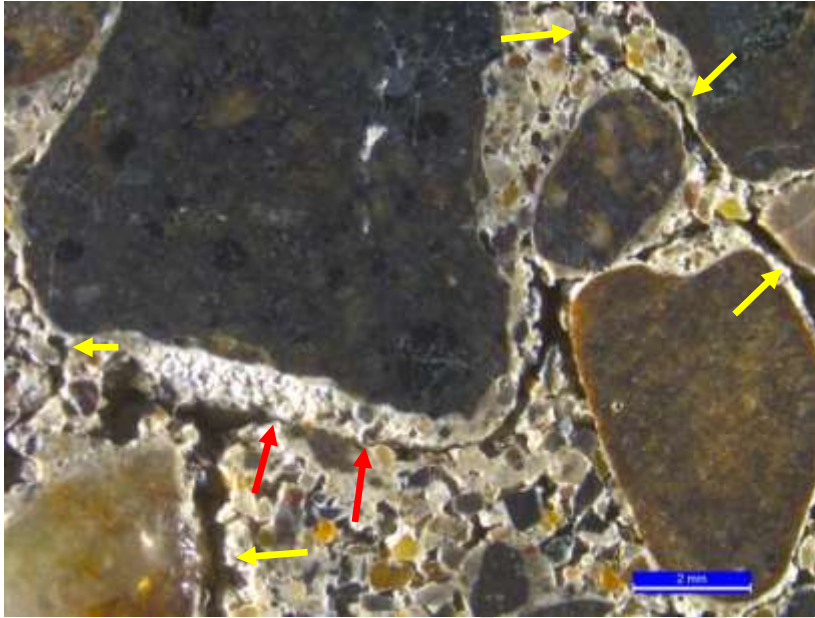
Figure 28. While most of the elongated voids run transverse (red arrows), some longitudinal voids (yellow arrows) are also observed in the backup mix.
