GREAT FALLS
CIVIC CENTER
FRIEZE
VENEER
REPORT

Malisani Inc. Installation Report

DATE: 11/28/2016
TO: **MR. GREGORY T. DOYON, GREAT FALLS CITY MANAGER**
FROM: TONY MALISANI, MALISANI INC
RE: GREAT FALLS CIVIC CENTER FRIEZE/INSTALLATION REPORT

Great Falls Civic Center

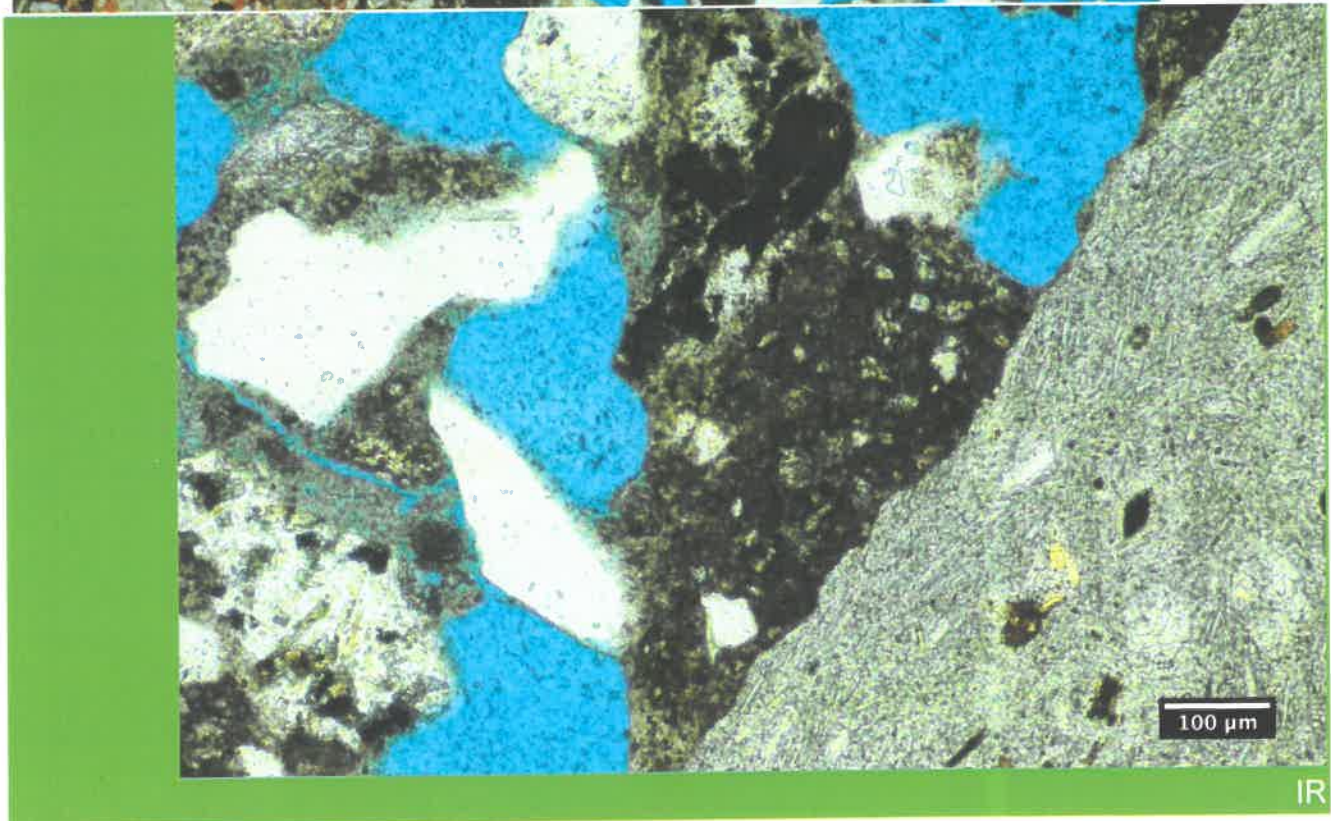
Igneous RF = 'IR', Air-entrapment macroporosity (blue).

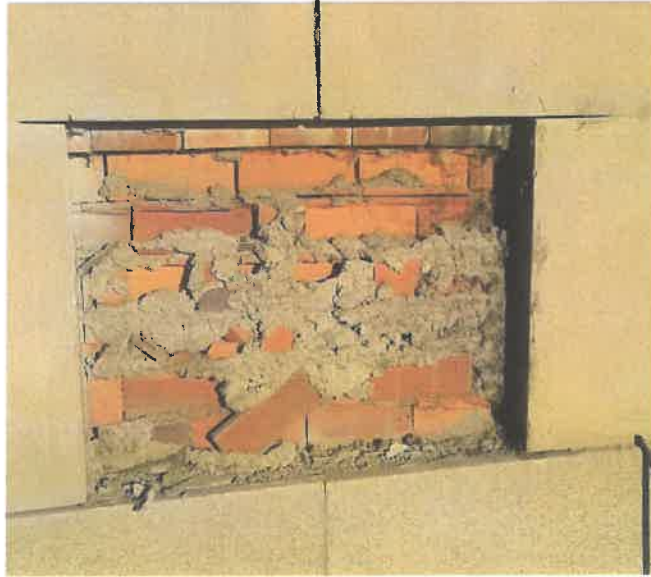
Photo 1

As specified we removed one piece of the exterior veneer from the entrance frieze of the Great Falls Civic Center. The installation of this piece had no masonry anchorage or vertical restraints. Please see photos 1, 3 and 4. The cladding was set in a concrete mortar with no attempt to adhere the piece to the substrate. Please see photo 2.
