Great Falls – Cascade County Historic Preservation Advisory Commission
Minutes from the November 8, 2023 meeting, held in the Gibson Room at the Civic Center

Boston and Montana Barn

4.0 Existing Conditions

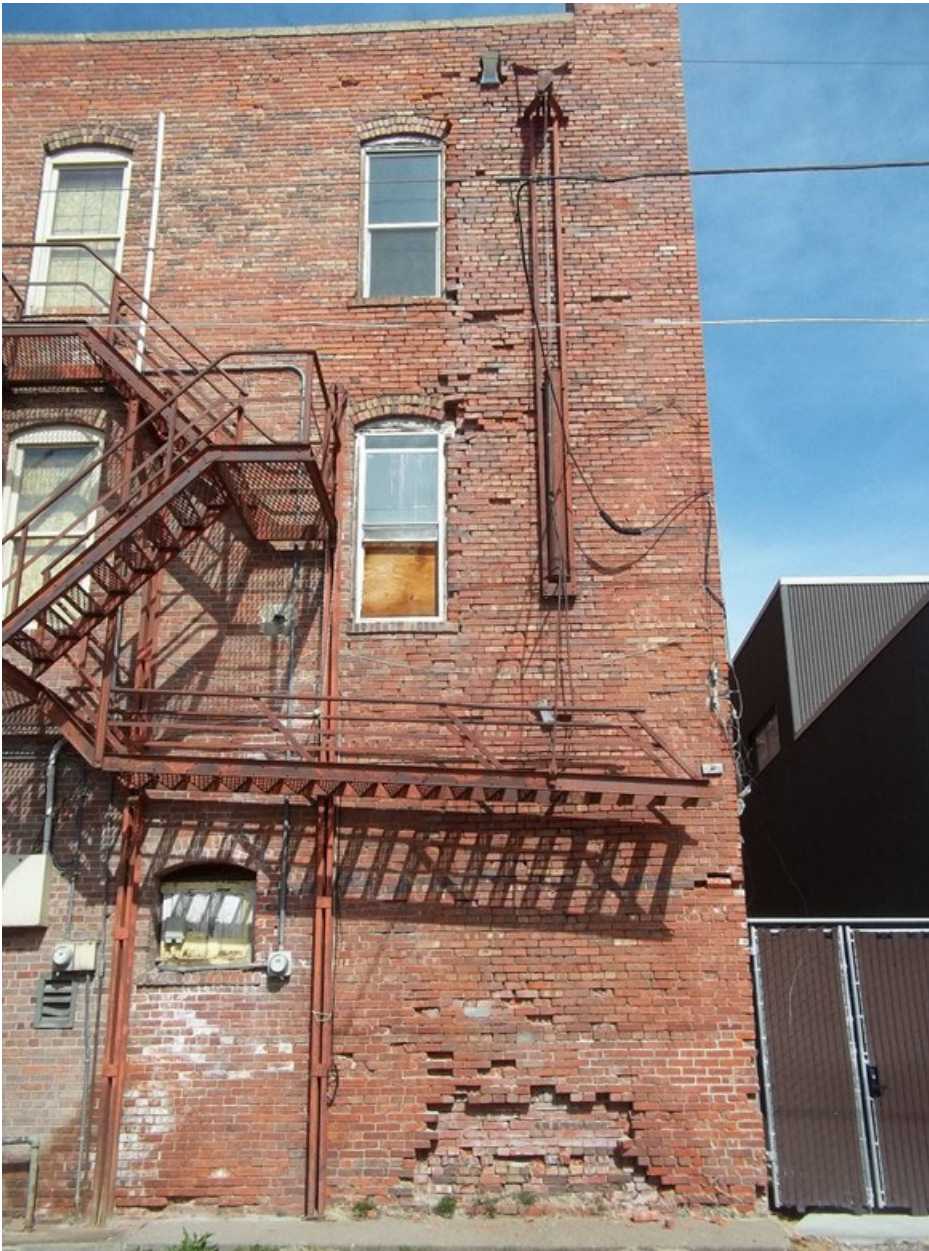
The south elevation lacks decorative elements and is made with a lighter red brick. The brick on the east third of the façade shows significant damage from moisture intrusion, with the exterior wythe bricks completely missing in several areas. The southeast corner of the building features the original chimney that projects above the roof.

MT_CascadeCounty_BaatzBlock_0006: Alley Façade partial, showing water intrusion damage on brick veneer, looking north, July 1, 2021, photographer: Julie M. Stiteler.

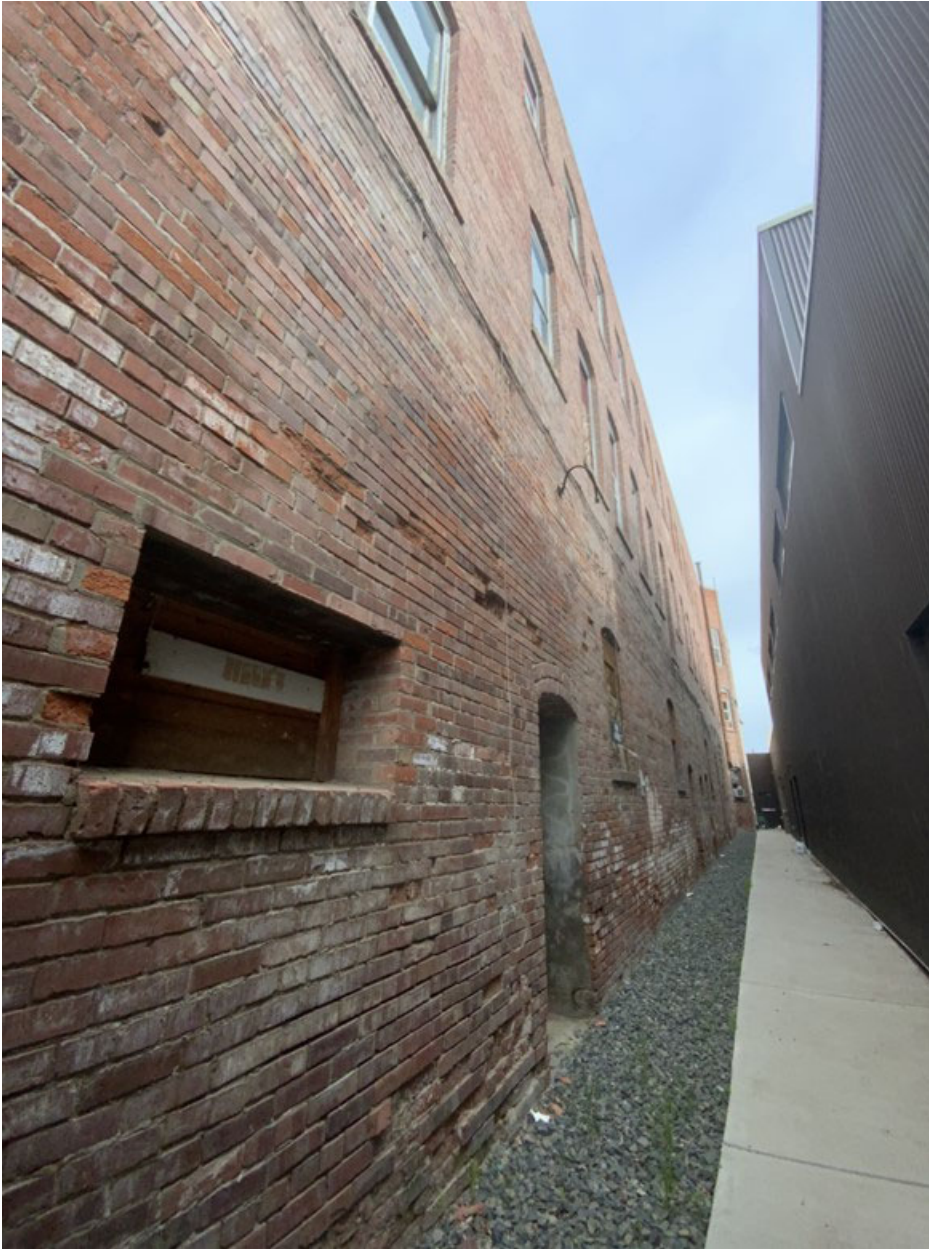
MT_CascadeCounty_BaatzBlock_0007: East Façade partial, showing obstruction by adjacent building, looking north northwest, June 7, 2022, photographer: BSPARK Architecture.

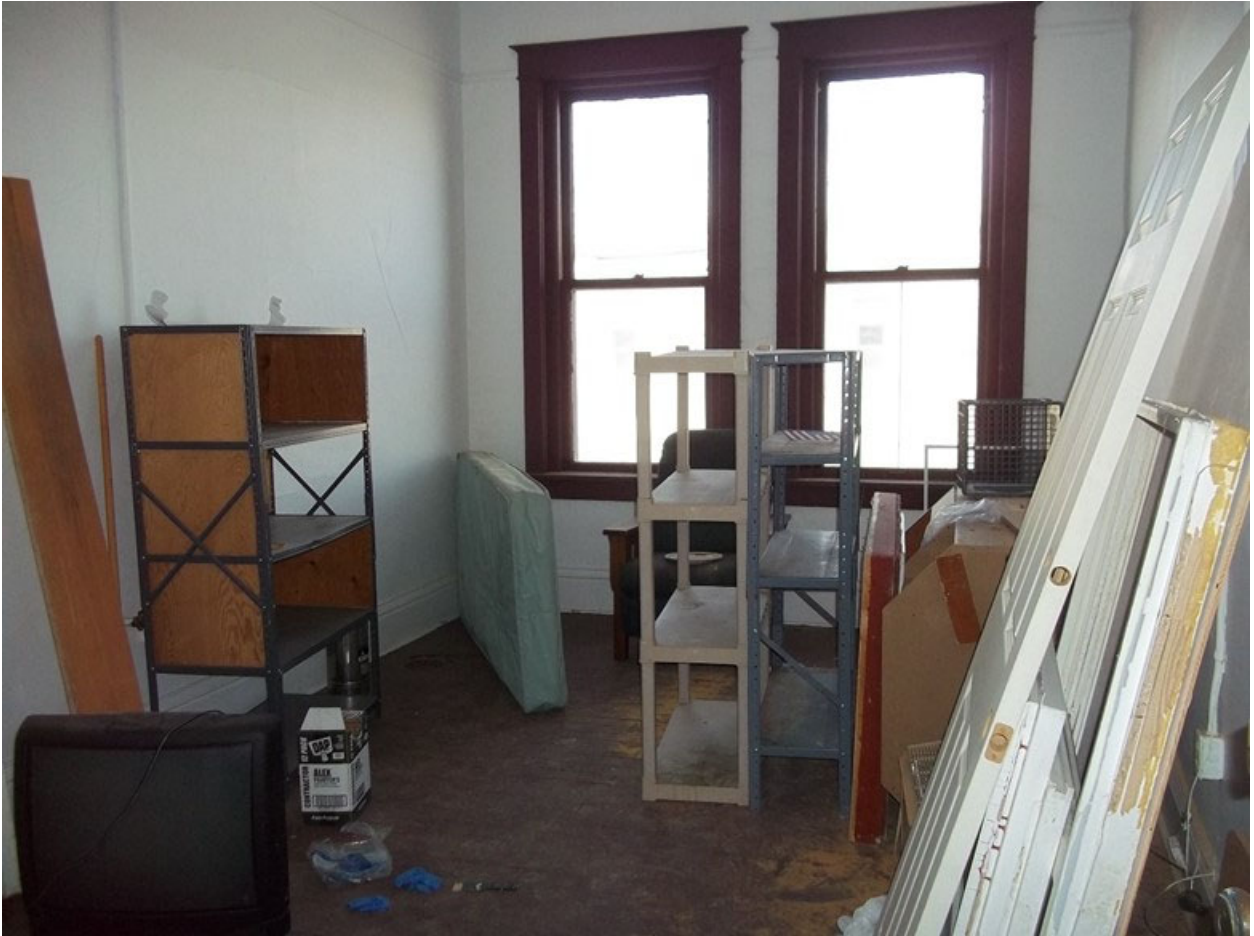
MT_CascadeCounty_BaatzBlock_0020: 2nd floor, typical hotel room with original wood windows, non-historic paint on windows and trim, looking east, March 22, 2021, photographer: Julie M. Stiteler.

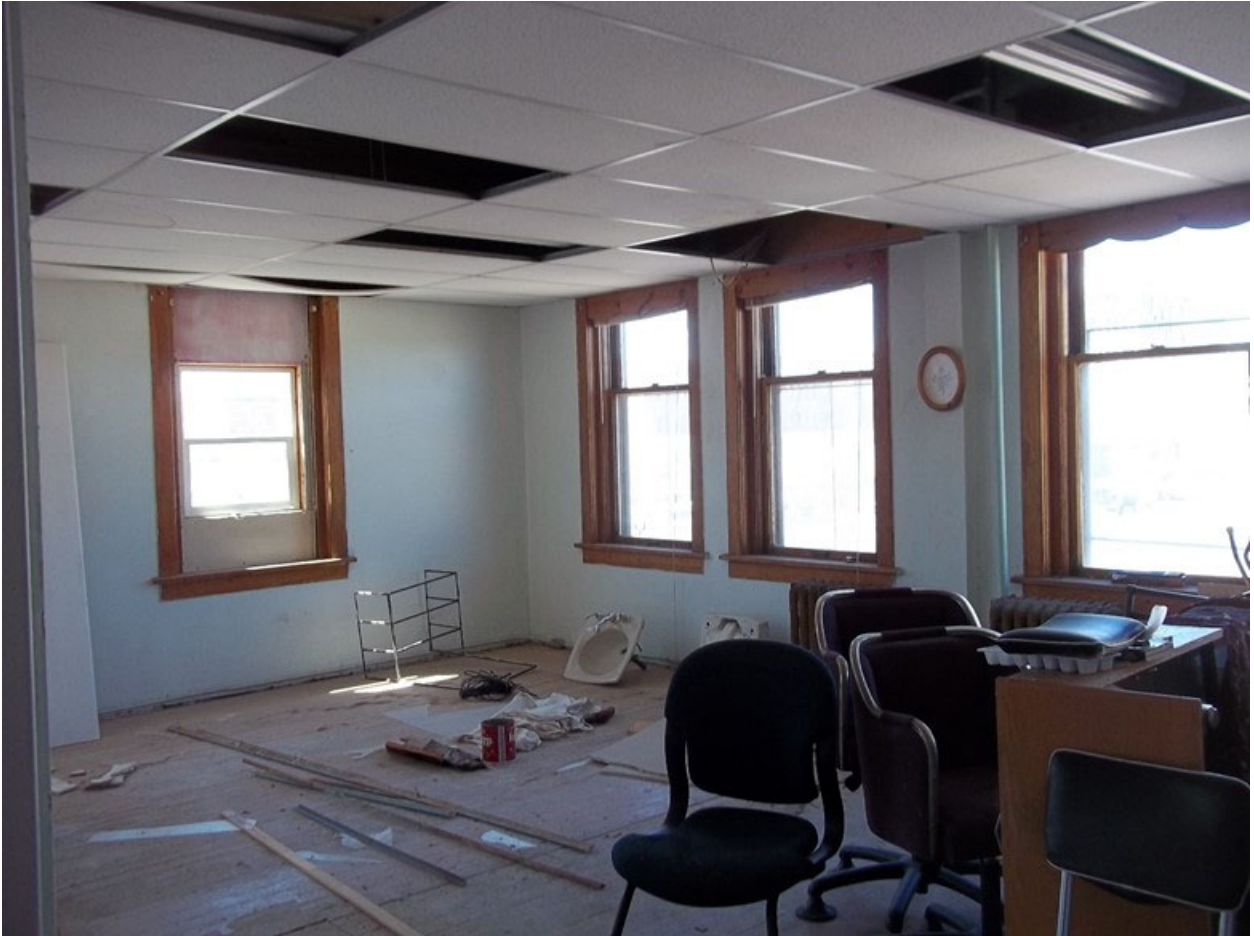
MT_CascadeCounty_BaatzBlock_0022: 2nd floor, non-historic remodel of north rooms including non-historic dropped ceiling, with original stained window trim, looking northwest, July 1, 2021, photographer: Julie M. Stiteler.

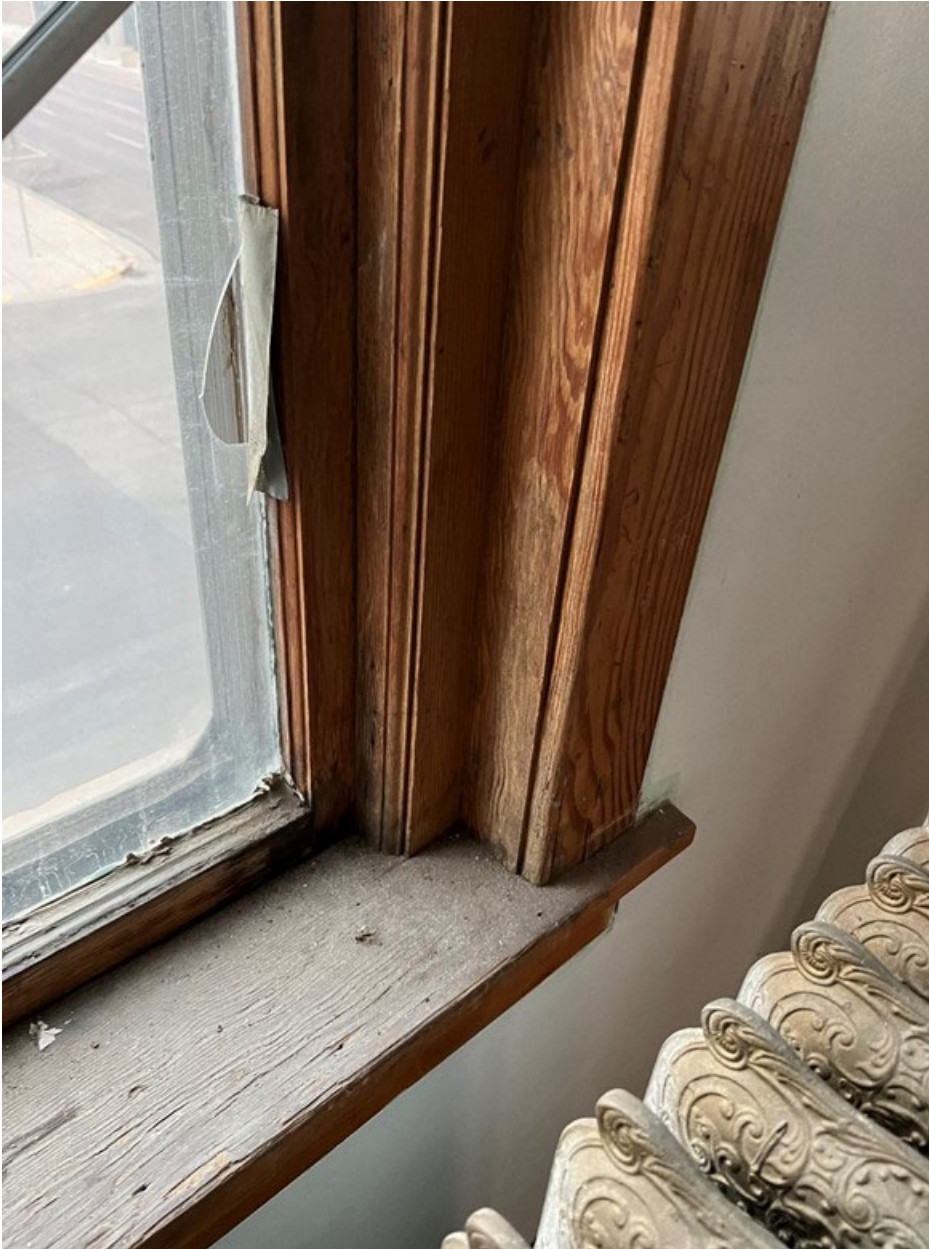
MT_CascadeCounty_BaatzBlock_0028: Original wood window detail, showing clear stain treatment on trim, looking northwest, September 11, 2022, photographer: Heather McMilin (Homeword).

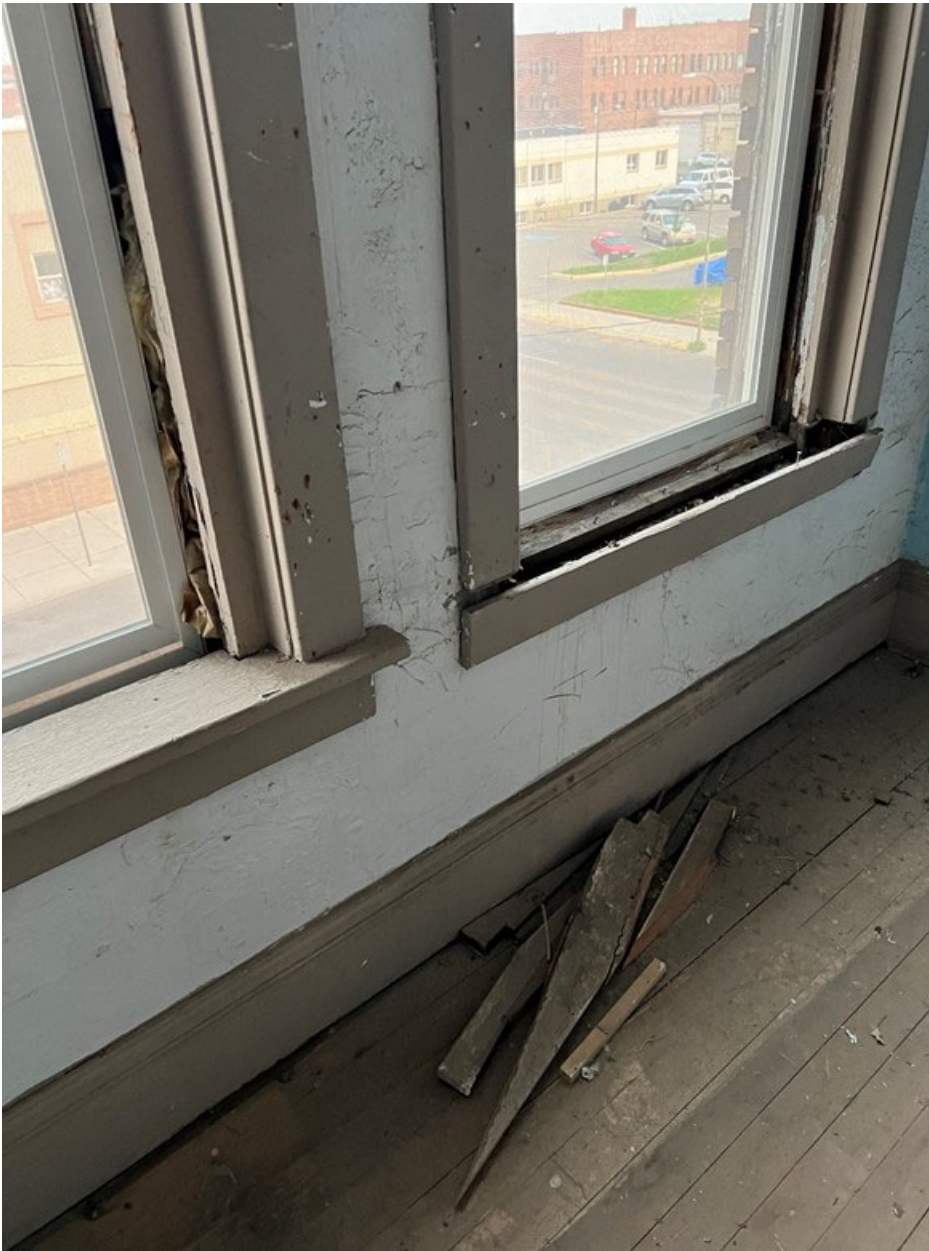
MT_CascadeCounty_BaatzBlock_0029: Replacement vinyl sash detail, showing damaged trim, looking southeast, September 11, 2022, photographer: Heather McMilin (Homeword).

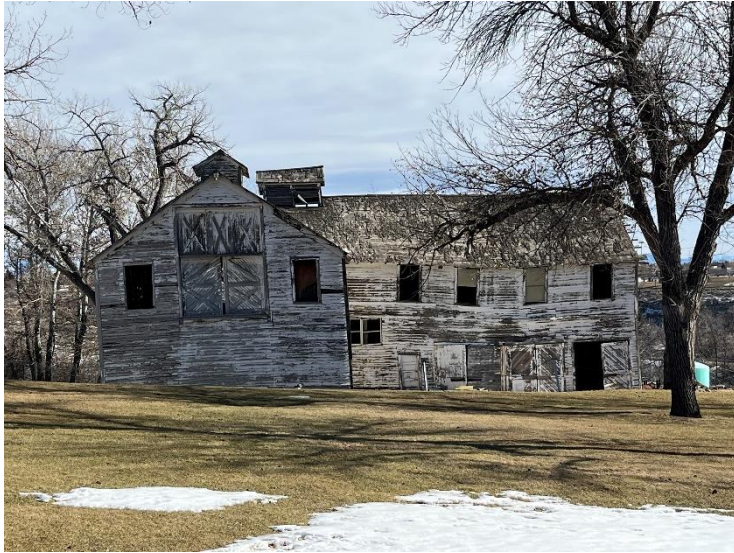
The existing building is a two-story T-shaped structure in plan with gable roof. Truss bearing elevation is approximately 20' above main floor level. Trusses in the north section appear to be stick-built common-style trusses. Construction of the roof in the southern section consists of larger heavy timber trusses with purlins spanning between them. Cupolas rest on the top of both the north and south sections. Top of roof is approximately 31'-9" above main floor, and the top of the cupolas sit approximately 37' above main floor.

Both floor levels are fully wood-framed with wood flooring. The main floor is framed over crawl space, accessible in the south half, but the north section is inaccessible and was unobserved at the time of this report. Foundation walls are sandstone construction, and carry the heavy timber frame for the floor structure. The second level is framed over heavy timber primary structure and is approximately 12'6" above main floor level.

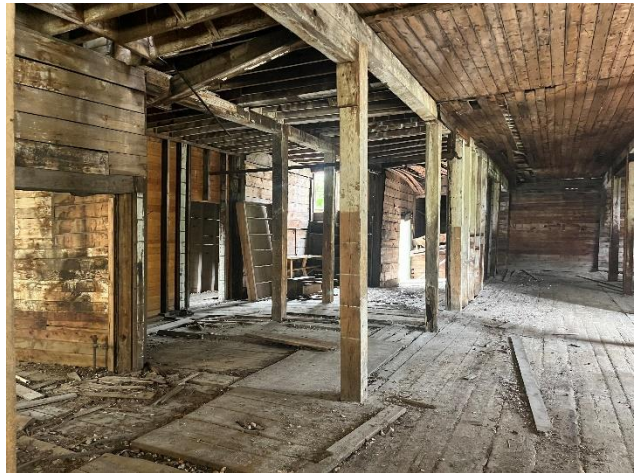
All walls are 2x framed and faced with painted narrow wood lap siding. The roof itself is sheathed and finished with wood shakes. All doors and windows are constructed completely of wood. The exterior grounds are primarily gravel and grade is typically at main floor level.
