# Boston and Montana Barn

Black Eagle, Montana

Existing Conditions Assessment

Recommendations for Stabilization and Protection

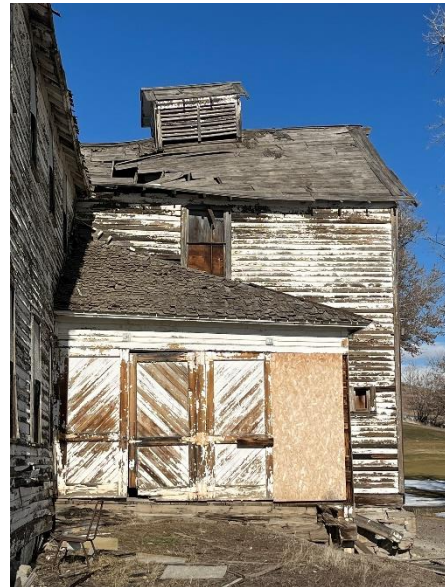
### 5.3 Set the north roof ridge elevation level

The existing shake roofing is well past its useful life and is neither complete nor capable of weather-protecting the interior of the building. Roof sheathing is heavily weathered and weakened throughout. Stick-built trusses on the north section are broken and the bottom chords are completely sheared from the primary structure, allowing the walls to shift laterally. Hip-jacks are broken, allowing the roof to sag, especially under the weight of snow. These failures have resulted in substantial sag in the ridge of the north section.

Once the exterior walls are plumb and the top plates are repaired as necessary, the roof can be stabilized by rebuilding the trusses and restoring a continuous, level ridge line at the roof. This will allow for resurfacing and weatherization of the roof assembly. It is our position that trying to weather-protect the structure without first setting the ridge level will compromise the weather-resistant properties and long term durability of any roofing system, and also make any future work such as permanent roofing much more difficult and costly.

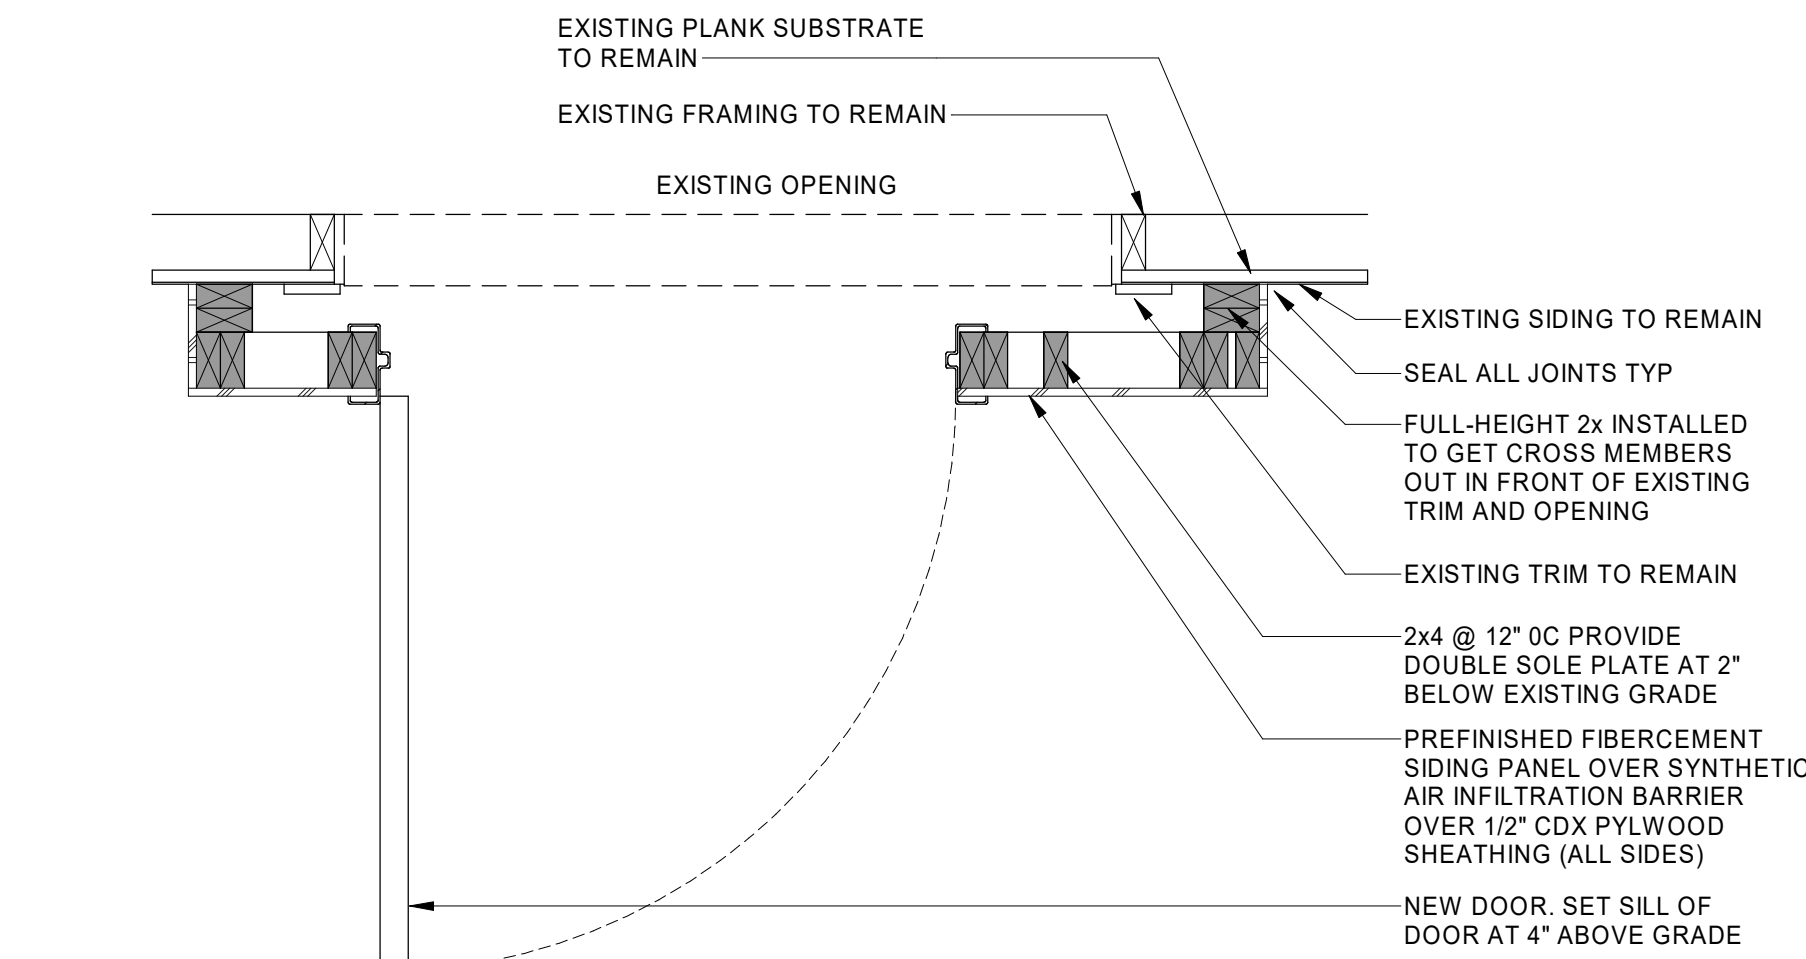
2  
A101  
OPERABLE DOOR OPENING DTL  
1" = 1'-0"

Doors are wood and mounted on hinges. Most are no longer plumb and don't easily close. Wood is heavily weathered, dry, cracking, and no level of weatherstripping exists.

1. REMOVE EXISTING DOOR LEAF AND STORE INSIDE IN WEATHERSAFE LOCATION. ATTACH TO AN INTERIOR WALL AND ELEVATE OFF THE FLOOR. KEEP FRAME AND HINGES IN EXISTING CONDITION. PREP EXTERIOR OF DOOR WAY TO ACCOMMODATE MOTHBALL COVERING AND NEW ACCESS DOOR PER PLAN DETAIL 2/A101.

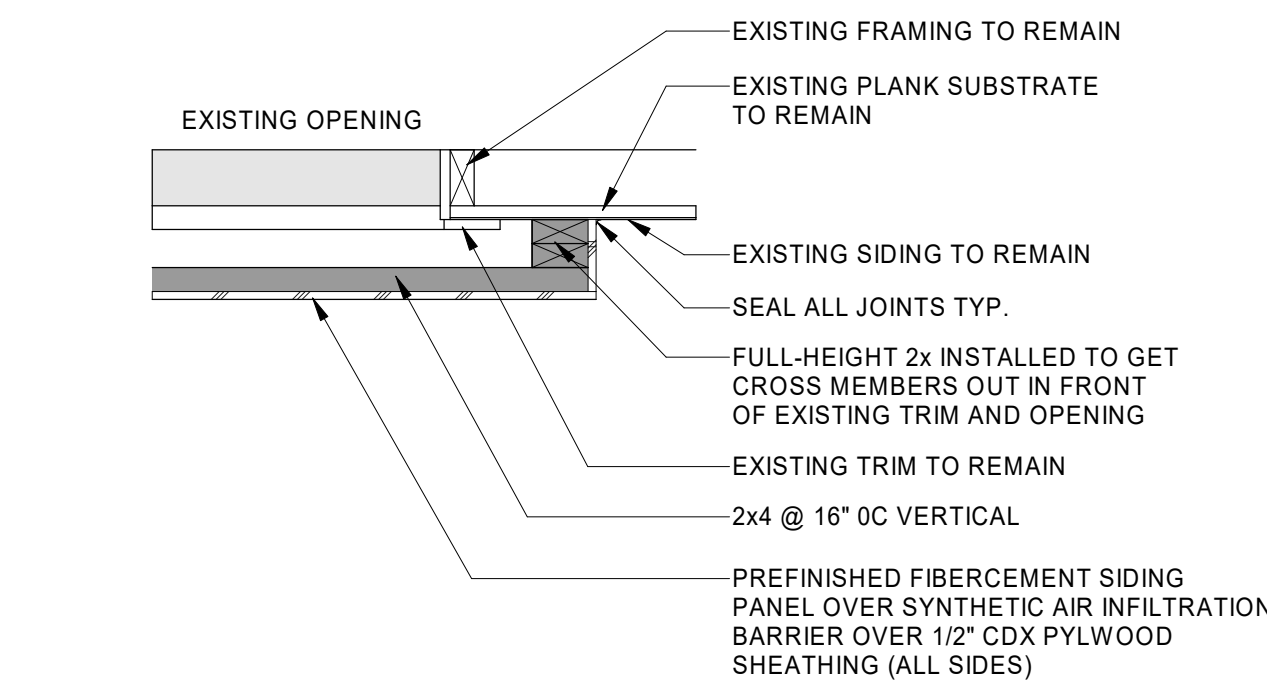
3  
A101  
OPENING COVER DTL  
1" = 1'-0"

Exterior windows consist only of heavily weathered frames. Many of the headers have been dislodged or are broken, and their nailed connection points severed. As a result, the windows are collapsing. They don't currently keep the weather out of the building, and are open for potential rodent or avian access to the building.

Windows can then be framed over, **protecting** the existing original window frames, trim, and other defining elements, while still allowing for protection from the elements, rodent and avian penetration. Doors shall all be closed and screwed shut to prevent leaking and/or intrusion. One door to remain operational for maintenance purposes only. We recommend this approach over trying to board up the window openings from the interior due to the lack of plumb/level conditions in the building and also because keeping water and snow out of the building will be difficult to accomplish unless handled from the exterior.

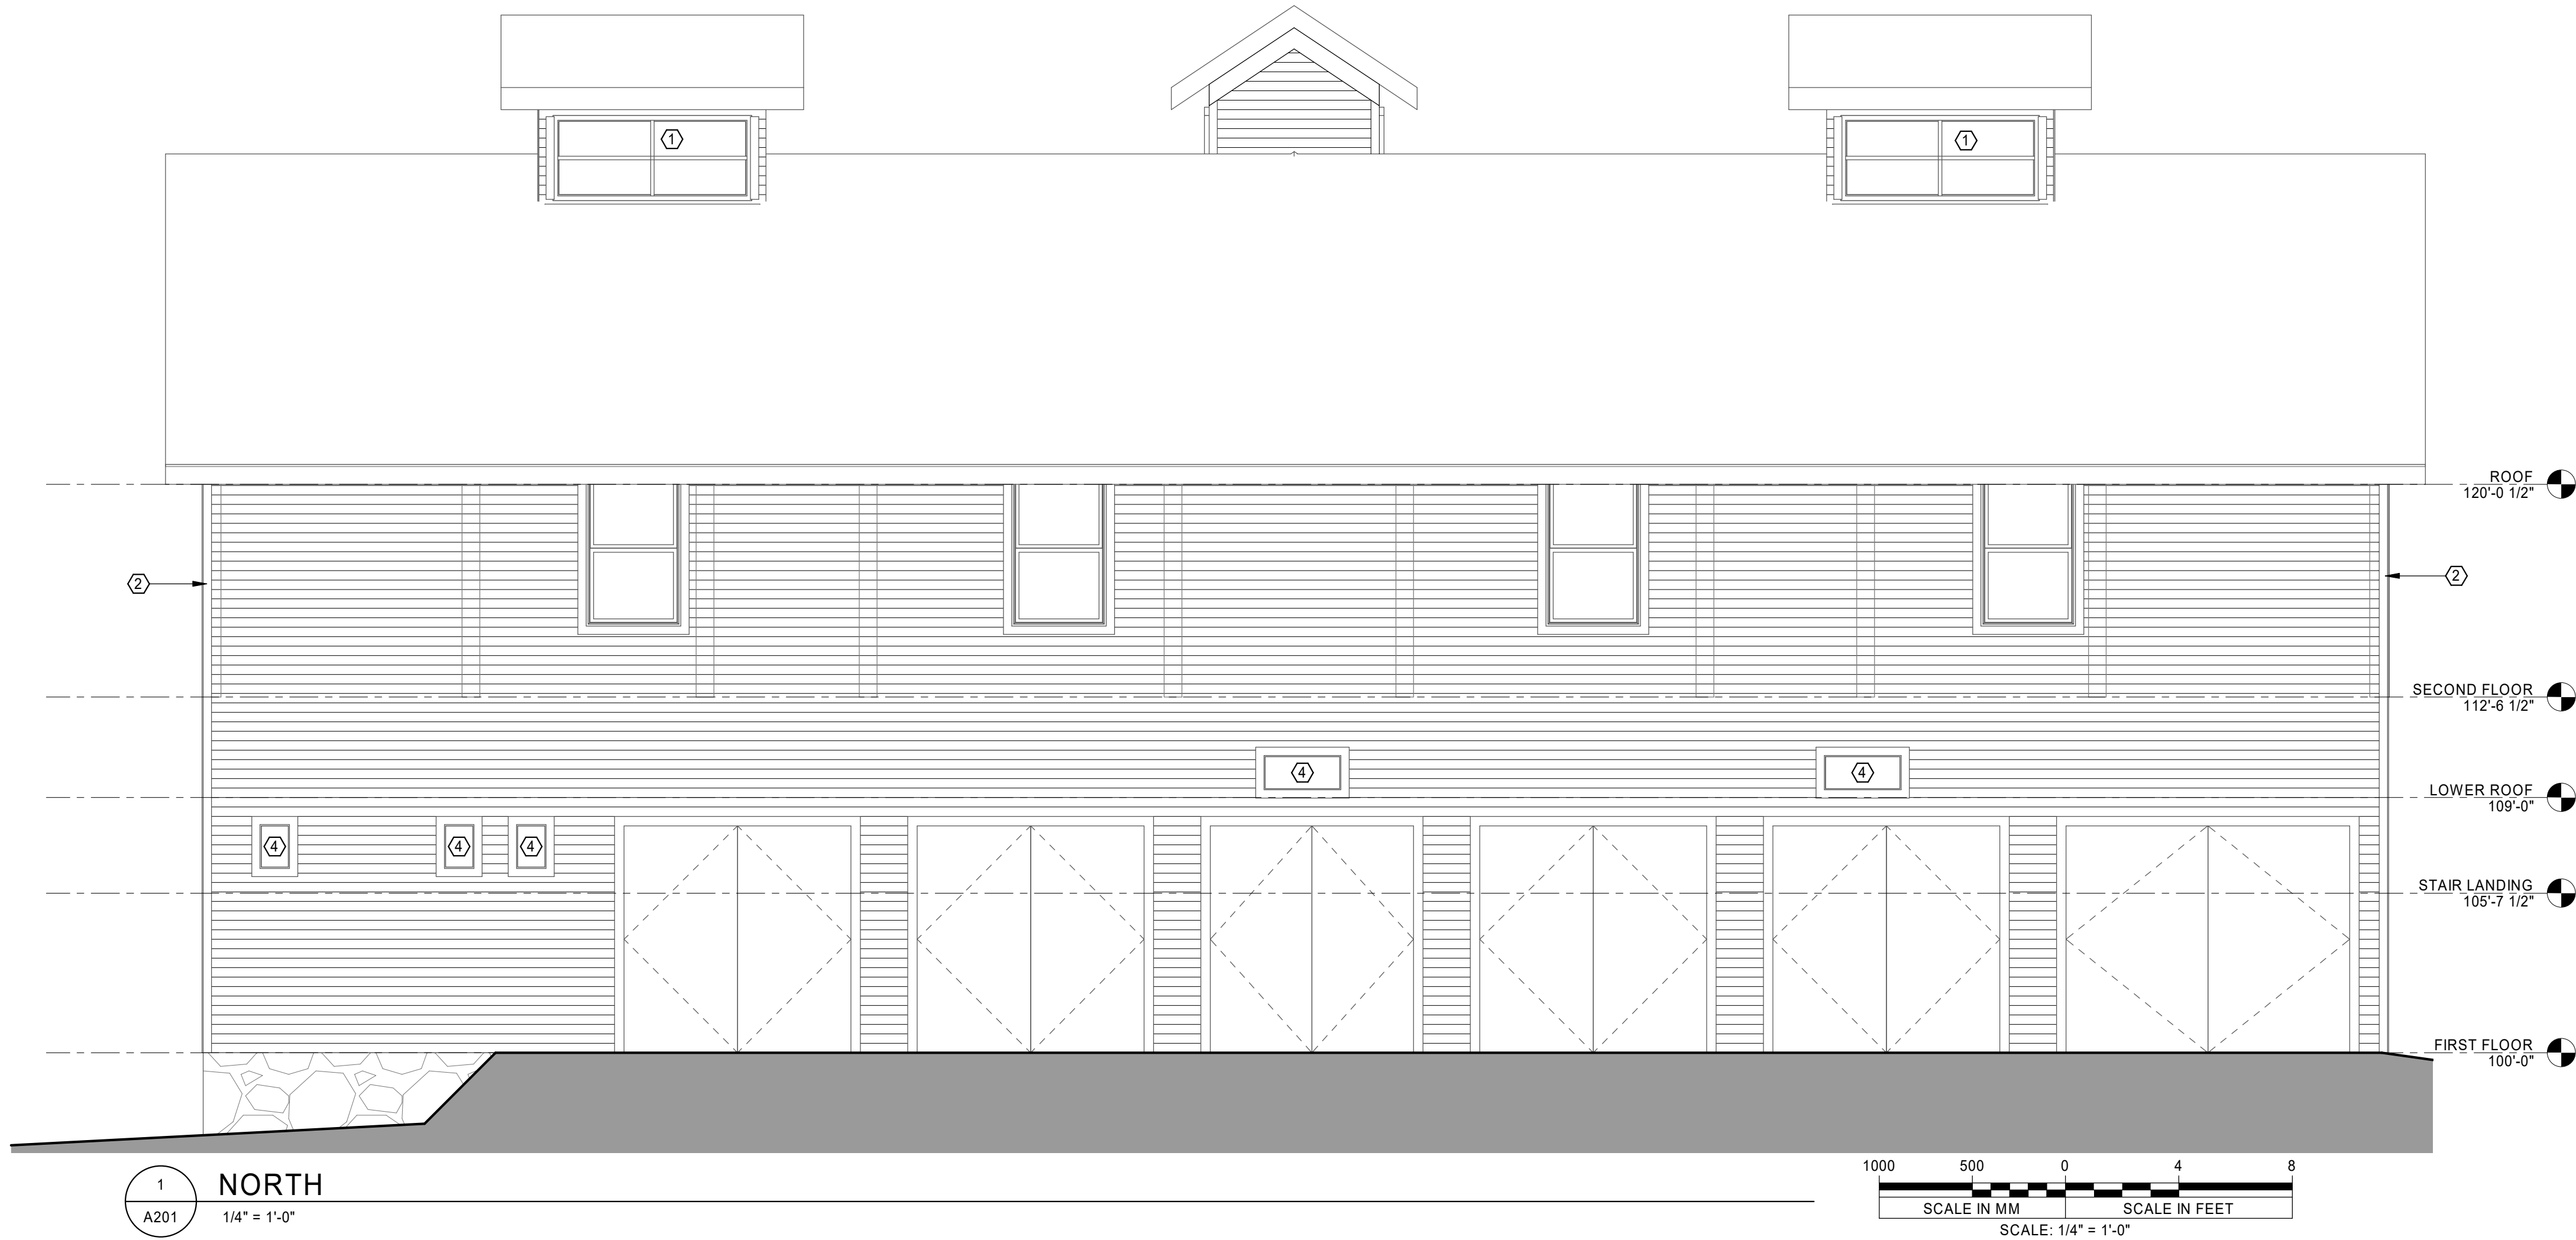
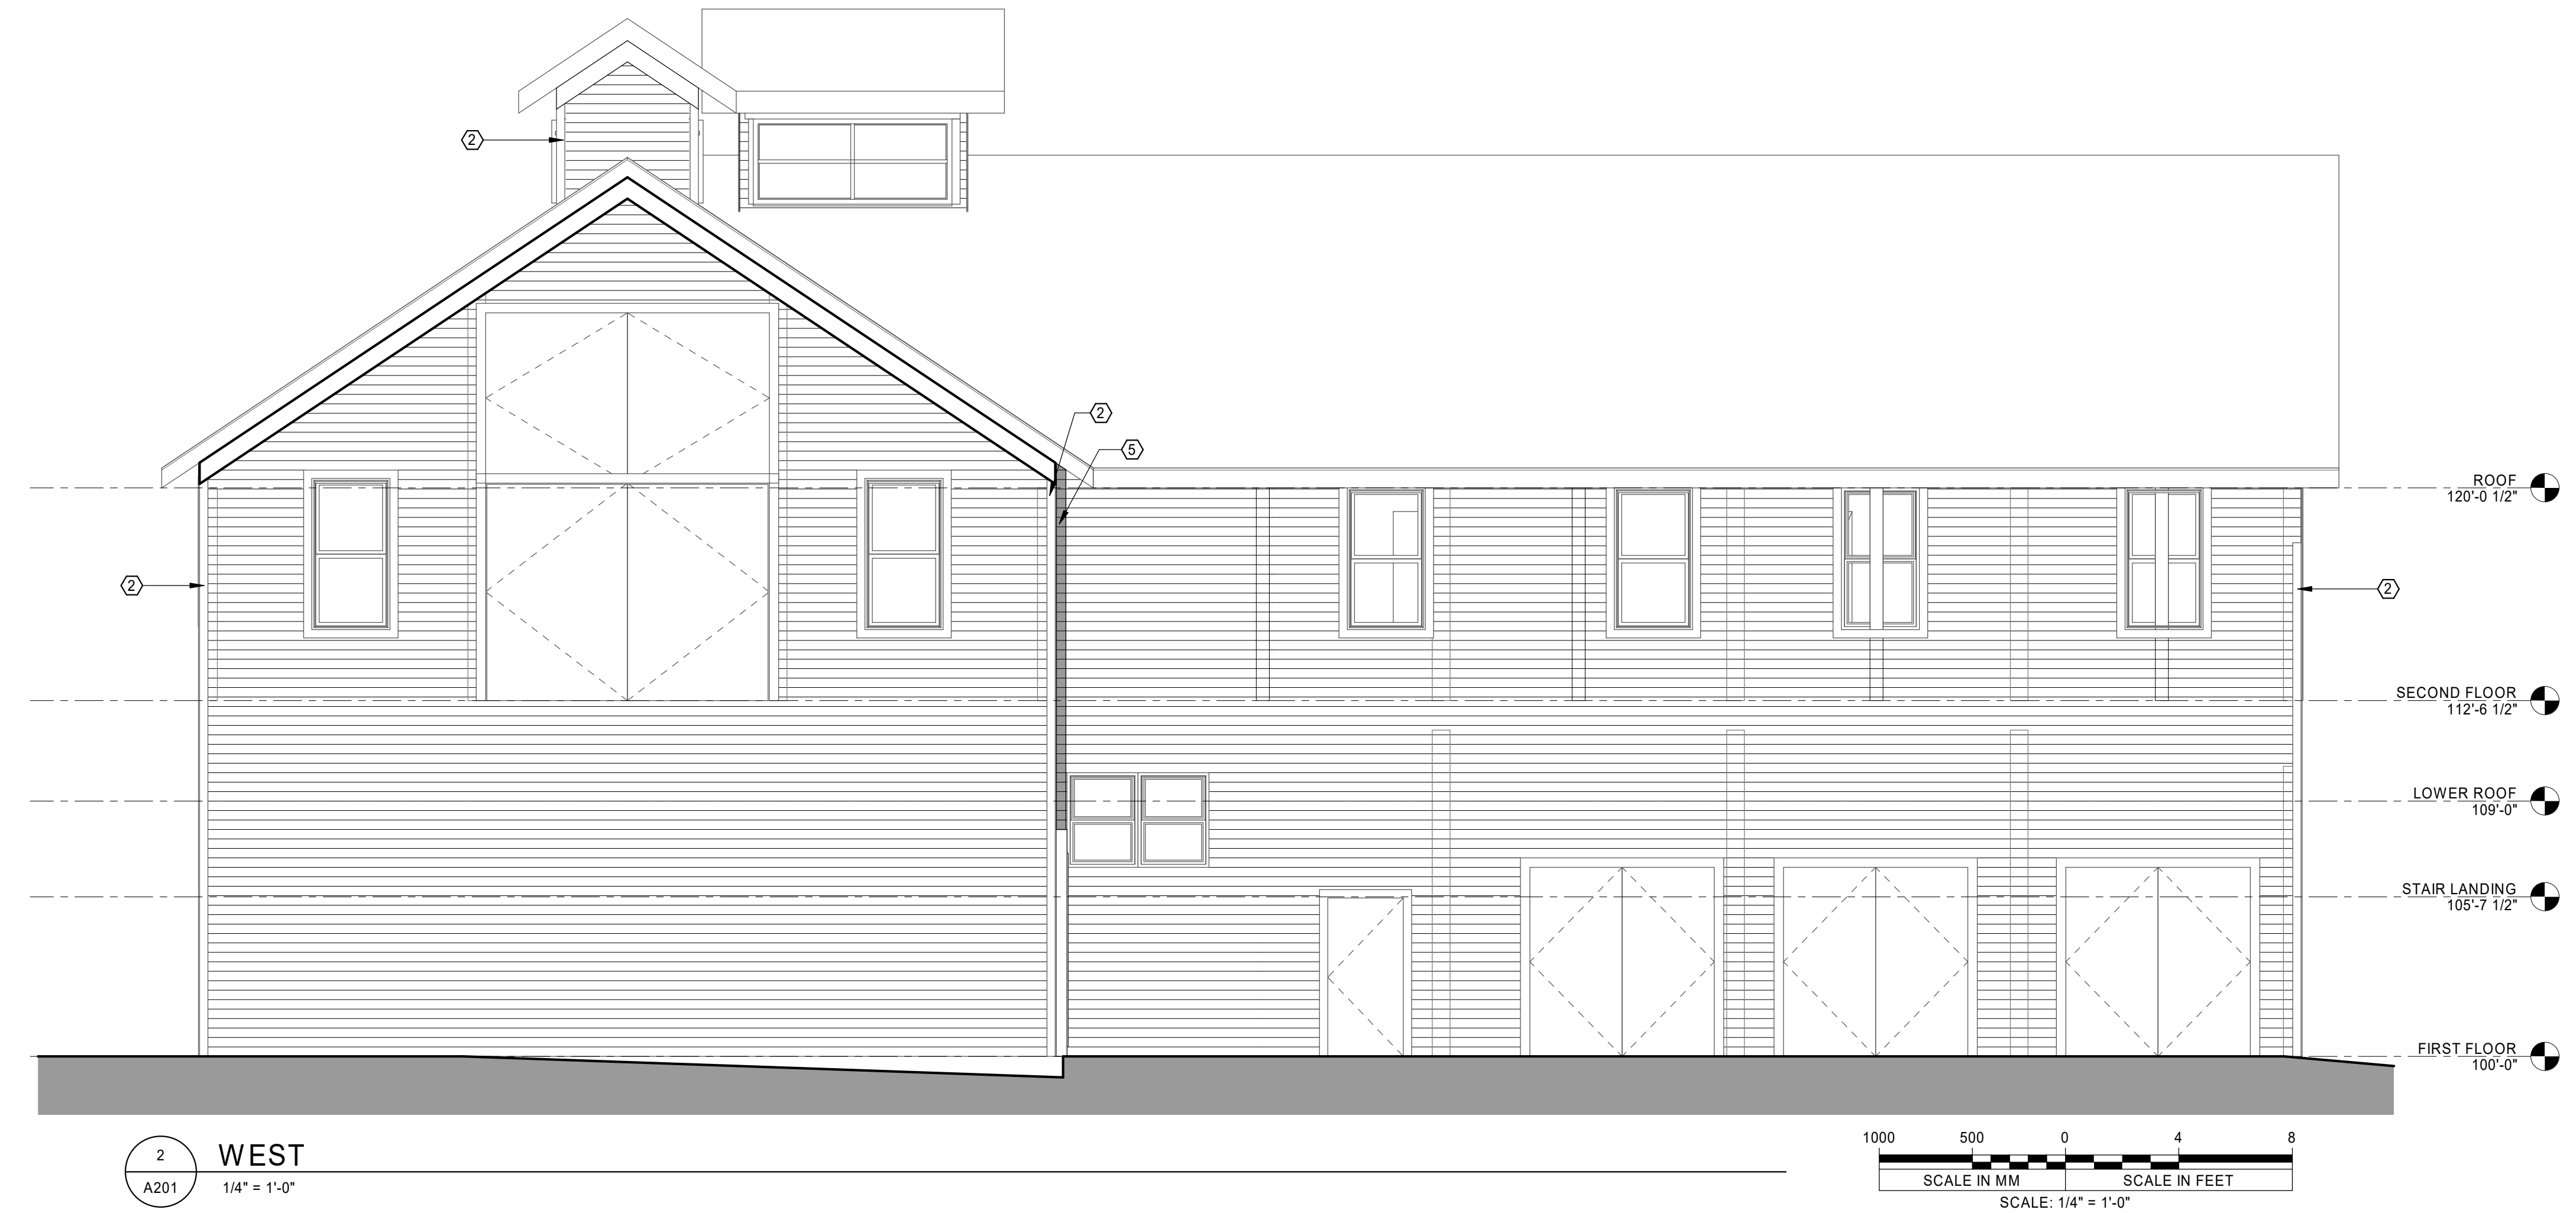
Exterior walls are failing. At the roof level, both the failure of the trusses on the north section as well as attempts to stabilize the structure have caused the walls to shift out of plumb heavily to the north. Much of the siding is intact, but checked in multiple areas and separating from the building.

1. CUPOLA LOUVERS: PRESERVE ALL EXISTING DOOR CONSTRUCTION. PROVIDE (2) THUMBTURN-STYLE HASP AT INTERIOR FACE OF DOOR. SET HASPS TO HOLD DOOR TIGHTLY SHUT. INSTALL BACKER ROD AT JAMBS AND HEAD OF DOOR TO FULLY SEAL ALL GAPS. PROVIDE ADJUSTABLE NEOPRENE SWEEP AT BOTTOM EDGE OF DOOR SET TIGHT TO FLOOR. INSTALL SIGN "NOT AN EXIT" ON INTERIOR FACE OF DOOR. PREP EXTERIOR OF DOOR TO ACCOMMODATE MOTHBALL COVERING PER DETAIL 3/A101

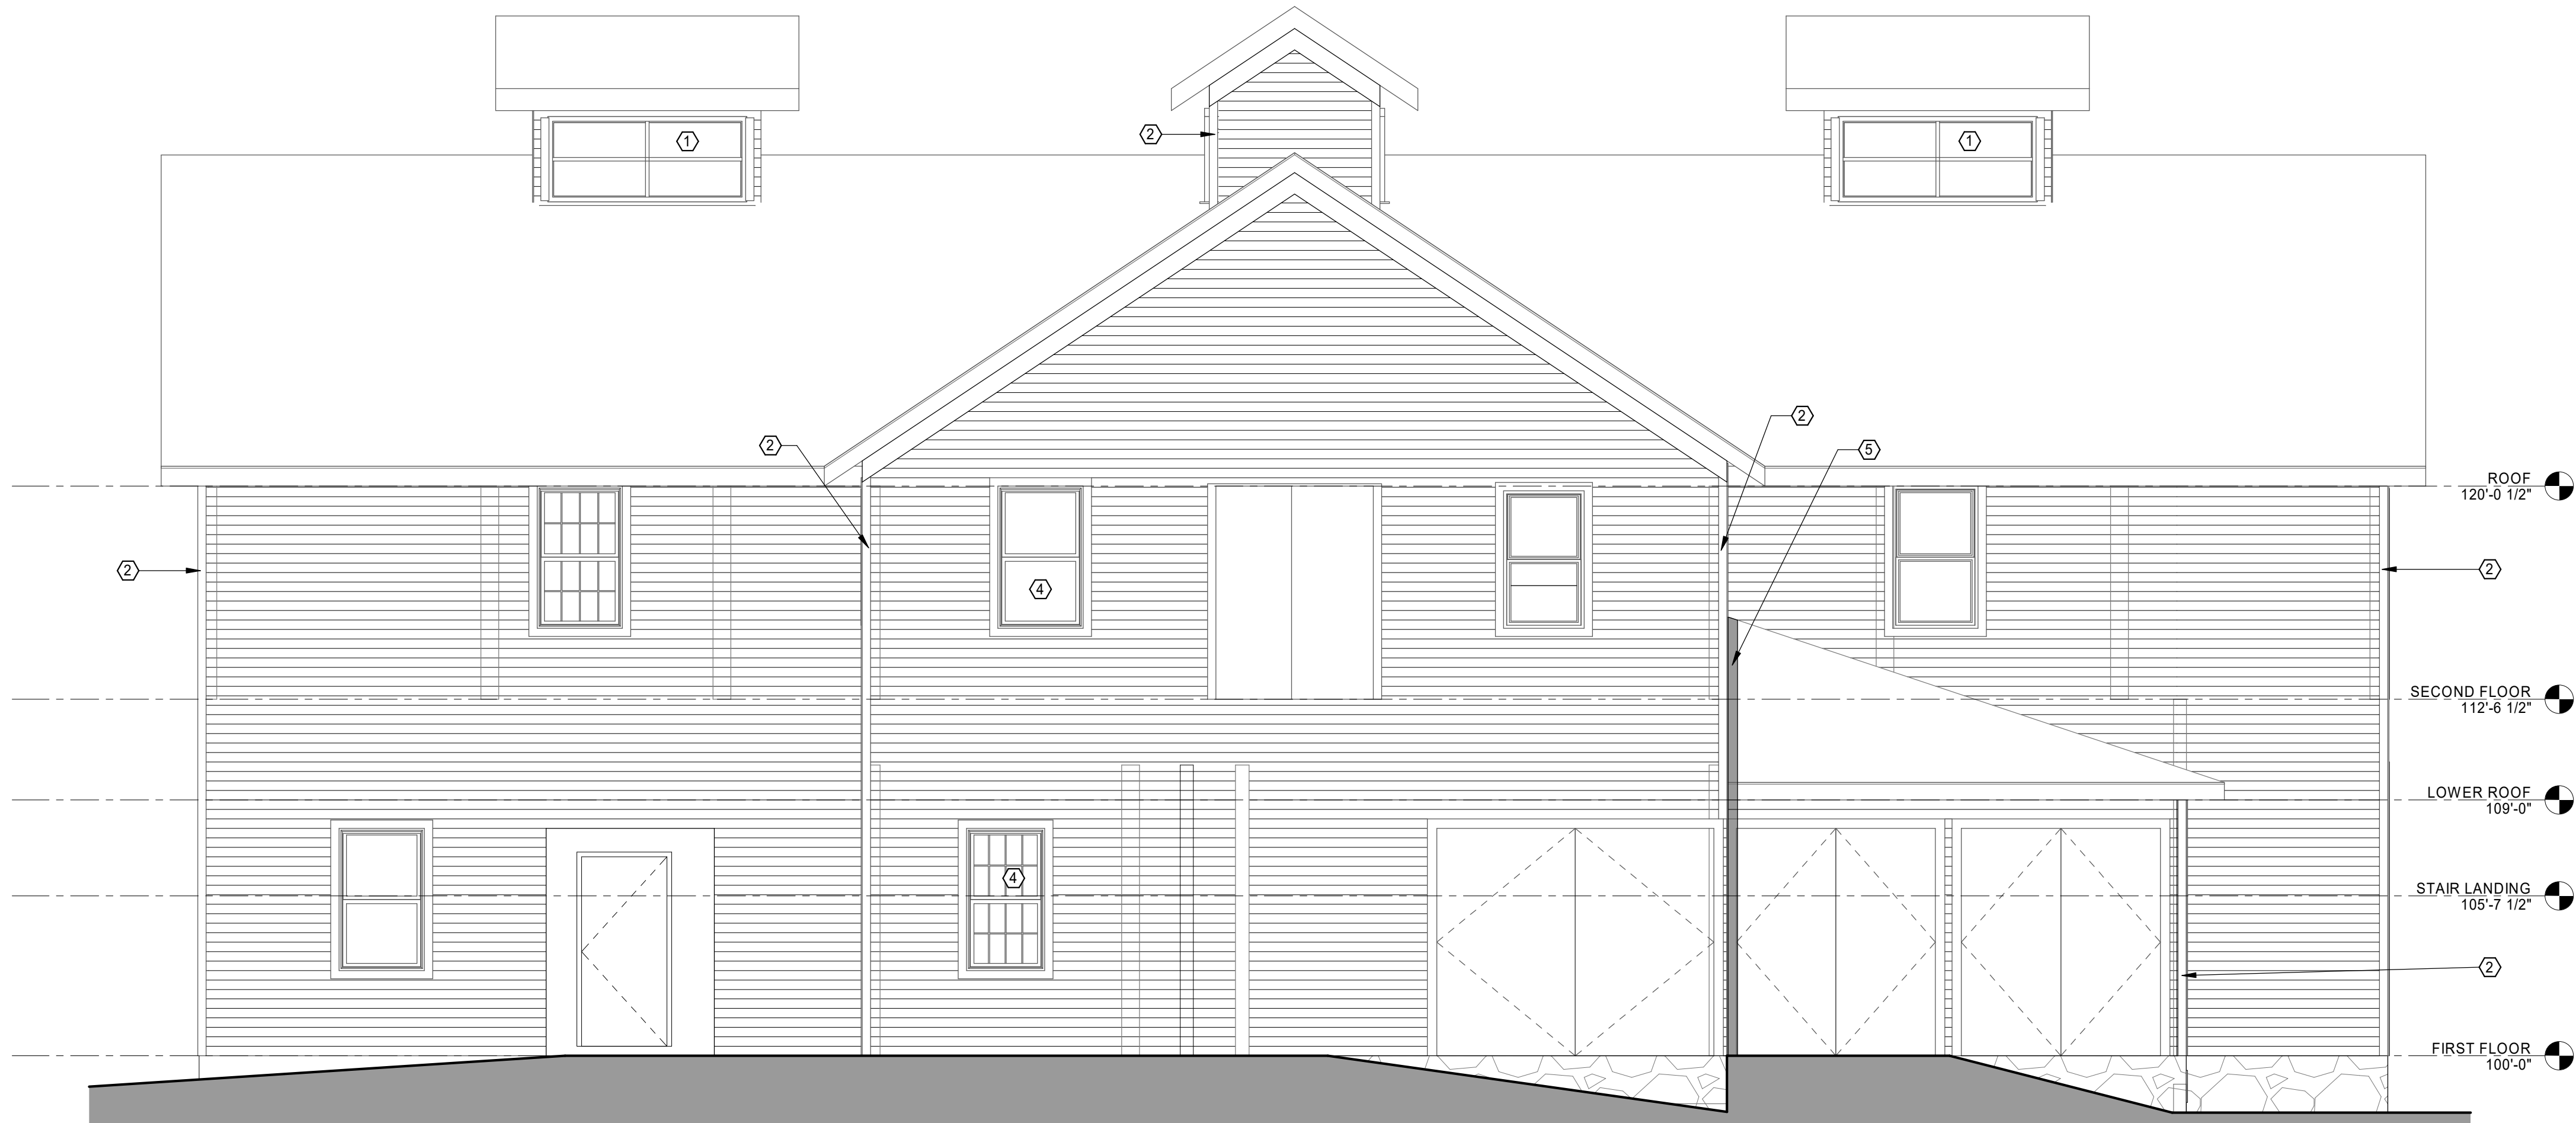
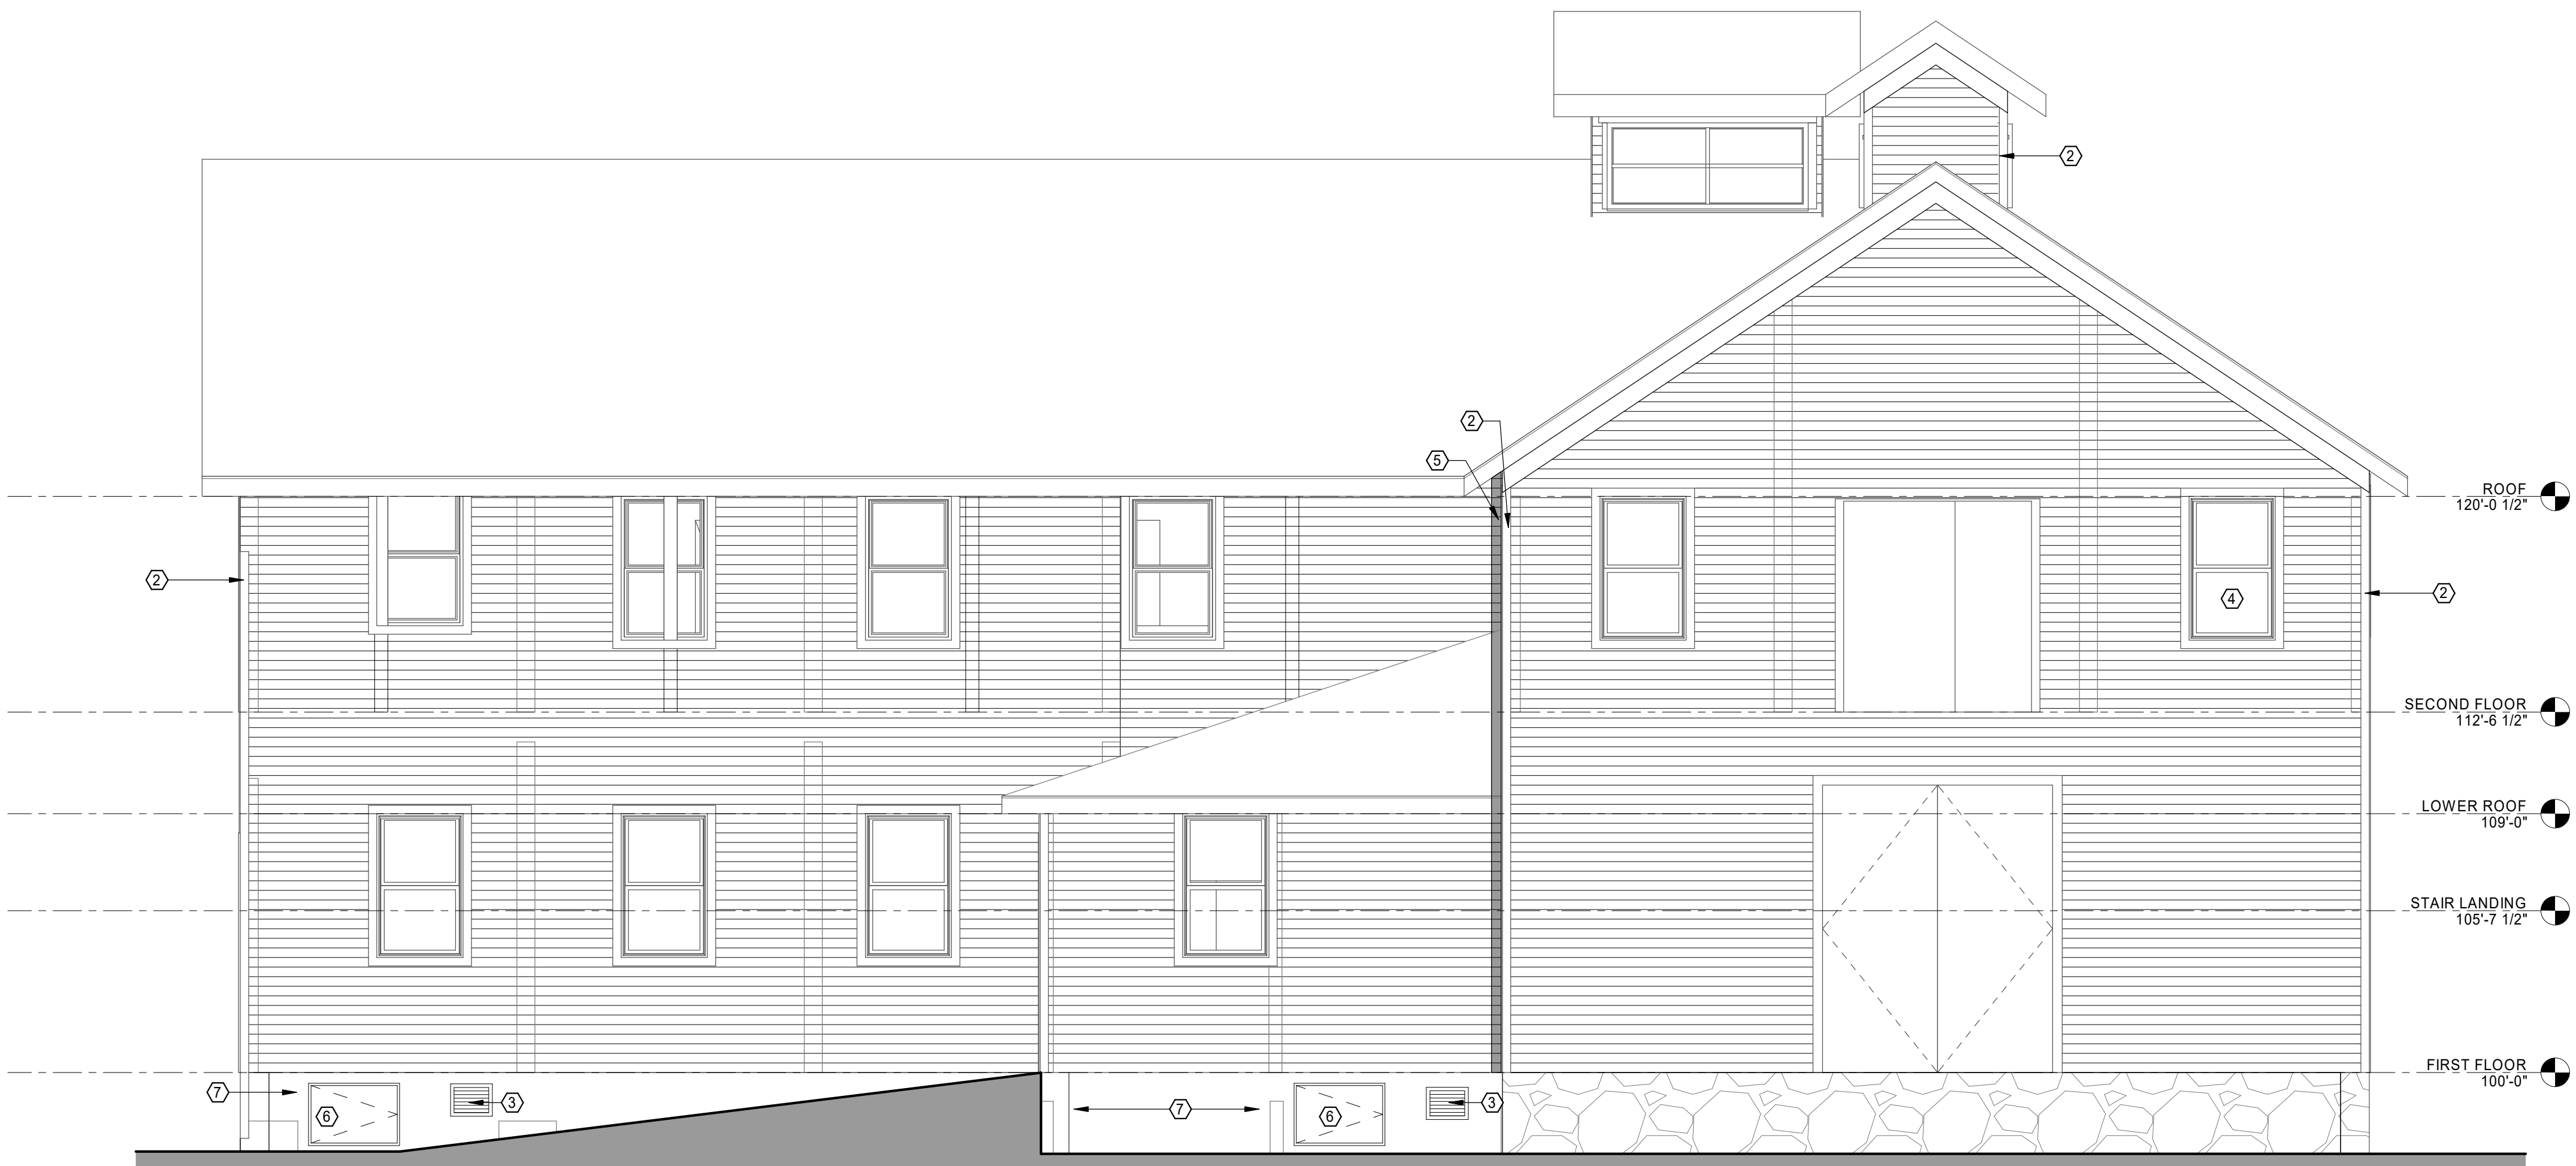
1 SOUTH  
A202  
1/4" = 1'-0"

Foundations in the north section are mostly unobserved due to lack of access to below-floor areas. Foundations in the south section are accessible from openings in the wall along the southeastern corner of the building. Sandstone is weathered and the joints require maintenance, but the stone is in adequate condition.

3. FOUNDATION VENT LOUVER WITH INSECT SCREEN.
4. LOUVER INSTALL. INSTALL NEW METAL LOUVERS IN EXISTING OPENINGS. SIZE TO MATCH OPENING. PROVIDE METAL INSERT SCREENS. SEE ENTIRE PERIMETER OF LOUVER TO EXISTING BUILDING.

5. FULLY SEAL GAP BETWEEN BUILDINGS WITH FLEXIBLE SEALANT.
6. CRAWL SPACE ACCESS DOOR. PROVIDE 24"H x 42"W PREFINISHED LOCKING HM ACCESS DOOR.
7. INFILL FRAME FROM 6" BELOW GRADE TO BOTTOM OF FLOOR FRAMING W/ P.T. 2x6 STUDS @ 12" O.C. FACE WEATHERBARRIER AND 24 GA 7/8" PREFINISHED CORRUGATED METAL SIDING PANELS SPANNING HORIZONTALLY. PROVIDE CONTINUOUS DRIP EDGE AT TOP OF PANELS TYP

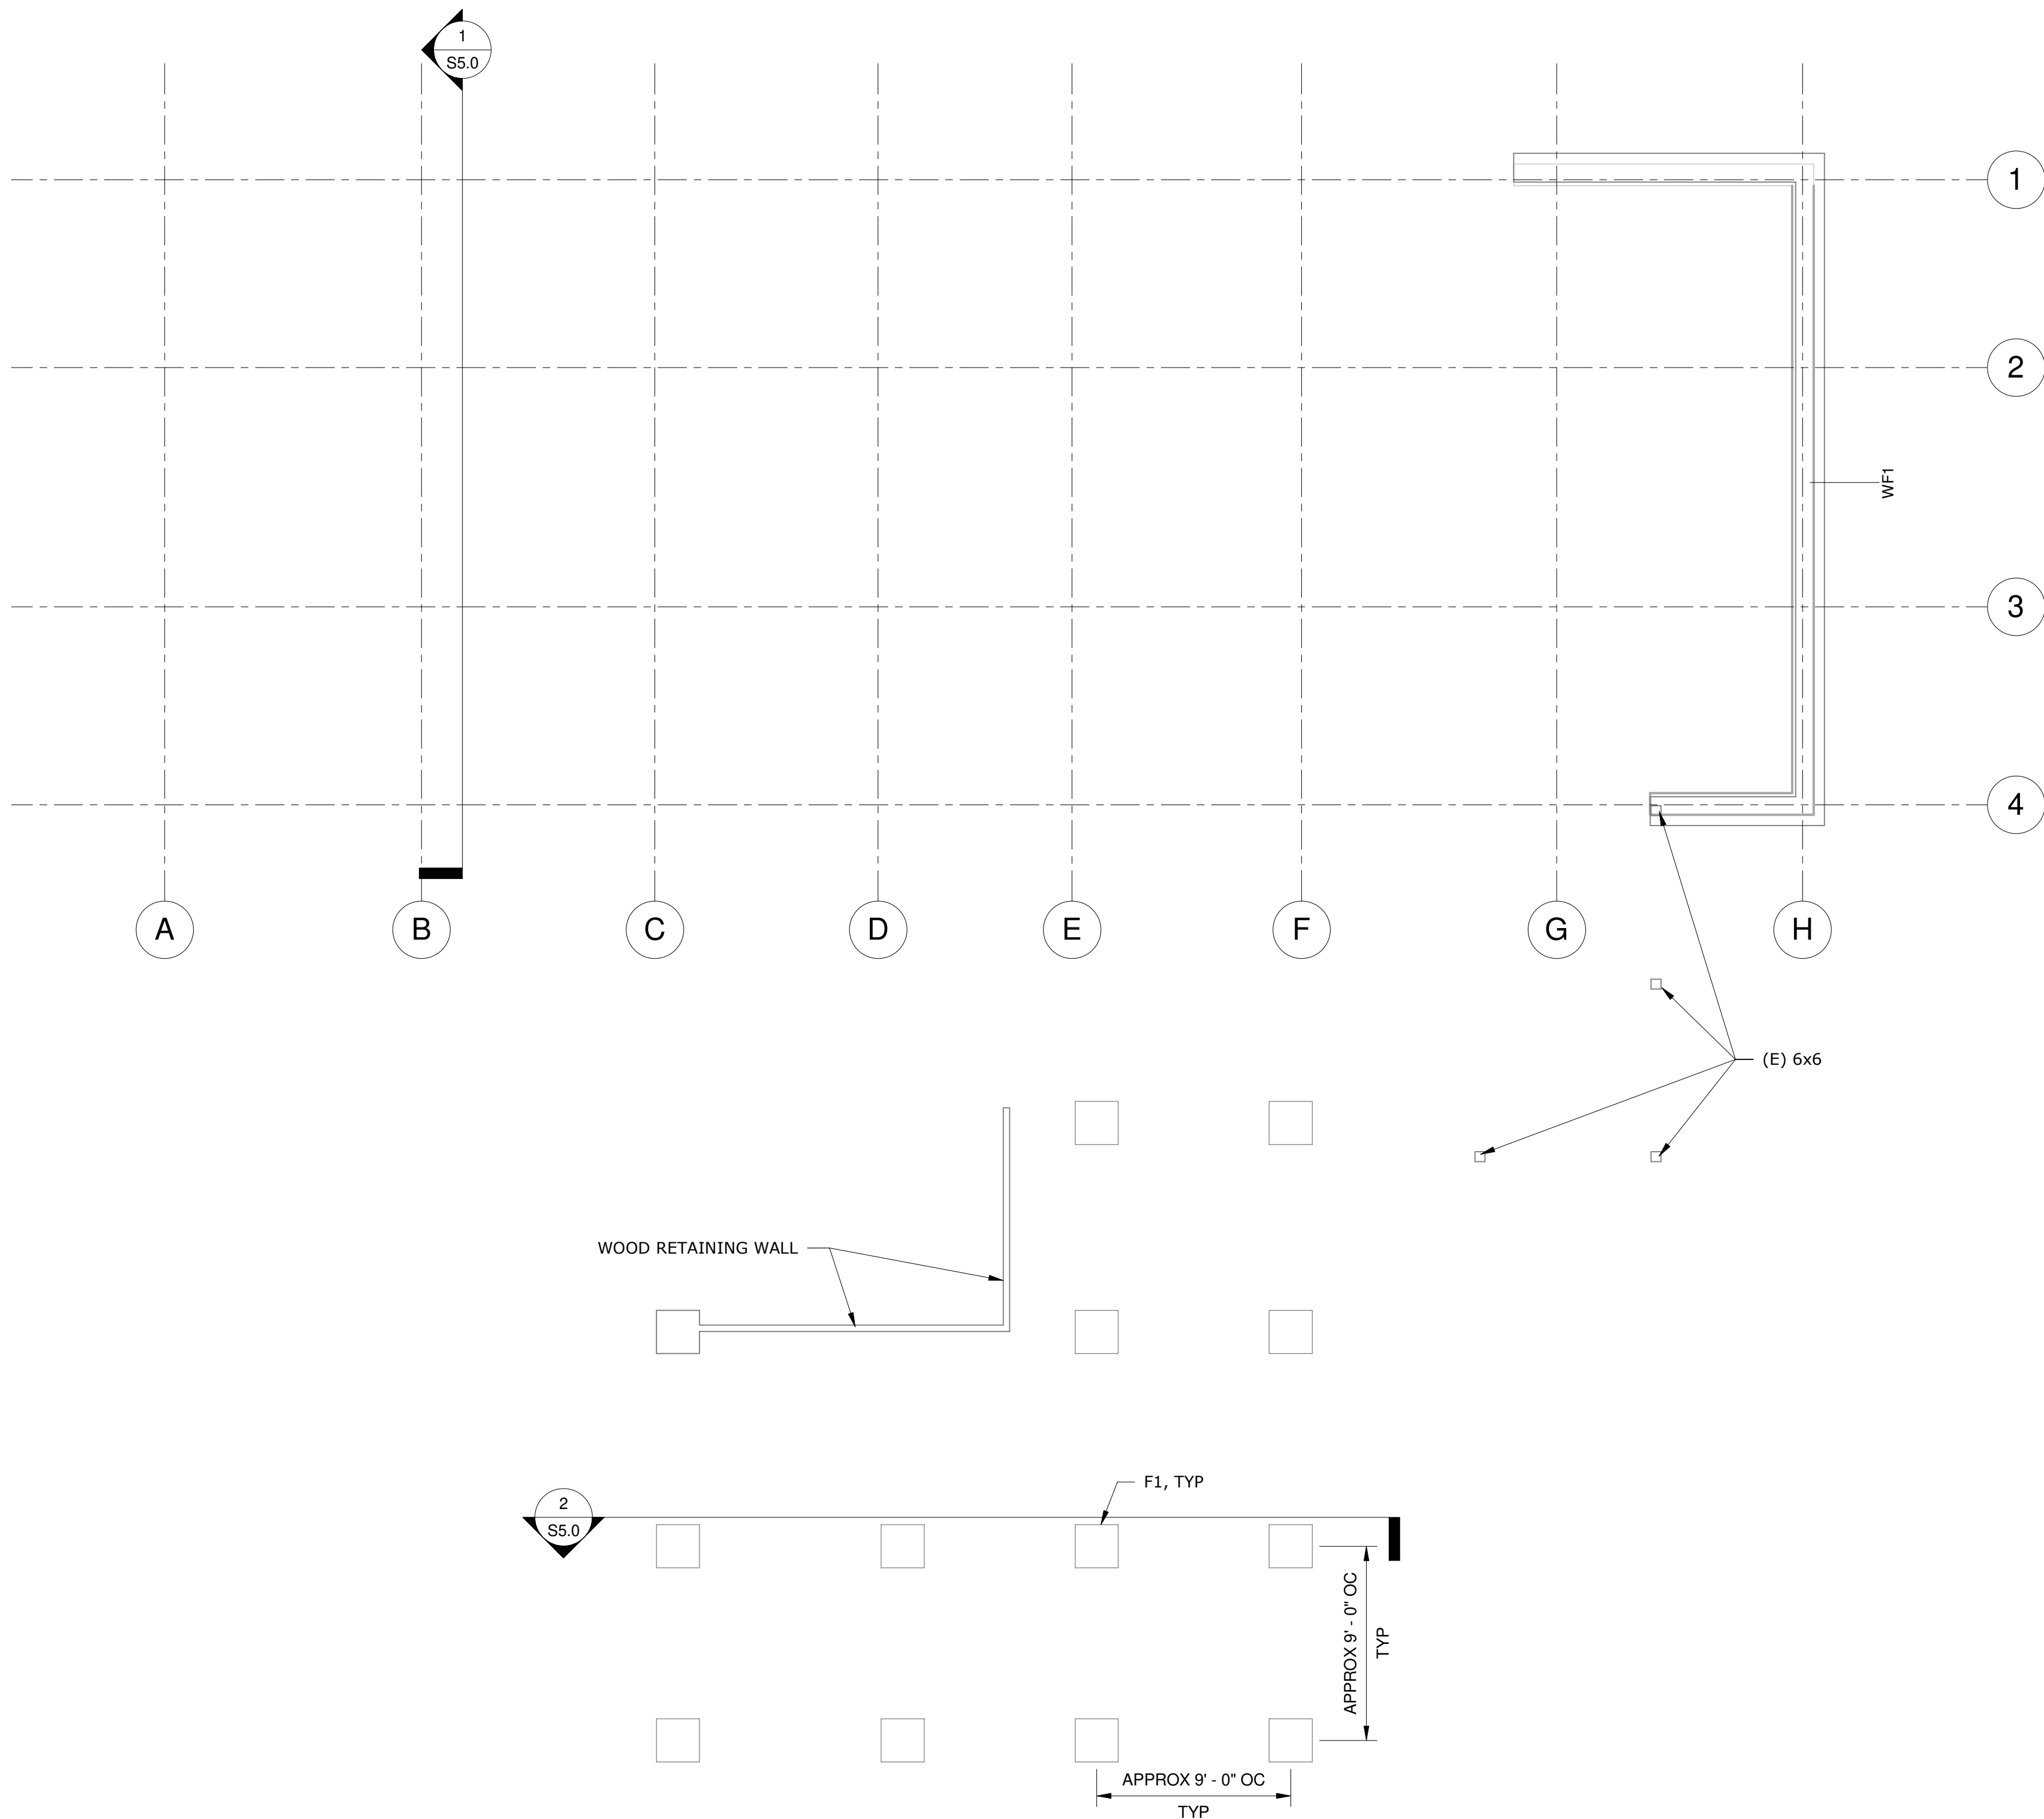
Primary structure is a series of heavy timber columns and beams serving as intermediate bearing for the building. Sizing of these beams and columns are in general accordance with the loading anticipated; however, many of the columns are suffering from dry-rot, and some of them have separations at their connecting points. The original design for the second floor required two parallel rows of columns to support the roof structure. These are all currently absent, resulting in a dangerous structural situation on the northern section. The structure is in danger of collapse.

- 1 DETERIORATED POST. REMOVE AND REPLACE PRIOR TO INITIAL BRACING.
- 2 2x4 LAID FLAT @ 4'-0" OC W/ (2) 16d NAILS INTO EA JOIST, MIN (3) JOIST LAP.
