# Boston and Montana Barn

Black Eagle, Montana

Existing Conditions Assessment

Recommendations for Stabilization and Protection

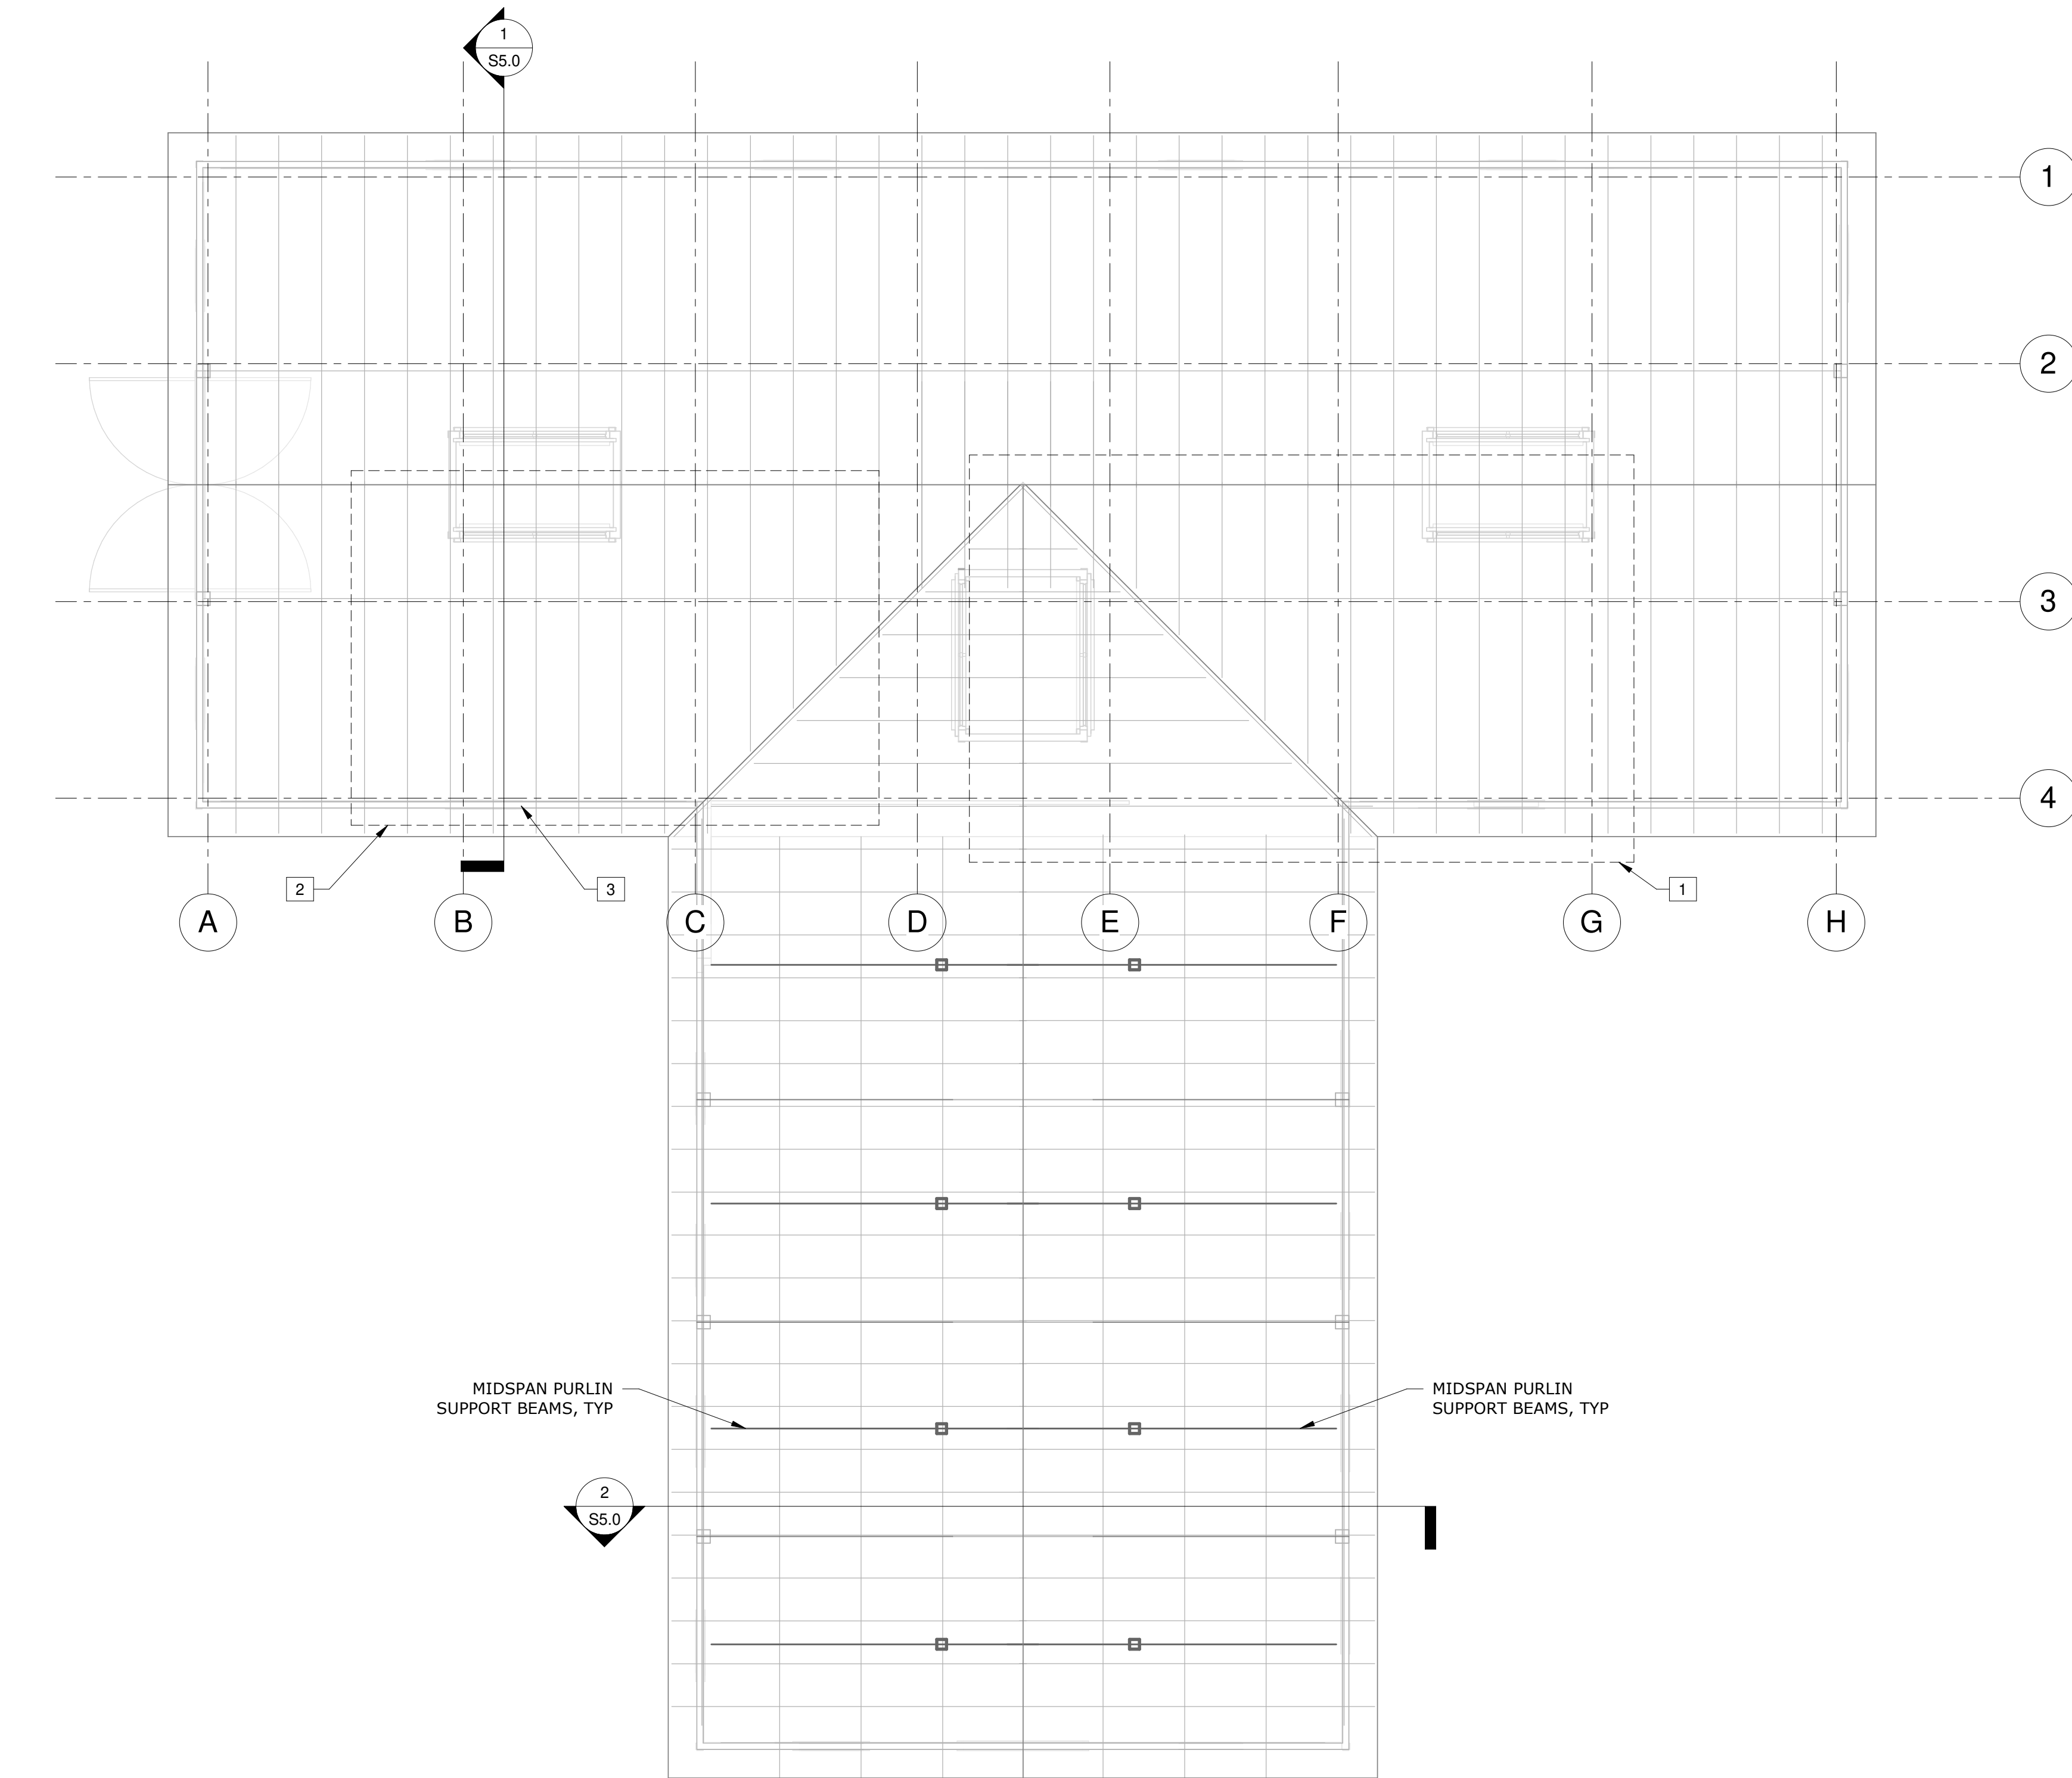
1 ROOF PLAN  
3/16" = 1'-0"

The existing shake roofing is well past its useful life and is neither complete nor capable of weather-protecting the interior of the building. Roof sheathing is heavily weathered and weakened throughout. Stick-built trusses on the north section are broken and the bottom chords are completely sheared from the primary structure, allowing the walls to shift laterally. Hip-jacks are broken, allowing the roof to sag, especially under the weight of snow. These failures have resulted in substantial sag in the ridge of the north section.

- ROOF SHEATHING TO BE 19/32" 40/20 RATING OSB W/ 8d NAILS @ 6" OC PANEL EDGES, 12" OC FIELD.
- WORKING PLATFORM TO BE ADDED BETWEEN WALLS ALONG GRID LINES 2 AND 3.
