**Great Falls – Cascade County Historic Preservation Advisory Commission
Minutes from the August 14, 2024 meeting, held at the Great Falls Portage Overlook and the PCD
Conference Room at the Civic Center**

Boston and Montana Barn

Existing Conditions Assessment

Recommendations for Stabilization and Protection

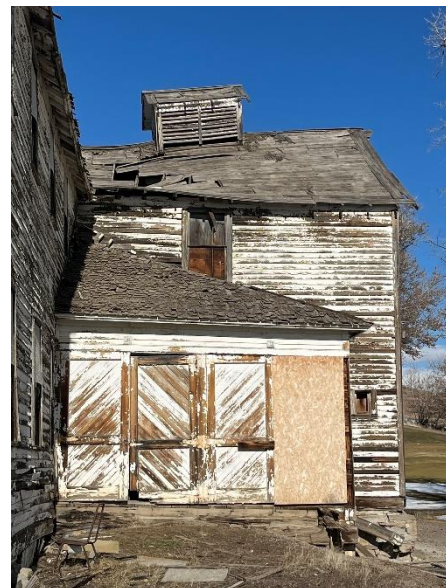
The existing shake roofing is well past its useful life and is neither complete nor capable of weather-protecting the interior of the building. Roof sheathing is heavily weathered and weakened throughout. Stick-built trusses on the north section are broken and the bottom chords are completely sheared from the primary structure, allowing the walls to shift laterally. Hip-jacks are broken, allowing the roof to sag, especially under the weight of snow. These failures have resulted in substantial sag in the ridge of the north section.

5.3 Set the north roof ridge elevation level

Once the exterior walls are plumb and the top plates are repaired as necessary, the roof can be stabilized by rebuilding the trusses and restoring a continuous, level ridge line at the roof. This will allow for resurfacing and weatherization of the roof assembly. It is our position that trying to weather-protect the structure without first setting the ridge level will compromise the weather-resistant properties and long term durability of any roofing system, and also make any future work such as permanent roofing much more difficult and costly.
