North Parking Structure

Engineering
Condition
Appraisal

Great Falls, MT

April 26, 2012

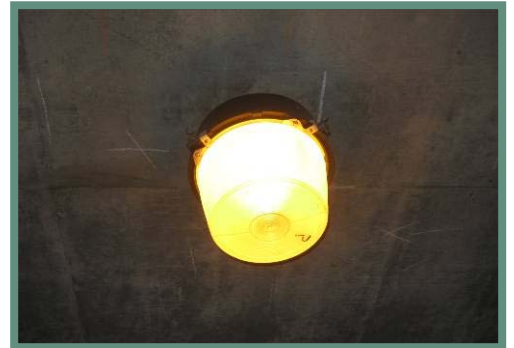
The lighting system consists of high pressure sodium light fixtures serviced by conduit that is embedded in the concrete slab. Typically the light fixtures are spaced one per bay with the light fixture centered within the bay. One light fixture at the level 1 ceiling near the exit to 4th Street was not functioning. The light fixture at the level 5 ceiling between column lines B & C and 10 & 11 has been removed, but has not been replaced. For additional information refer to Section V – Lighting Survey.

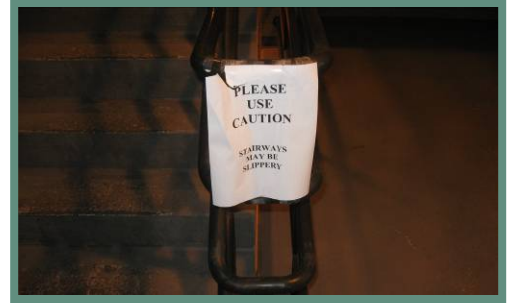
Signs were observed in the stair towers warning pedestrians that the stairways may be slippery.

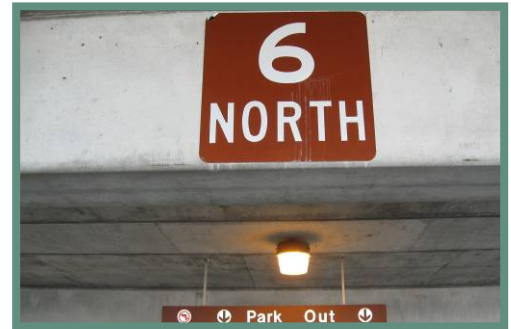
The signs are in generally good condition with the following exceptions. One of the signs is missing at Level 6, graffiti was observed on a few of the signs, and the exit signs near the stair towers are not illuminated.

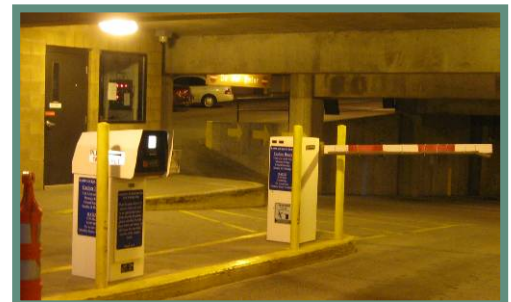
Revenue Control Equipment: The revenue control equipment consists of Federal APD TD-249 Ticket Spitters and Model G-89 Auto Gates. The equipment is approximately 15 years old. The revenue control equipment appears to be functioning properly. The revenue for this structure is collected by cashier during normal business hours, and by honor system after hours and on weekends.

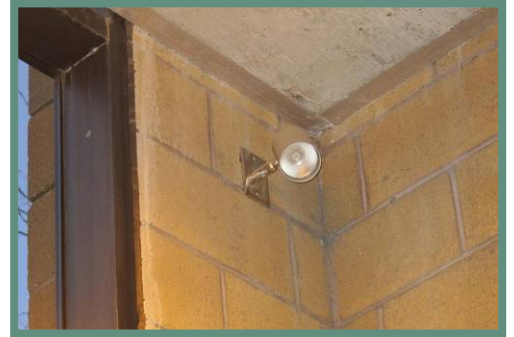
Security/Safety: The overall security/safety perception of the parking structure is generally good. The stair towers are well lit and the structure has adequate openness. The exits are clearly marked with exit signs, however the exit signs were not illuminated. Security cameras were observed inside the stair towers at Level 1 and near the office at the west end of Level 1. Smoke detectors and emergency egress lighting were observed in the stair towers.

Intercoms are provided at each level within the stair towers, but there is no signage to identify them.

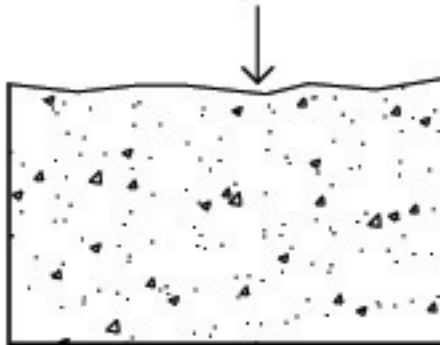
2. CONCRETE IS FROZEN IN A SATURATED STATE CAUSING HIGH STRESSES. LOOSE FLAKES APPEAR ON SURFACES AS THE MORTAR BREAKS AWAY.

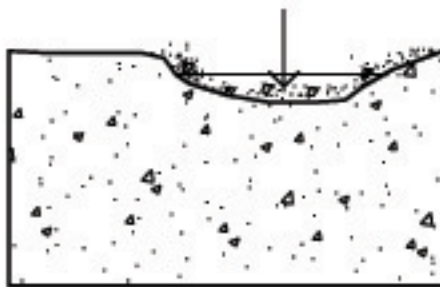
**FIGURE A-5
CONCRETE SURFACE SCALING**

3. AS FLAKING PROGRESSES, AGGREGATE IS EXPOSED AND EVENTUALLY BREAKS AWAY, THEREBY EXPOSING MORE PASTE TO FREEZE-THAW DAMAGE IN EXTREME CASES. APPARENTLY SOUND CONCRETE CAN BE REDUCED TO A GRAVEL-LIKE STATE IN A SHORT PERIOD OF TIME.
