Addendum No. 01
Date: February 8, 2021
Project: City of Great Falls Envelope Renovation

GREAT FALLS
CIVIC CENTER
FRIEZE
VENEER
REPORT

Concrete Core Evaluation

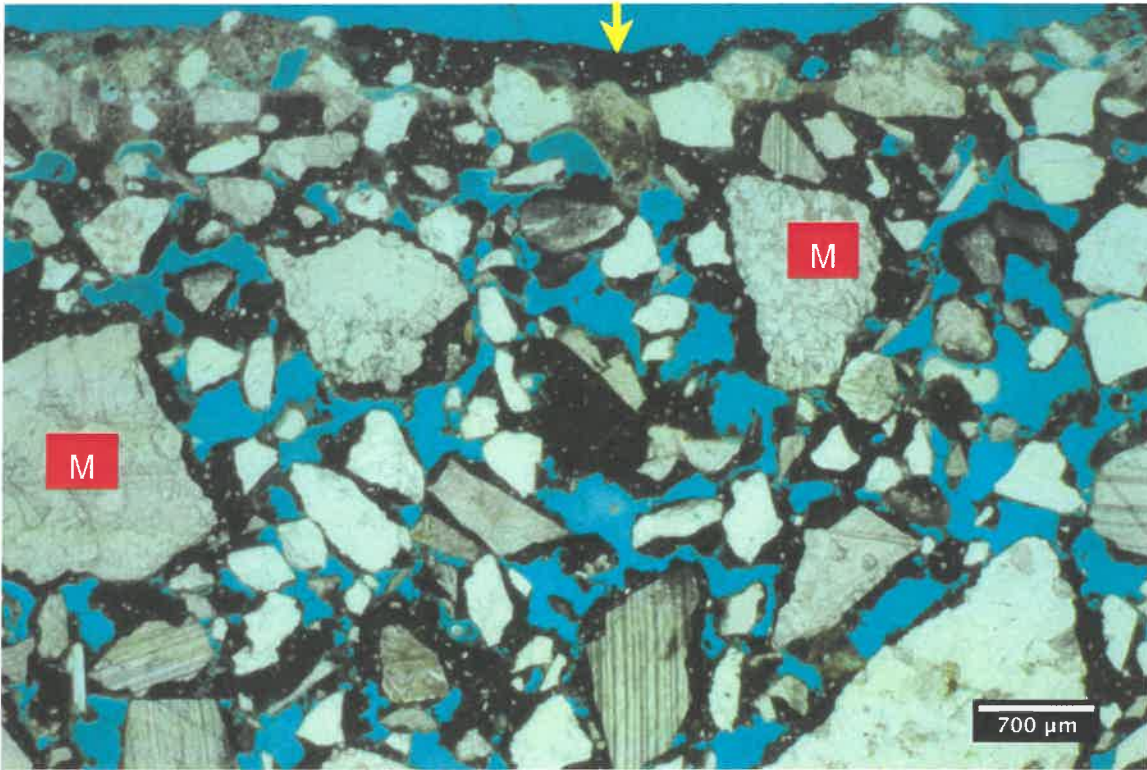
Marble RF's = 'M', ICRI CSP 5 surface profile (yellow arrow). Air-entrainment macroporosity (blue).

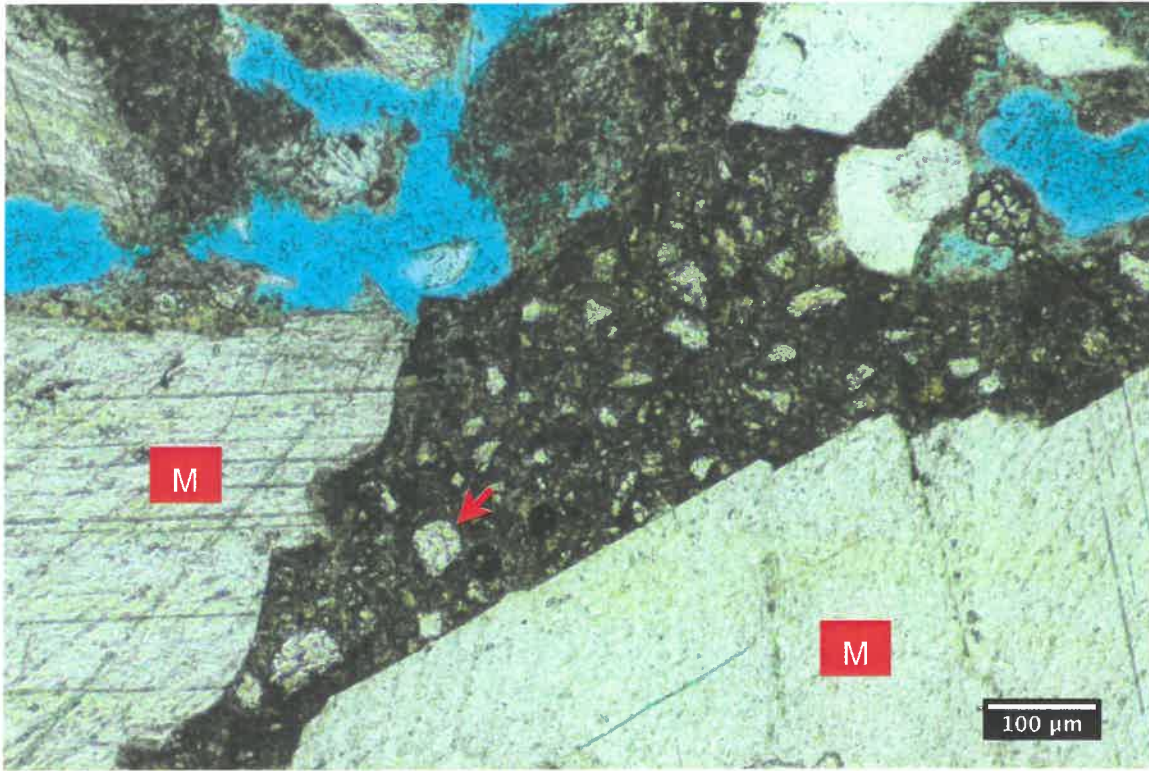
Marble RF's = 'M', Calcium aluminate crystals (red arrows) within calcite-rich cement paste. Air-entrainment macroporosity (blue).

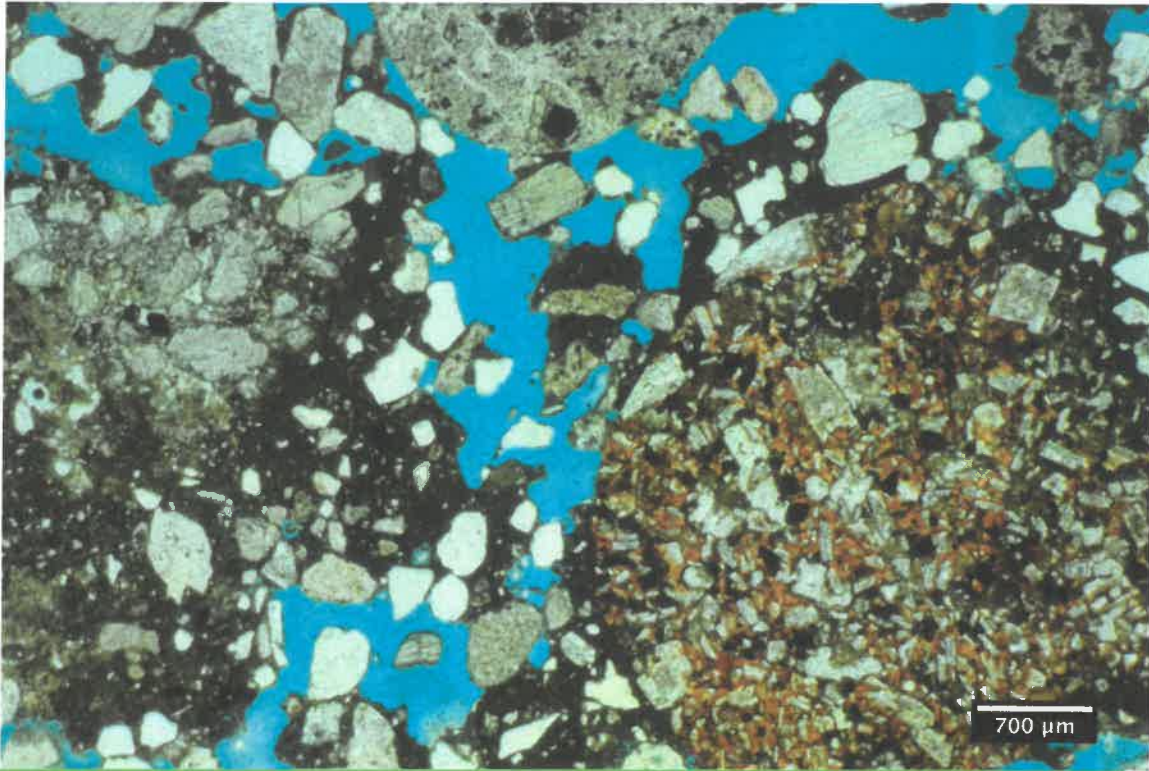
Concrete substrate ('CS'), Igneous RF's = 'IR', Topping cement ('TC'). Airentrapment macroporosity (blue).

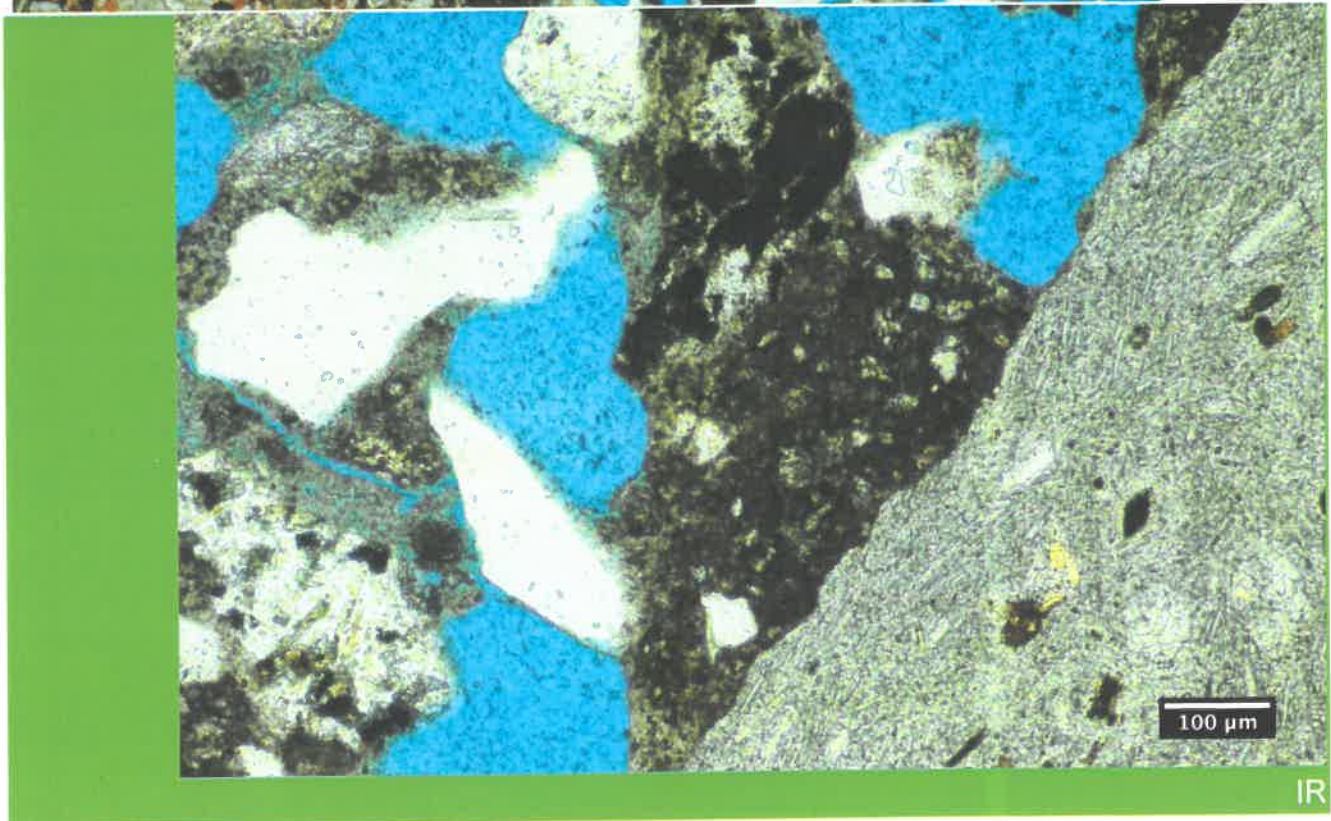
Igneous RF = 'IR', Air-entrapment macroporosity (blue).

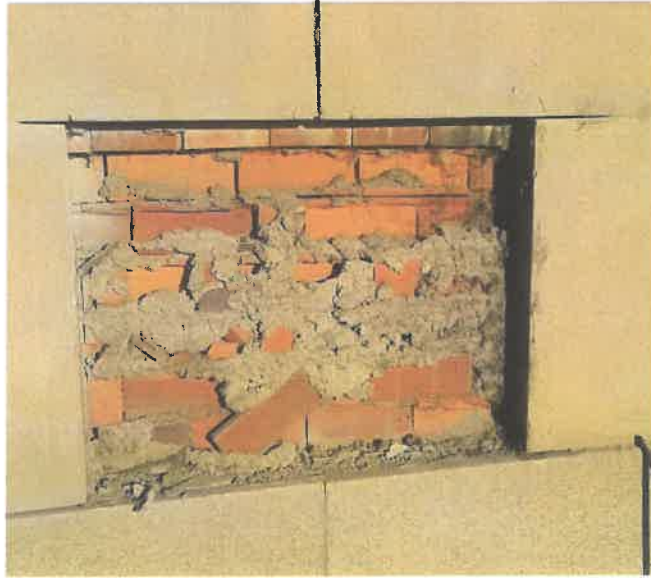
Photo 1

As specified we removed one piece of the exterior veneer from the entrance frieze of the Great Falls Civic Center. The installation of this piece had no masonry anchorage or vertical restraints. Please see photos 1, 3 and 4. The cladding was set in a concrete mortar with no attempt to adhere the piece to the substrate. Please see photo 2.

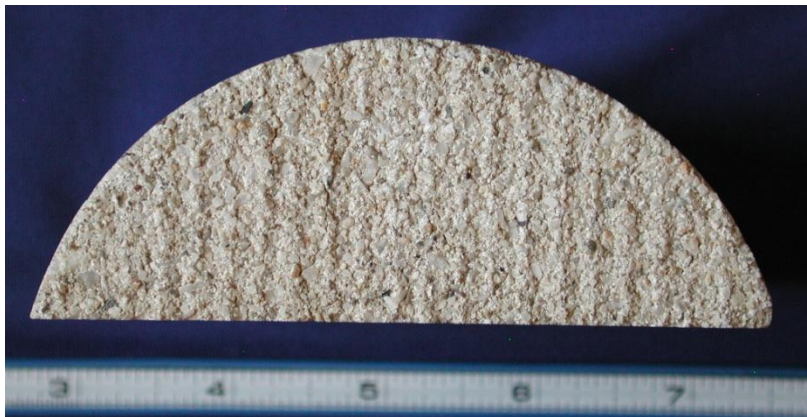
Figure 6. View of the finely ridged, exposed surface of the face mix.

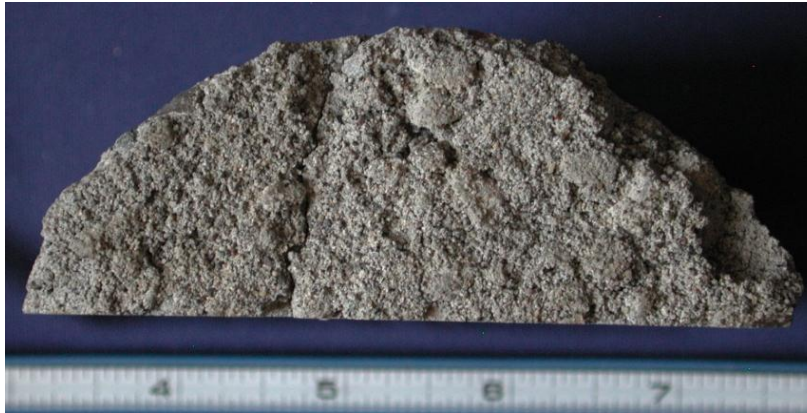
A 3/8-inch-diameter reinforcing bar is embedded 2-1/8 from the exposed surface of the core. The surfaces of the rebar exhibit significant corrosion. Cracks radiate in all directions from the location of the rebar. The cracks appear to be caused by corrosion of the embedded reinforcing bar. The concrete is not well densified within 1 inch of the inner surface of the core. A few cracks were detected within this 1 inch zone. The cracks in this zone usually follow the areas of abundant air voids related to incomplete consolidation. There is no evidence of cracking related to any deleterious chemical reactions within the concrete or paste. (Figures 4 through 8)

Figure 7. View of the inner, poorly densified surface of the backup concrete.

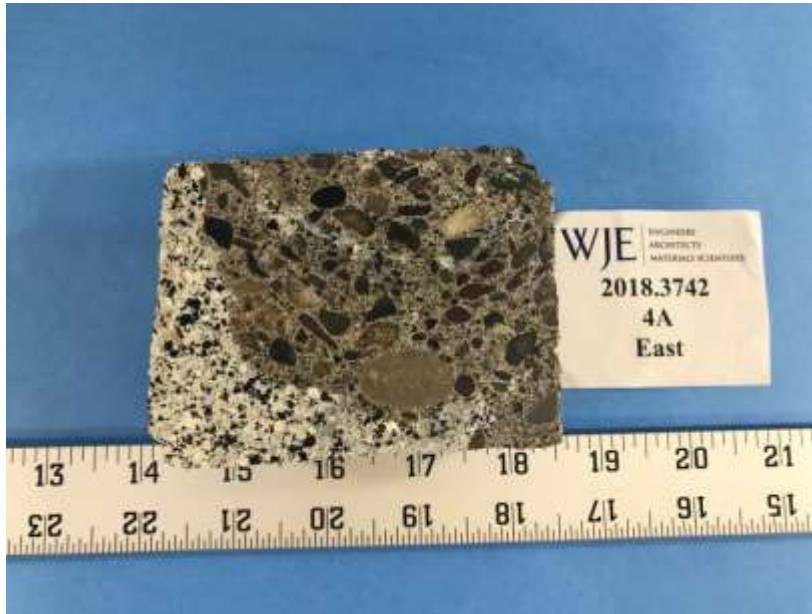
Figure 20. Lapped cross section of Core 4A. Exterior surface is on the left side of the image.

The cores each contain a variable thickness face mix that resembles natural stone (Figure 22 and Figure 23), and a backup mix that looks more like traditional concrete. The interface between the face mix and the backup mix is intimate, with the two mixes often intermixed. Portions of the face mix are visible within the backup mix, which is especially apparent in Core 4A East (Figure 20).

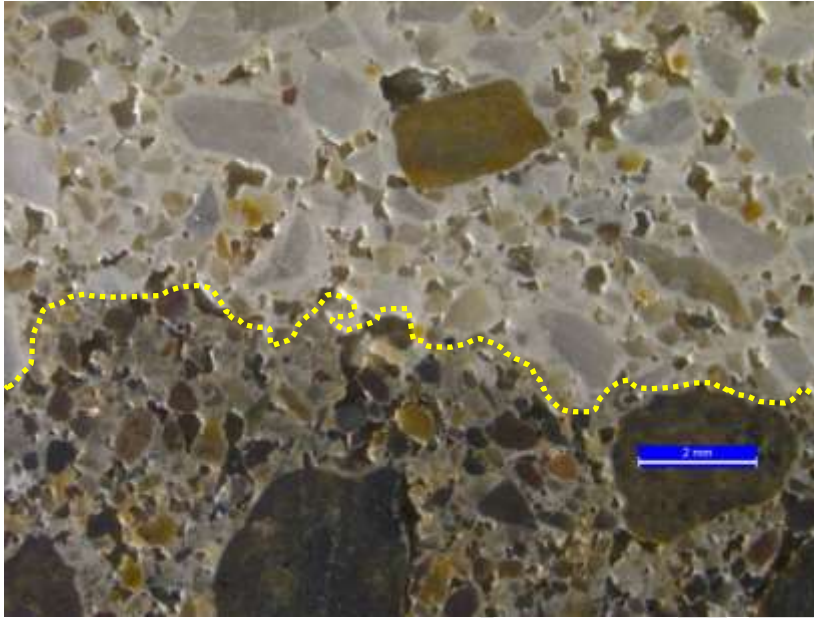
Figure 22. Boundary between the face mix (above dotted yellow line) and backup mix in Core 1A South. The face mix in this core resembles a limestone or sandstone natural stone.

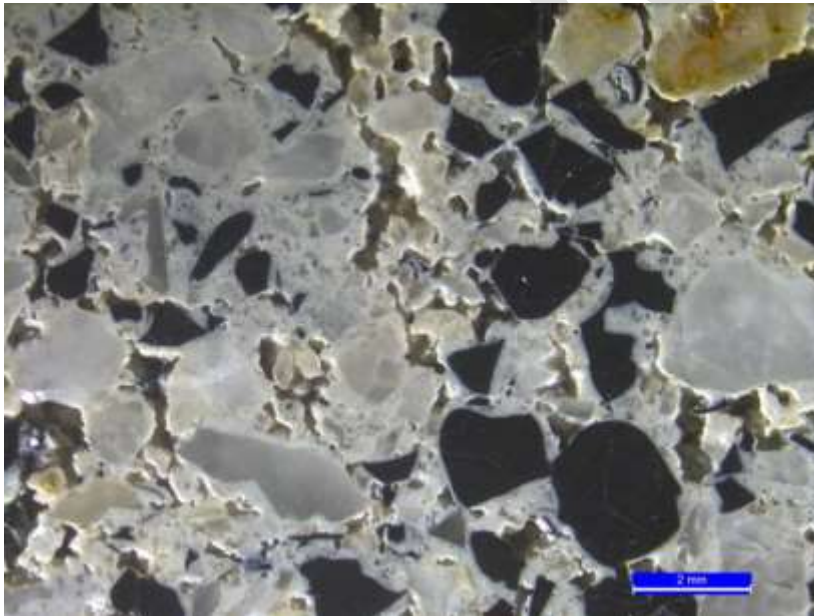
Figure 23. Image of a lapped cross section showing the face mix in Core 4A South. This face mix appears similar to a granite natural stone.

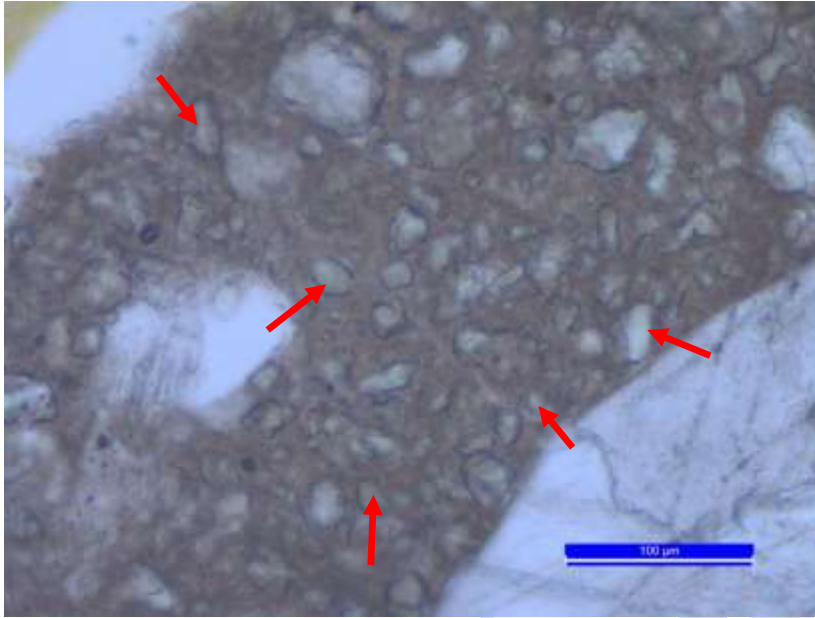
Core 3A North contains a white to beige surface mix with exposed aggregate particles. The cast stone is composed of coarse sand-sized crushed limestone and siliceous sand dispersed with white portland cement matrix (Figure 24). No supplementary cementitious materials such as slag cement, fly ash or silica fume were observed. No pigment was apparent. The aggregate appears hard and sound, and no evidence of material-related distress, such as alkali-aggregate reactivity is observed.

Figure 24. White portland cement (red arrows) present within the face mix of Core 3A North. Plane-polarized light image.

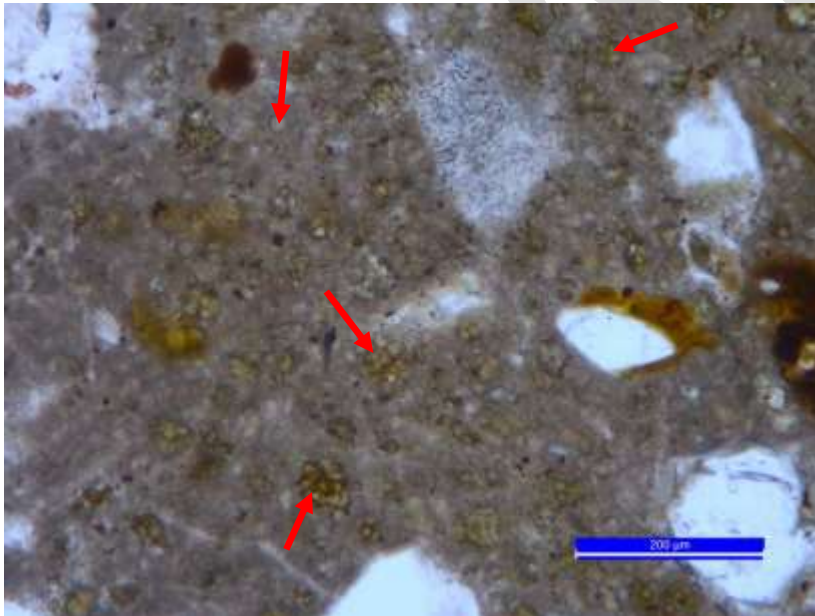
The backup mix is a traditional concrete, with nominal maximum-sized 3/8 inch pea gravel aggregate dispersed in non-air entrained portland cement paste (Figure 25). The backup mix also represent a dry tamp material, with non-spherical and irregularly shaped entrapped air voids generally abundant in each sample, and few to no spherical air voids.

Figure 25. Ordinary grey portland cement (red arrows) present within the backup mix in Core 3A North. Plane-polarized light image.
